**2025 OSIM Bridge Inspections Report**

**Town of Grand Valley  
5 Main Street North  
Grand Valley, ON L9W 5S6**

**November 2025  
30053109.2025**

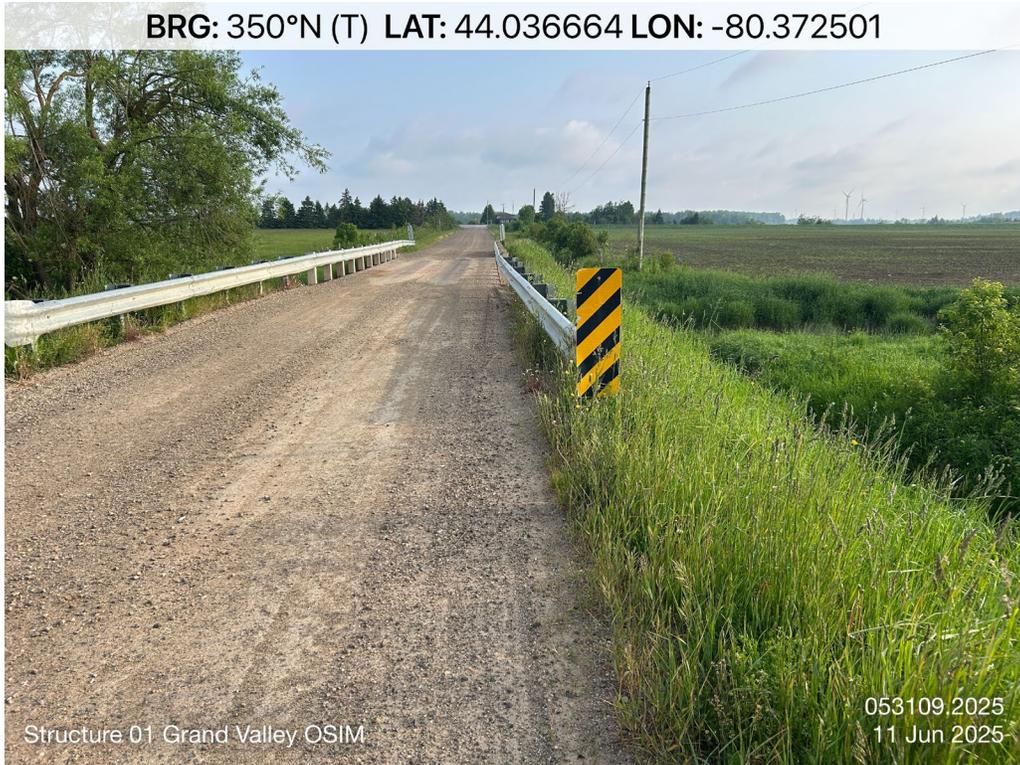
**APPROACH WEARING SURFACE – SOUTH – MODERATE POTHoles**

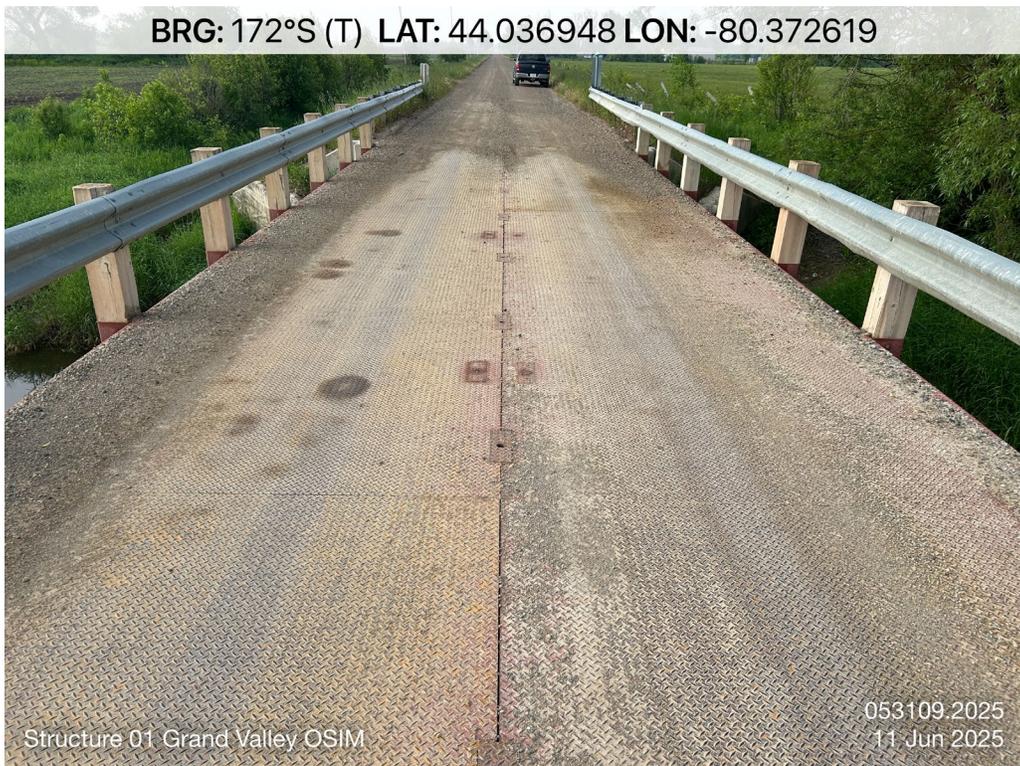
**DECK TOP – NORTH – LIGHT SURFACE CORROSION**

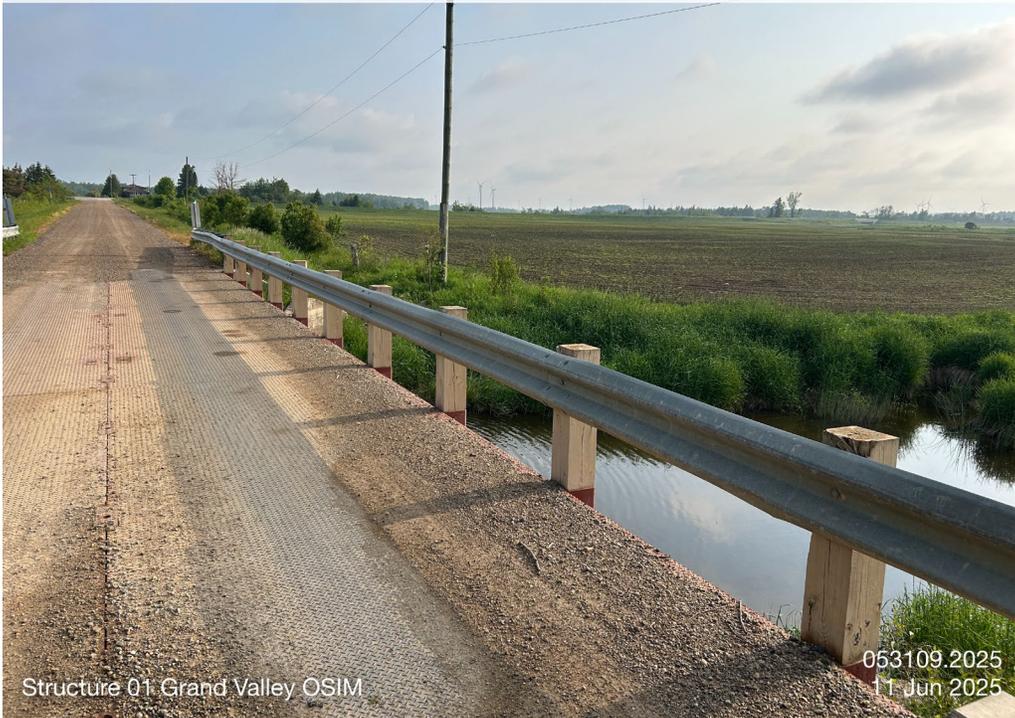
**BARRIER – EAST – IMPACT DAMAGE TO NORTH POSTS**

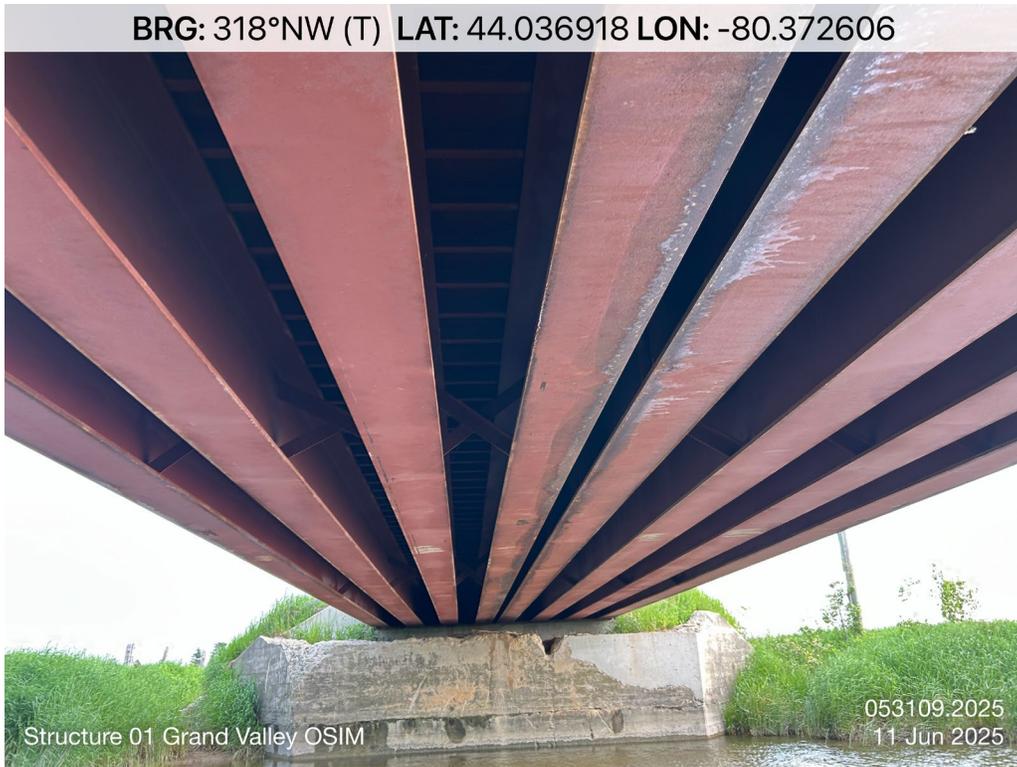
**GIRDERS – MIDDLE – LIGHT SURFACE CORROSION**

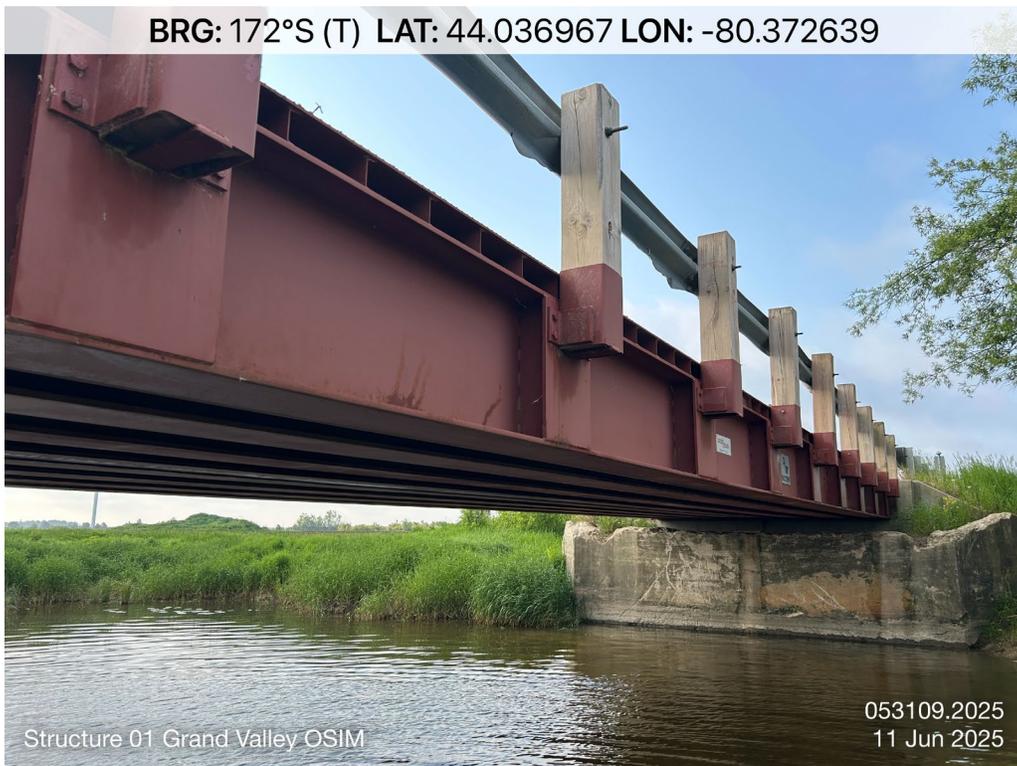
**ABUTMENT WALLS – SOUTH – HAIRLINE STAINED CRACKS**

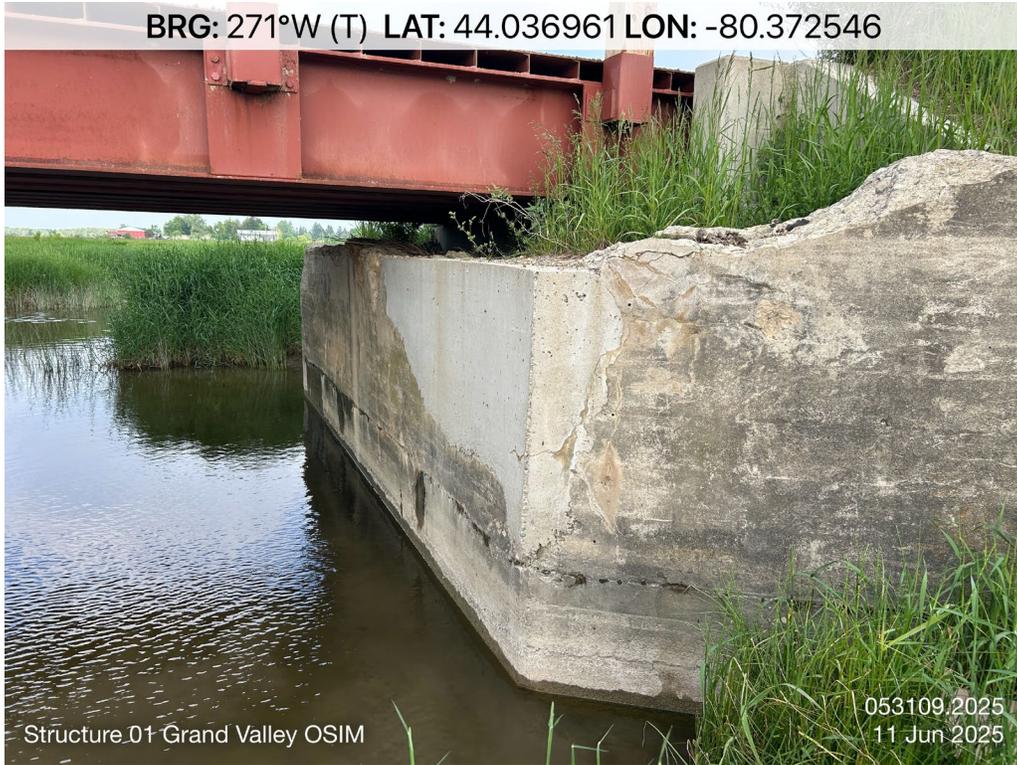
**FOUNDATION – NORTH – TOP OF FOOTING EXPOSED**

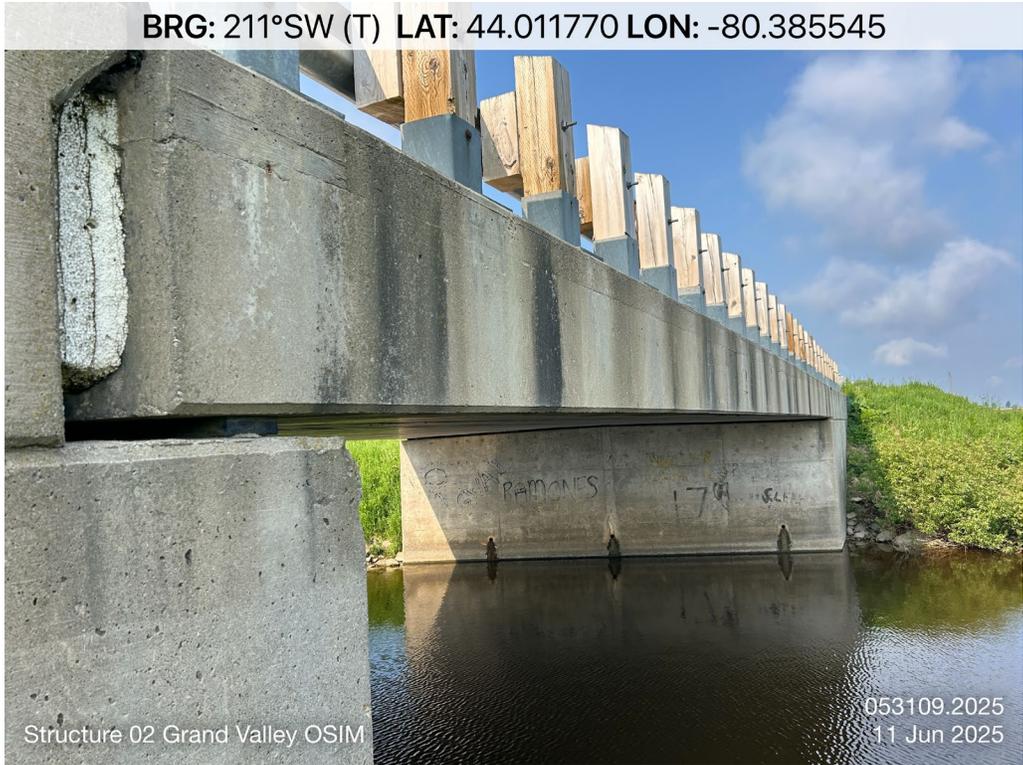
**SOFFIT EXTERIOR – NORTH – MOISTURE STAINING**

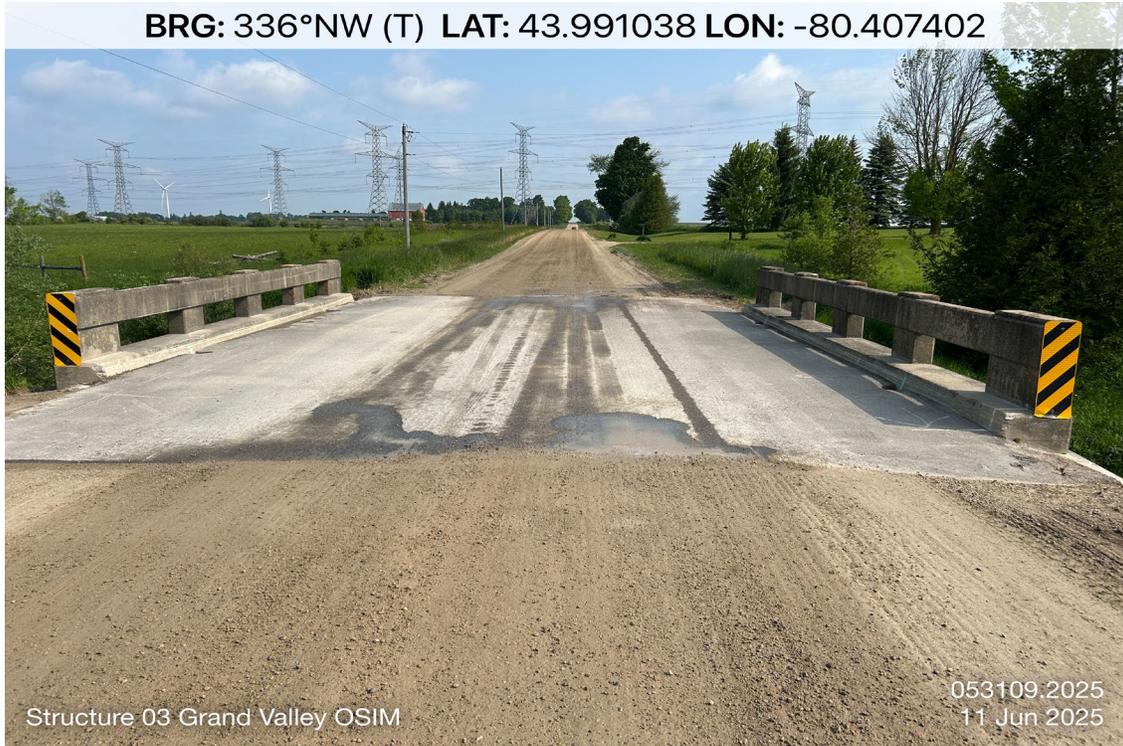
**DECK WEARING SURFACE – SOUTH – SURFACE PONDING ON DECK**

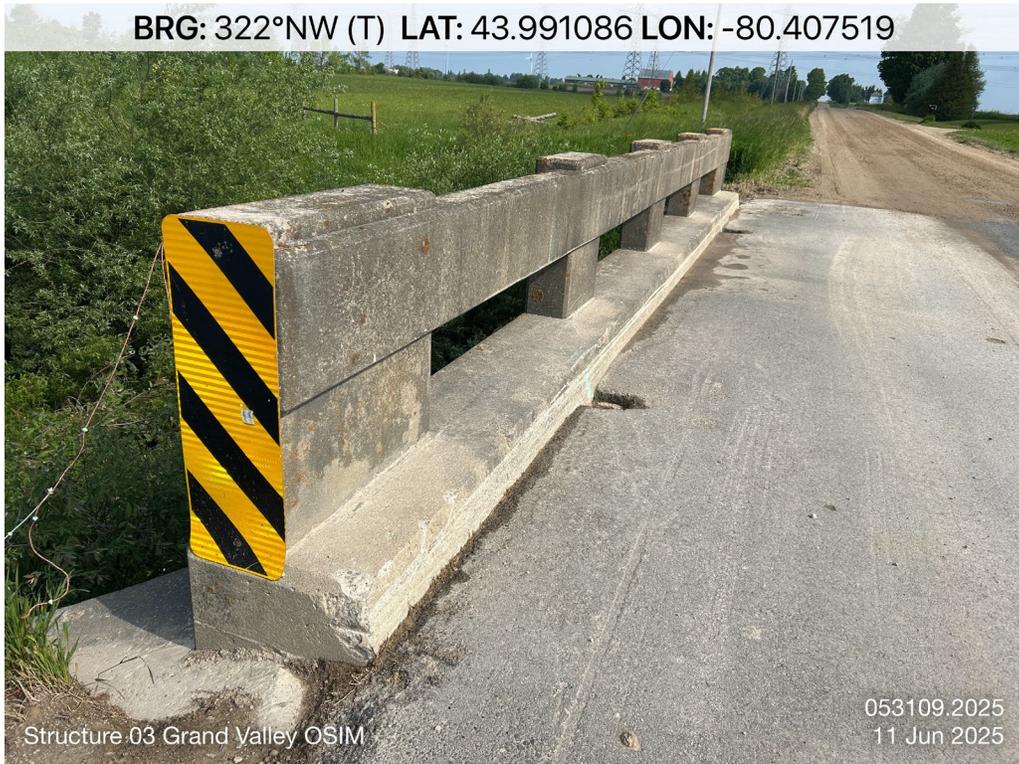
**BARRIERS – SOUTHWEST – SMALL SPALL**

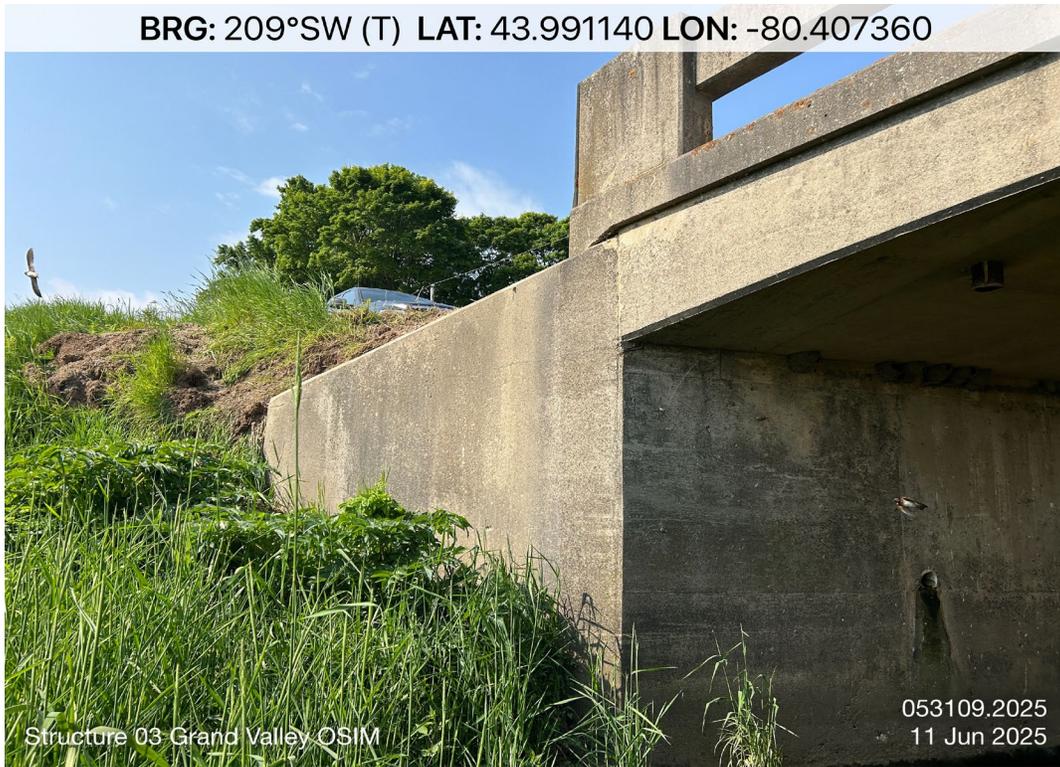
**WINGWALL – SOUTHEAST – LIGHT SCALLING**

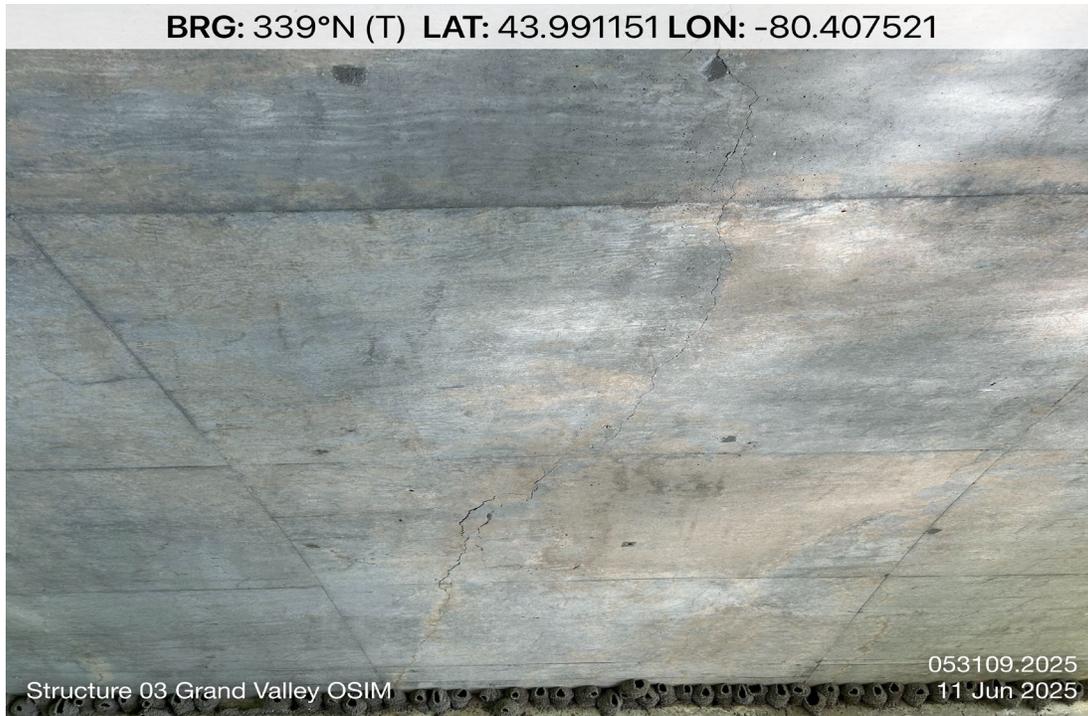
**SOFFIT – INTERIOR – WIDE AND MEDIUM CRACKS THROUGH SPAN AND LIGHT DELAMINATIONS**

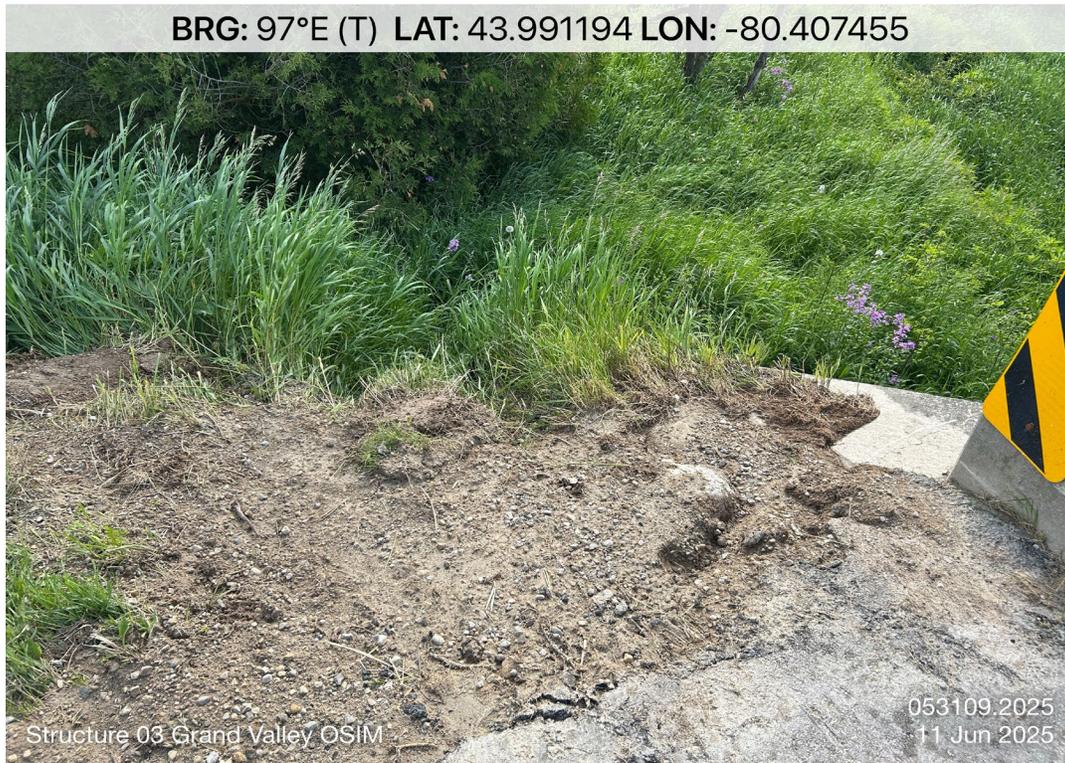
**EMBANKMENT – SOUTHEAST – WASHOUT/EROSION**

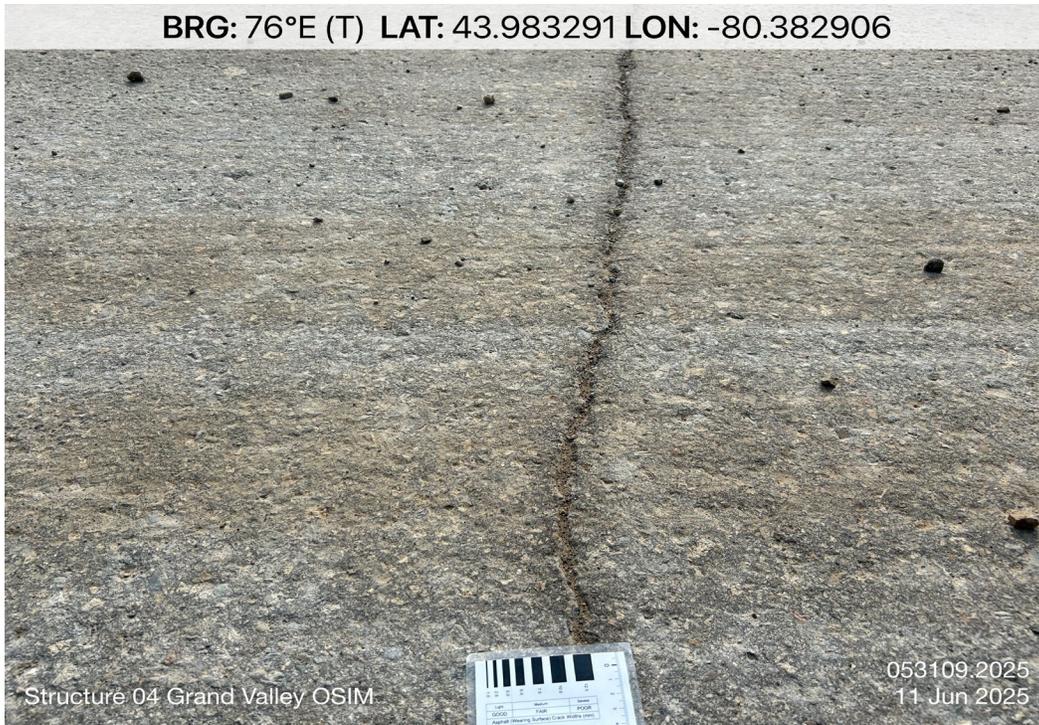
**DECK TOP – WEST – WIDE LONGITUDINAL CRACK THROUGH CENTER WITH DELAMINATIONS**

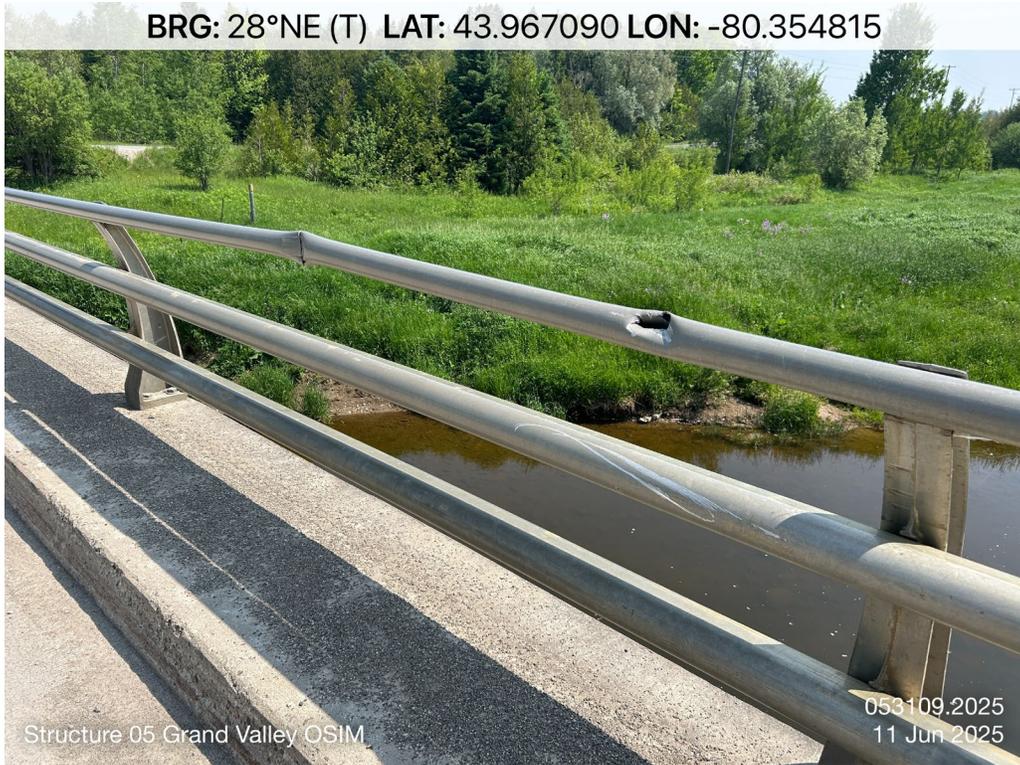
**RAILING SYSTEM – SOUTHEAST – IMPACT DAMAGE**

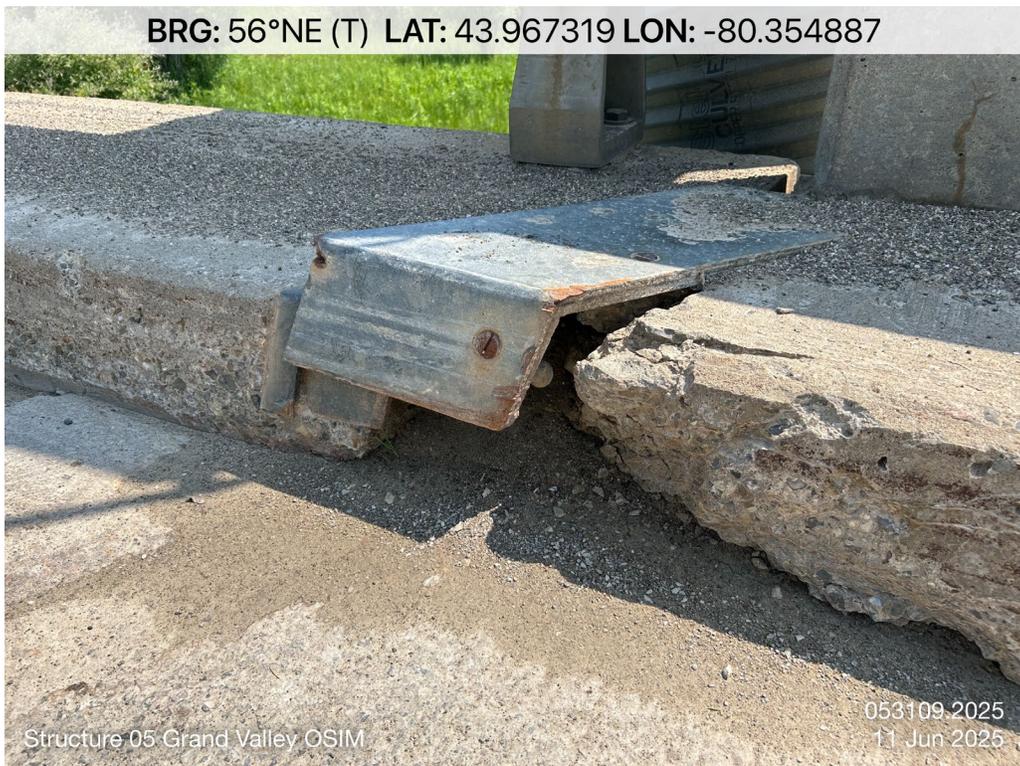
**CURB – EAST – IMPACT DAMAGE, SPALL AND ABRASIONS THROUGHOUT**

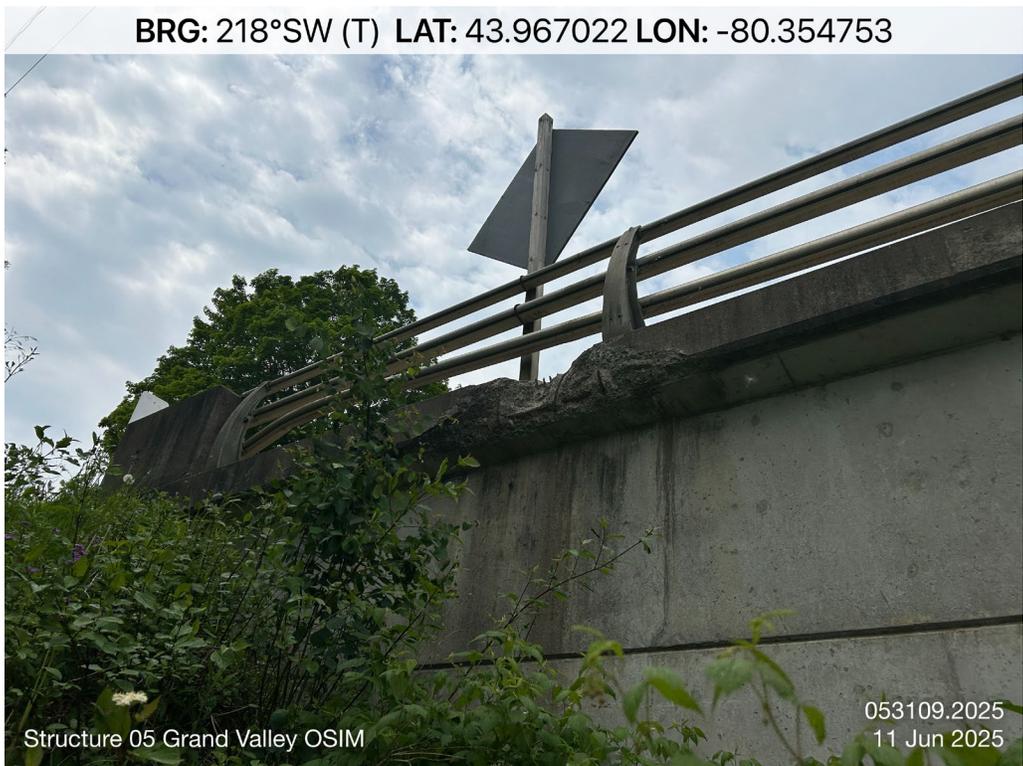
**WINGWALL – NORTHEAST – SEVERE SPALL WITH EXPOSED CORRODED REBAR**

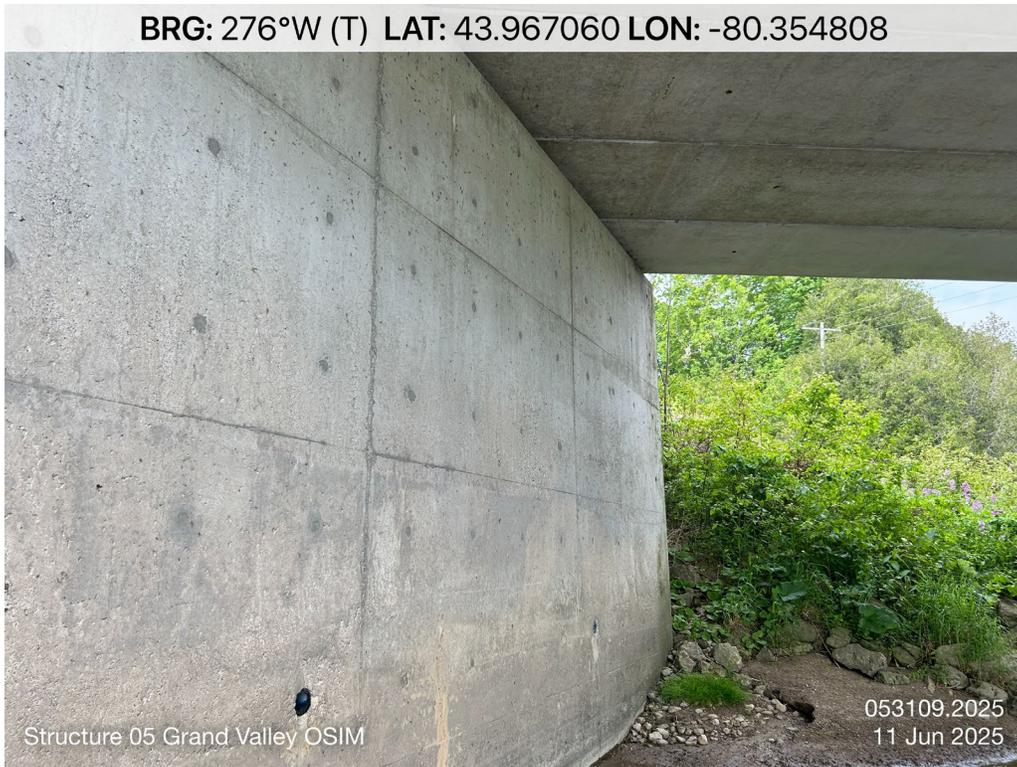
**ABUTMENT WALL – SOUTH – FULL HEIGHT CRACK AND LIGHT HONEYCOMBING**

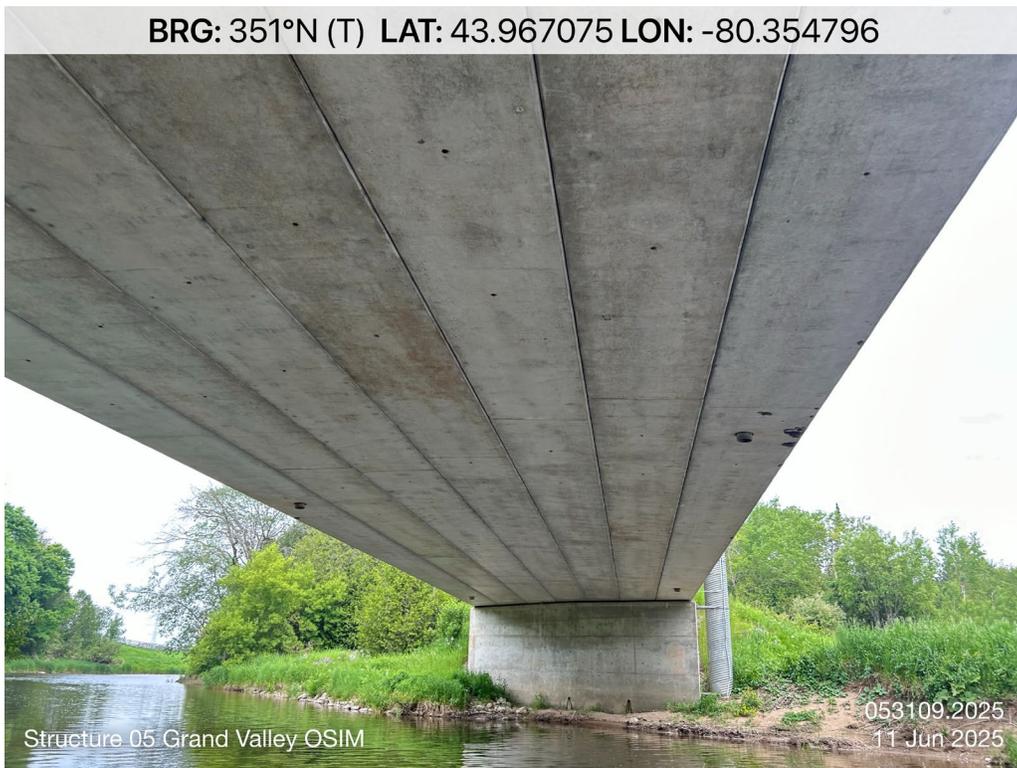
**GIRDERS – MIDDLE – SPALLS AROUND DECK DRAINS**

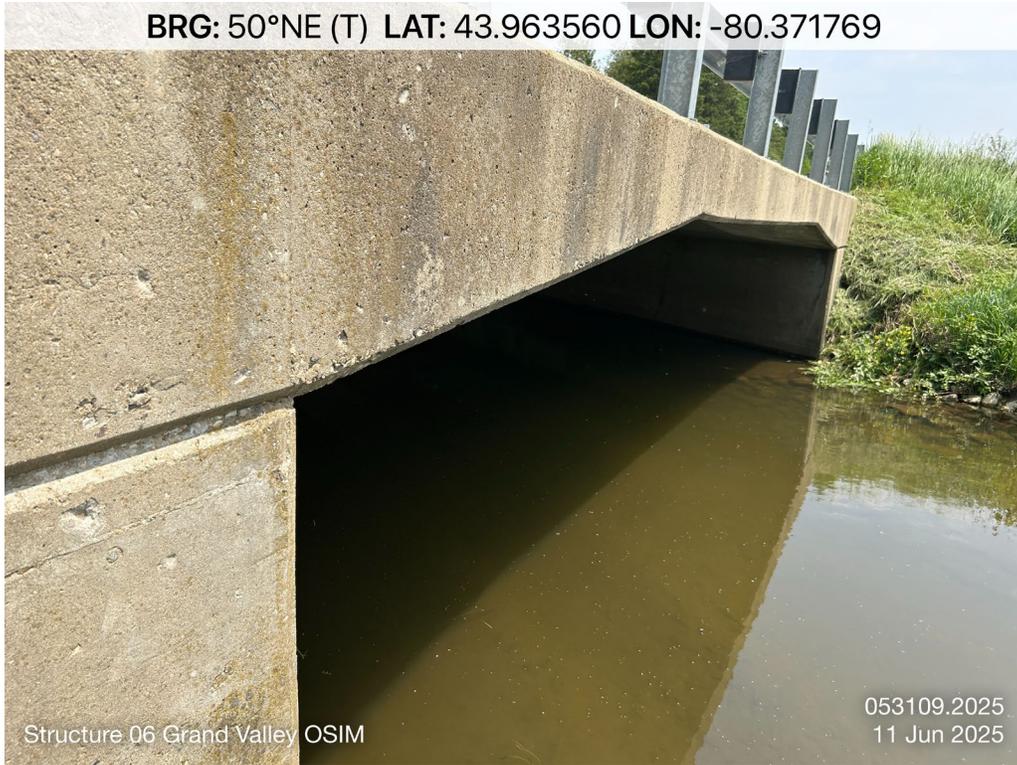
**SOFFIT EXTERIOR – SOUTH – NARROW STAINED CRACKS**

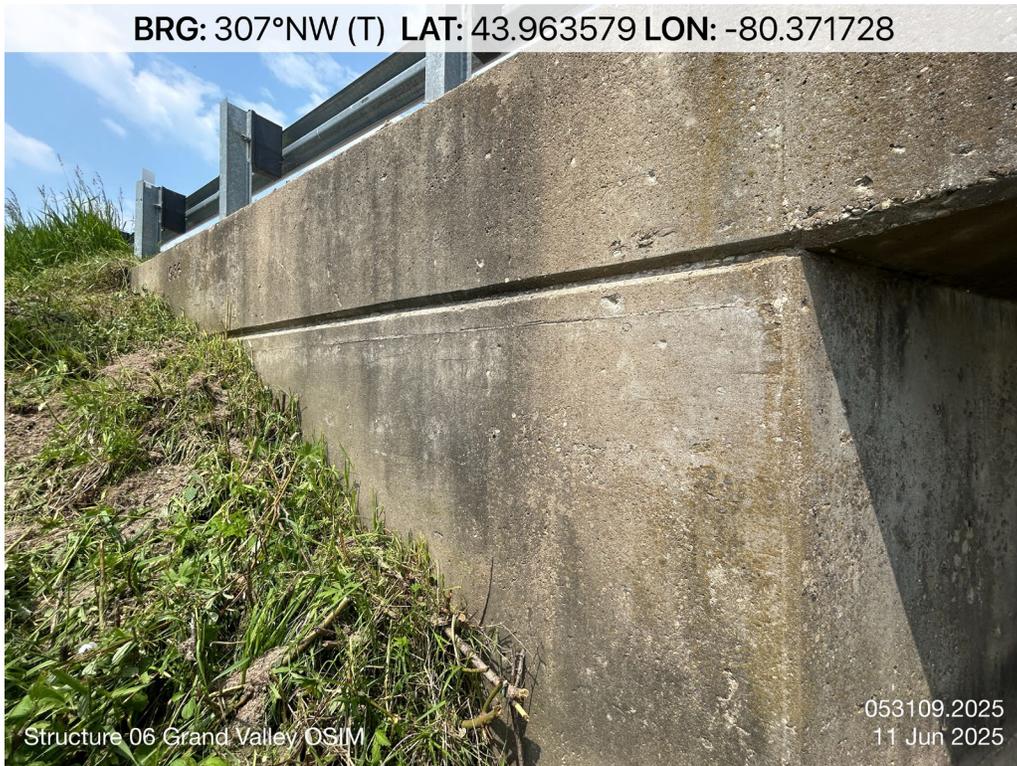
**WINGWALL – SOUTHWEST – NARROW STAINED CRACKS**

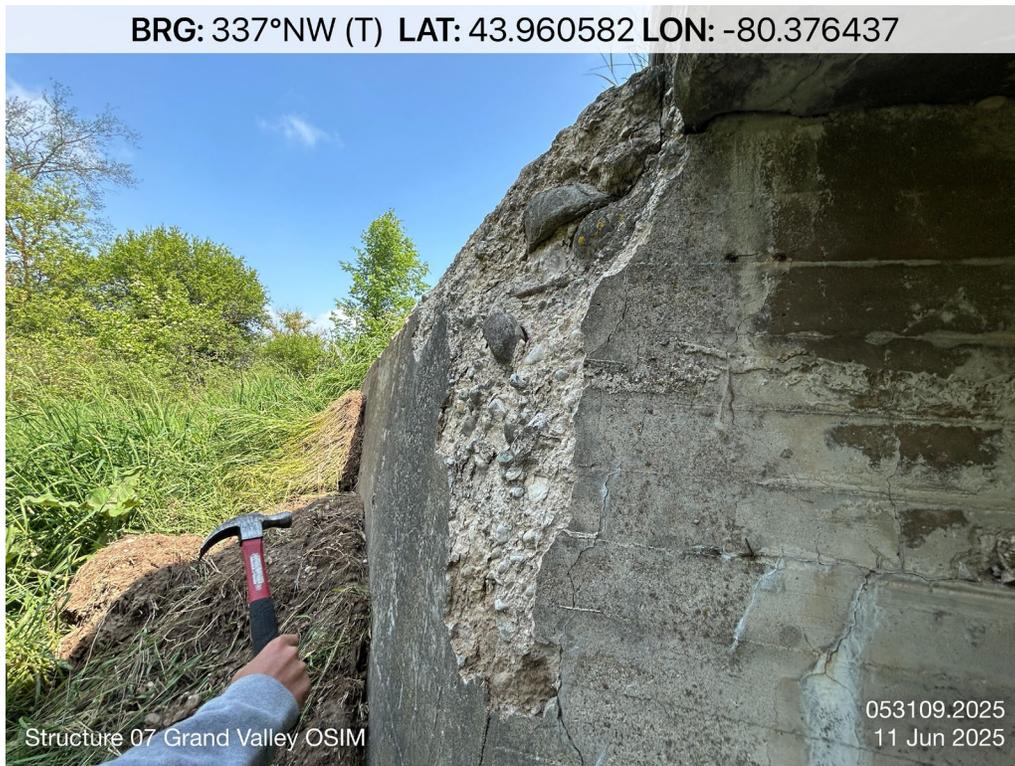
**WINGWALL – NORTHWEST – DISINTEGRATIONS AND COLD JOINTS**

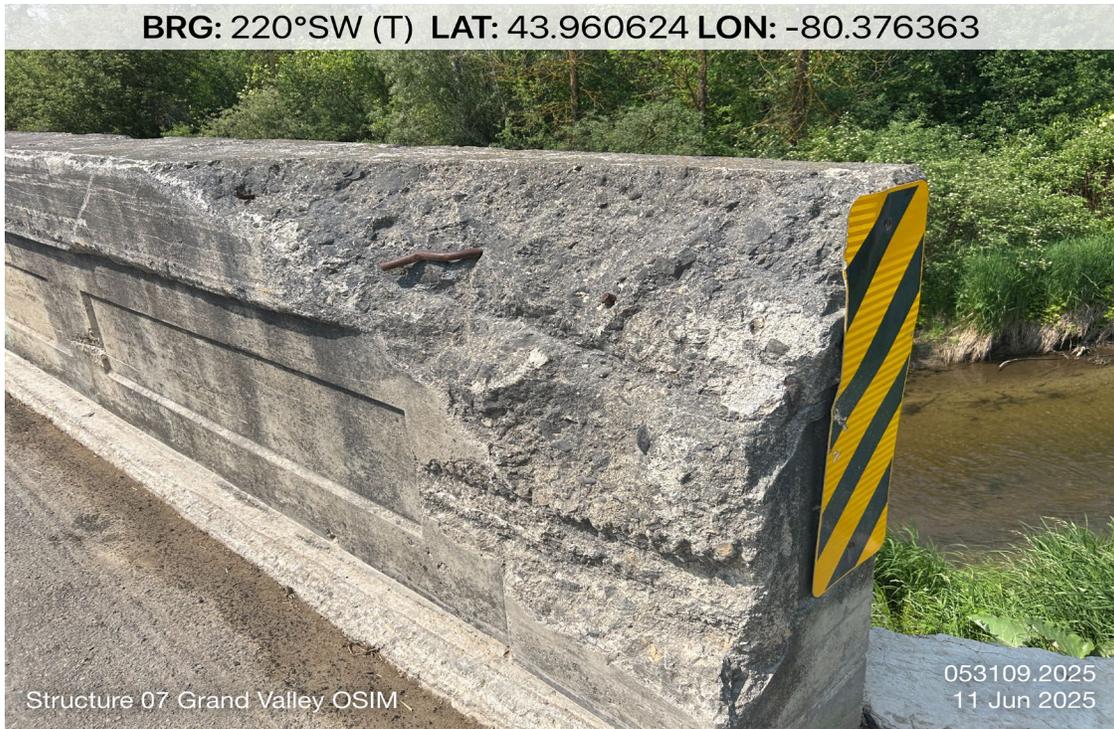
**GIRDERS – SOUTHWEST – SEVERE SPALLS WITH EXPOSED CORRODED REBAR, DISINTEGRATIONS AND DELAMINATIONS**

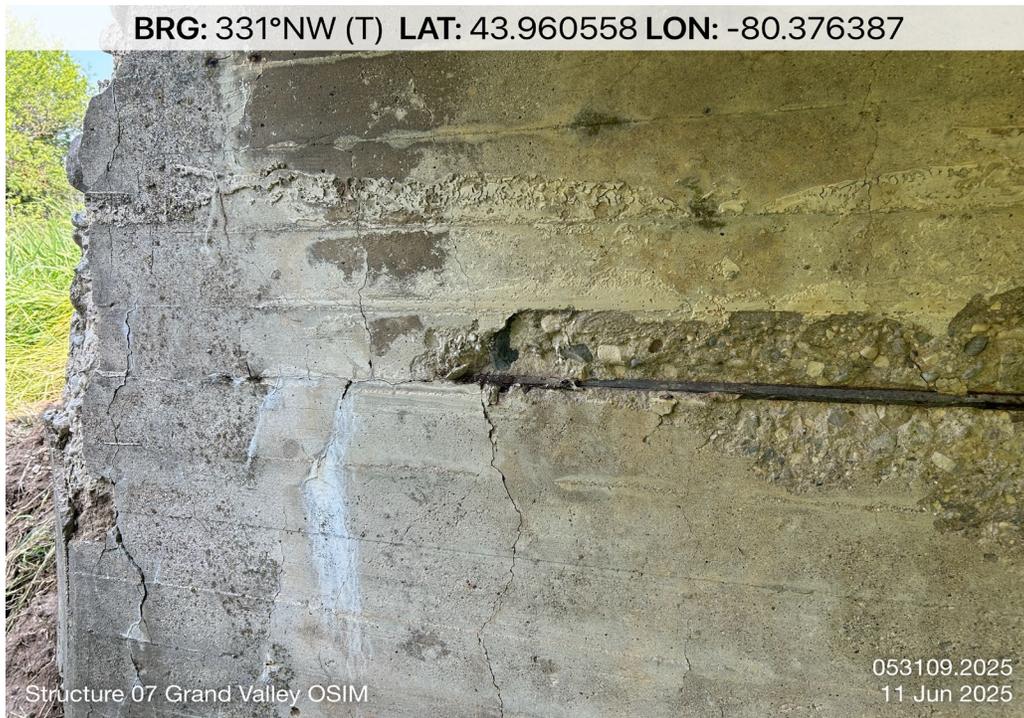
**ABUTMENT WALLS – NORTH – SPALLS WITH EXPOSED CORRODED REBAR, EROSION AT THE BASE, MEDIUM TO WIDE CRACKS AND DELAMINATIONS**

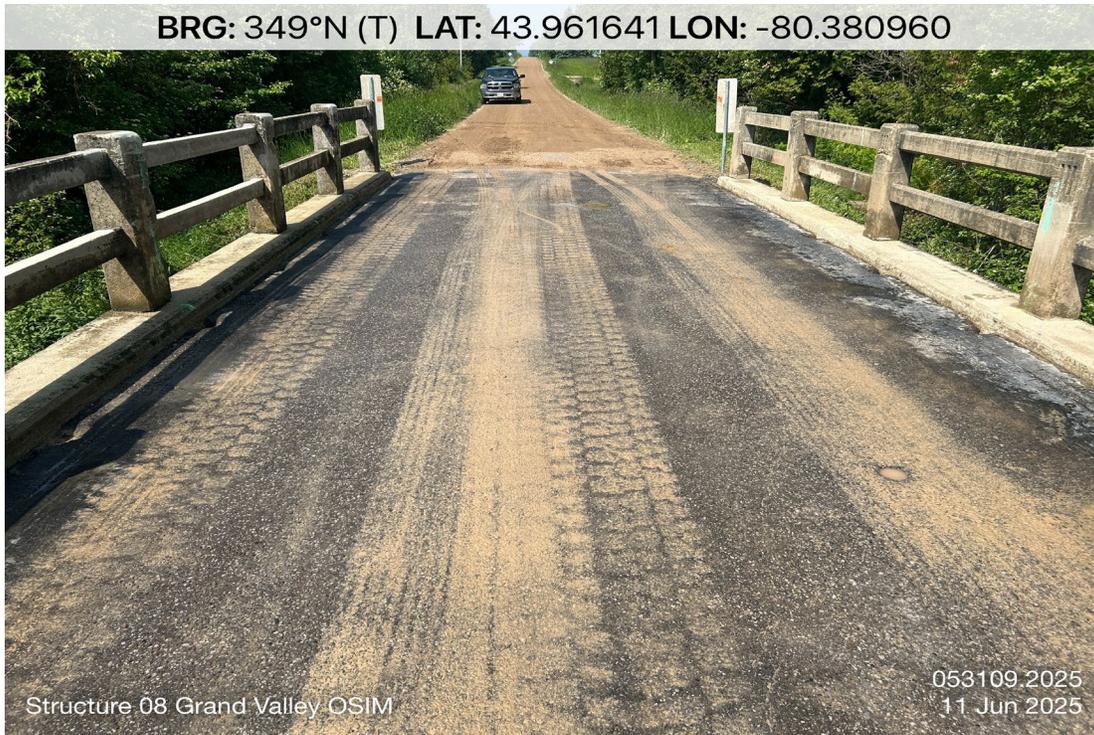
**DECK TOP – WEST – LOCALIZED SPALLING WITH EXPOSED CORRODED REBAR AND SCALING THROUGHOUT**

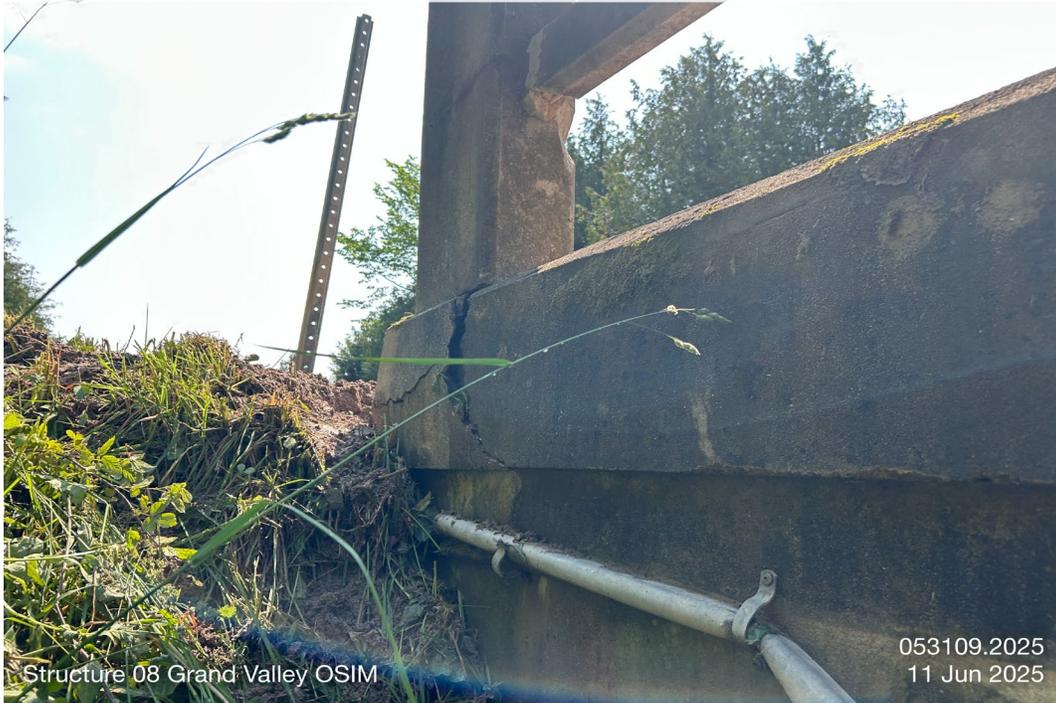
**WINGWALL – NORTHEAST – WIDE CRACK WHERE IT MEETS CURB**

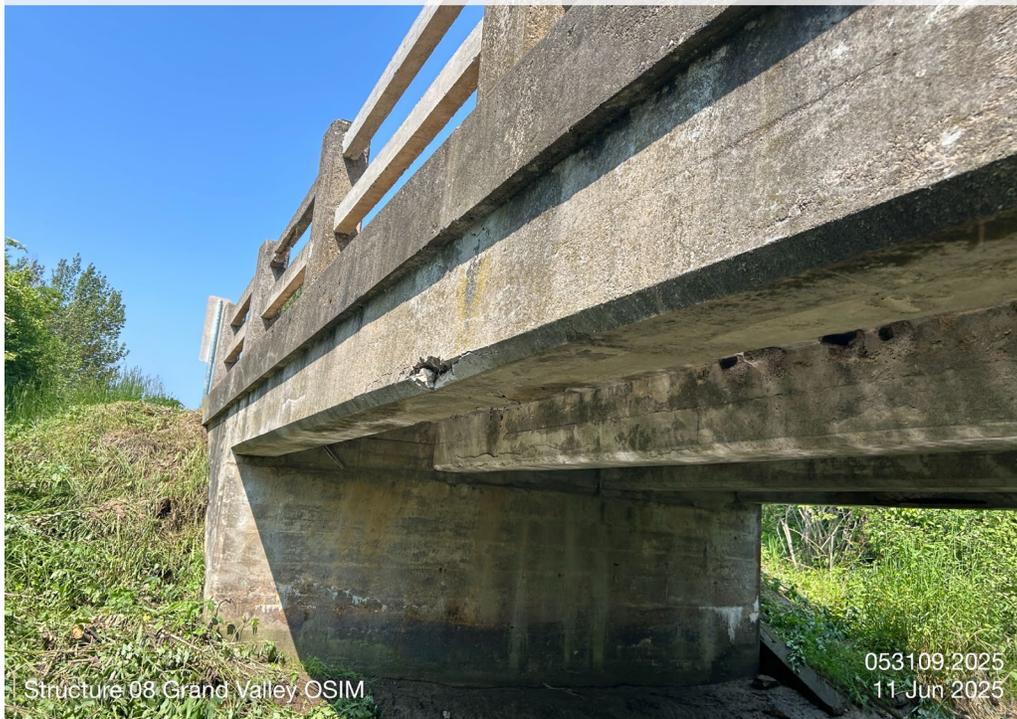
**SOFFIT EXTERIOR - SOUTH – SMALL POPOUTS AND DELAMINATION NE**

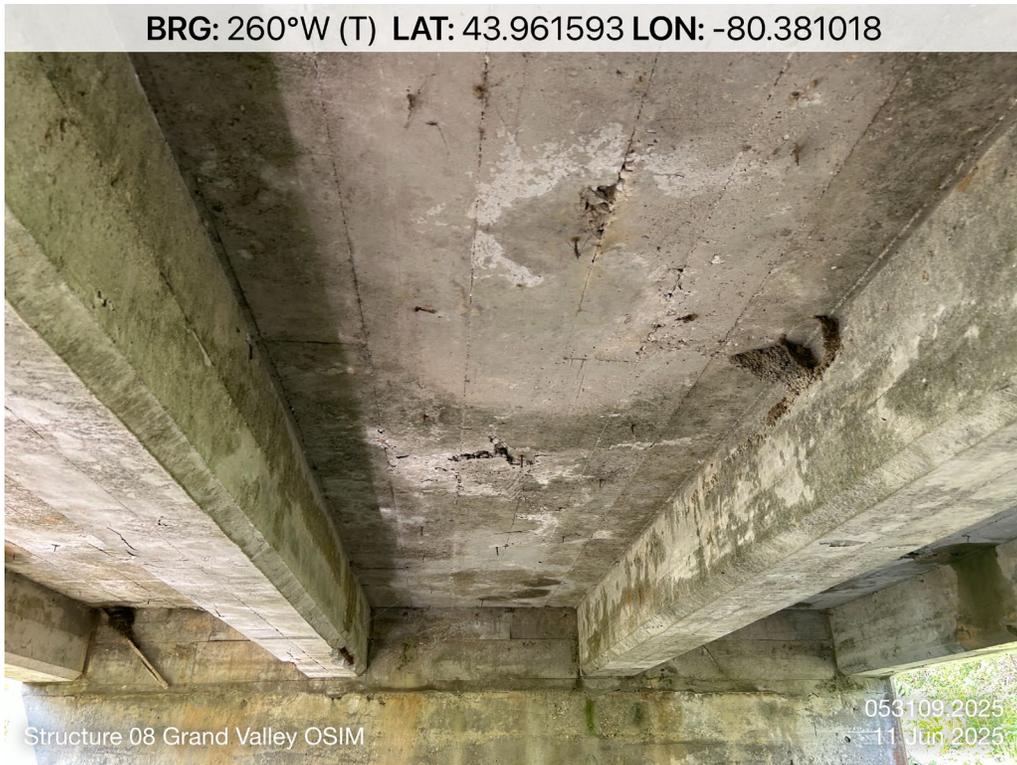
**SOFFIT INTERIOR - WEST – DELAMINATIONS AND SPALLS THROUGHOUT**

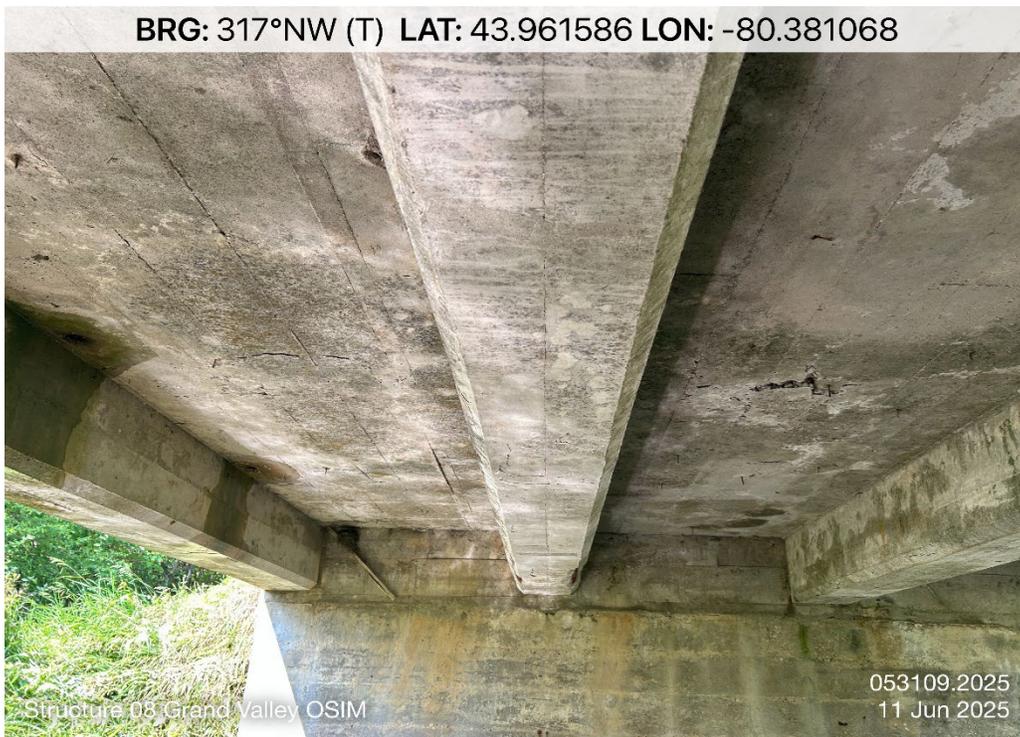
**GIRDERS – MIDDLE – WIDE HORIZONTAL CRACKING WITH EXPOSED CORRODED REBAR WITH DELAMINATIONS**

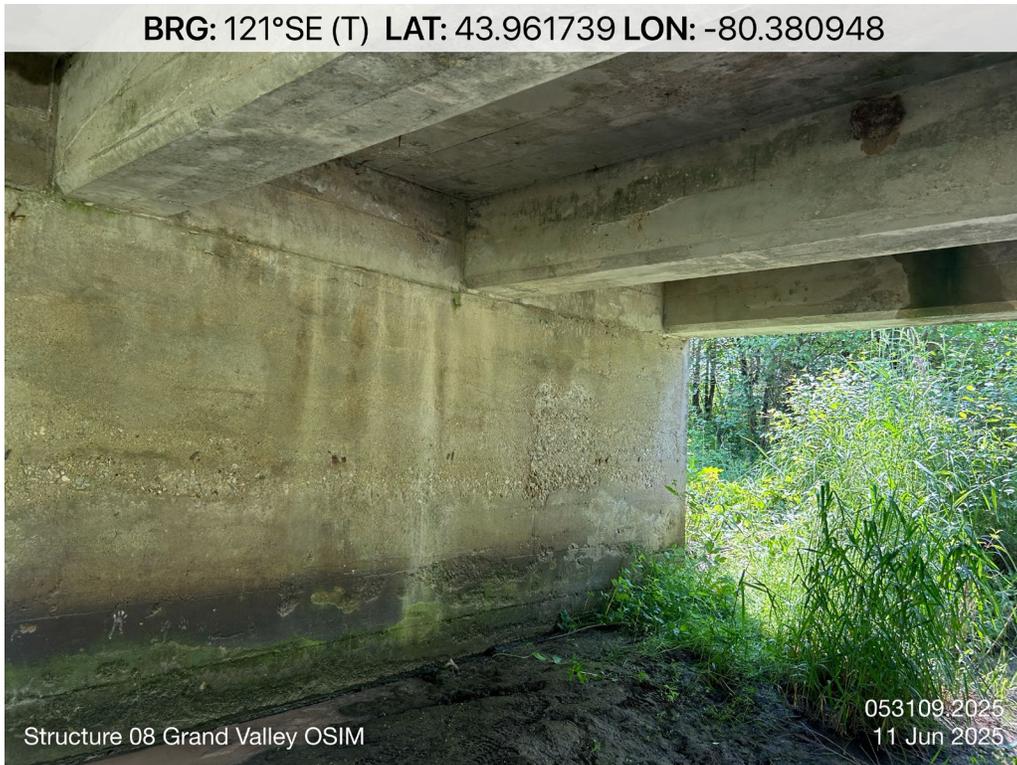
**ABUTMENT WALLS – EAST – MODERATE SCALLING AND VERTICAL CRACK**
