**2025 OSIM Bridge Inspections Report**

**Town of Grand Valley  
5 Main Street North  
Grand Valley, ON L9W 5S6**

**November 2025  
30053109.2025**

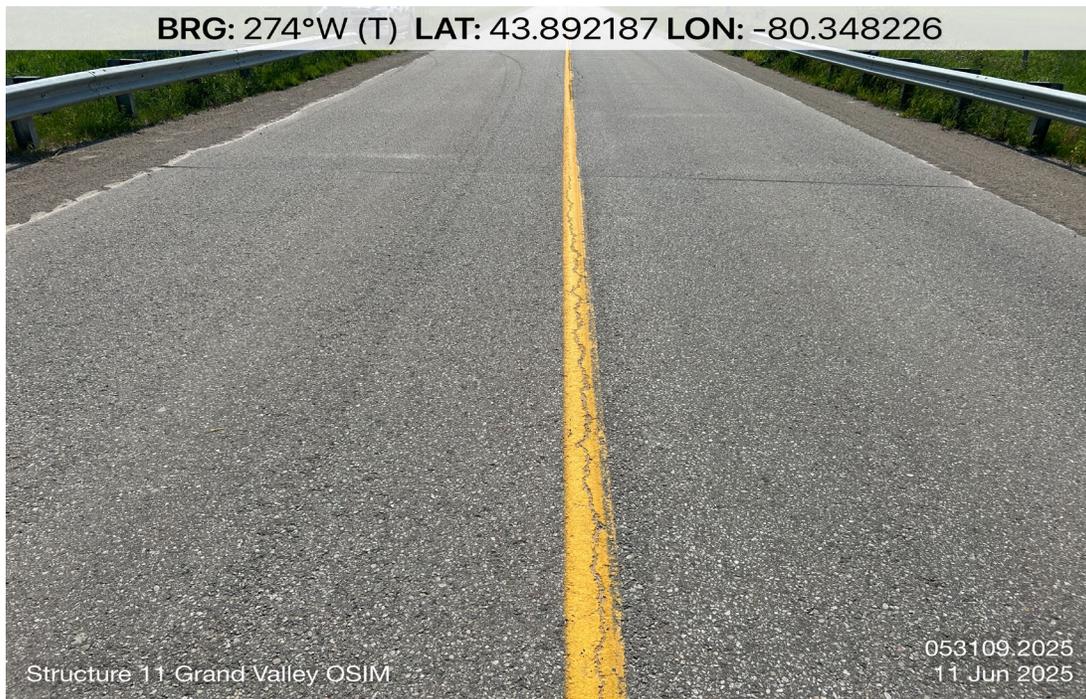
**DECK WEARING SURFACE – EAST – SEVERE LONGITUDINAL CRACK ALONG CENTERLINE**

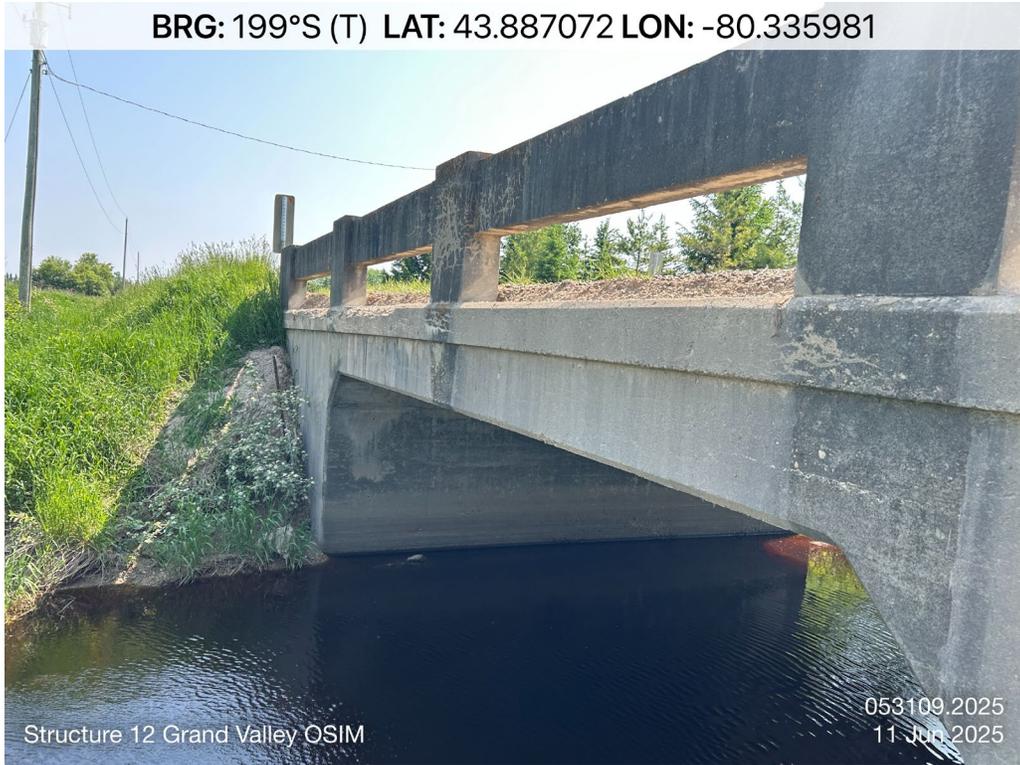
**SOFFIT EXTERIOR – SOUTHEAST – STAINED EFFLORESCENCE CRACKS**

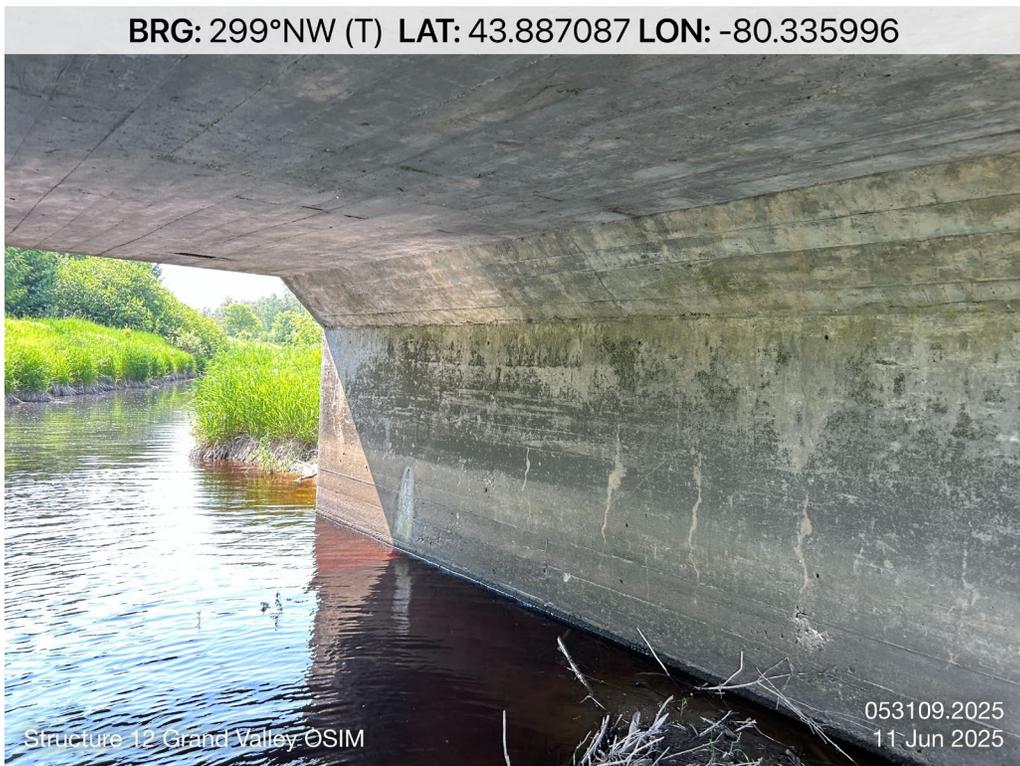
**SOFFIT – INTERIOR – LIGHT HONEYCOMBING THROUGHOUT CENTER**

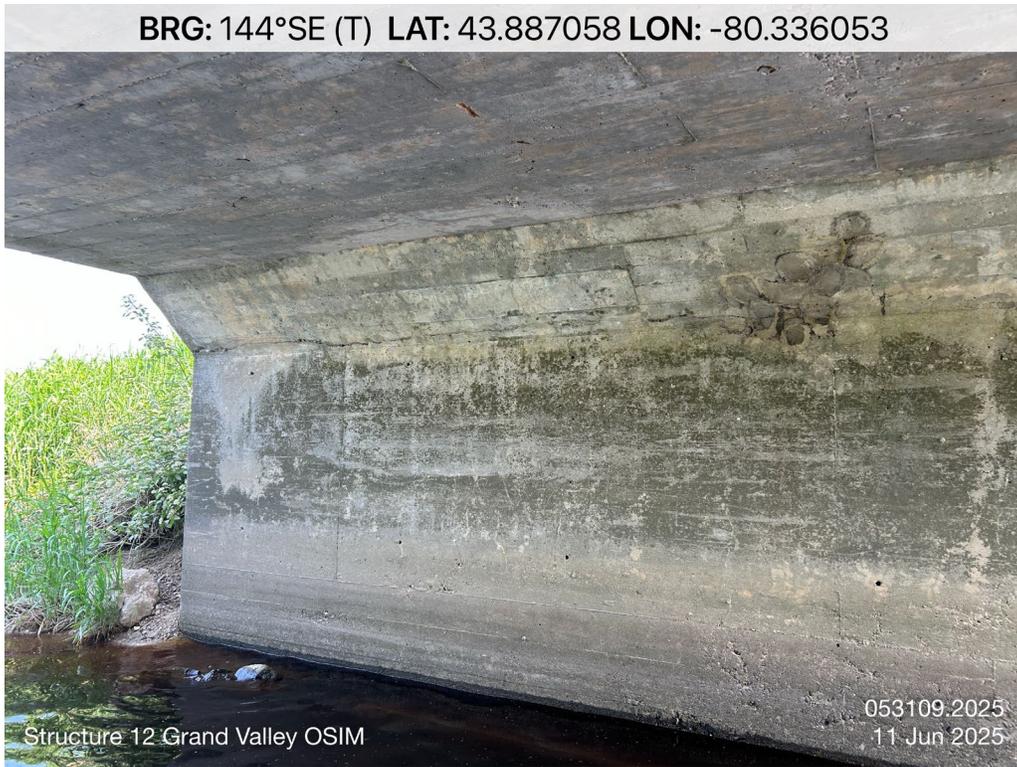
**ABUTMENT WALLS – SOUTH – LIGHT SCALING AND VERTICAL HAIRLINE CRACKS**

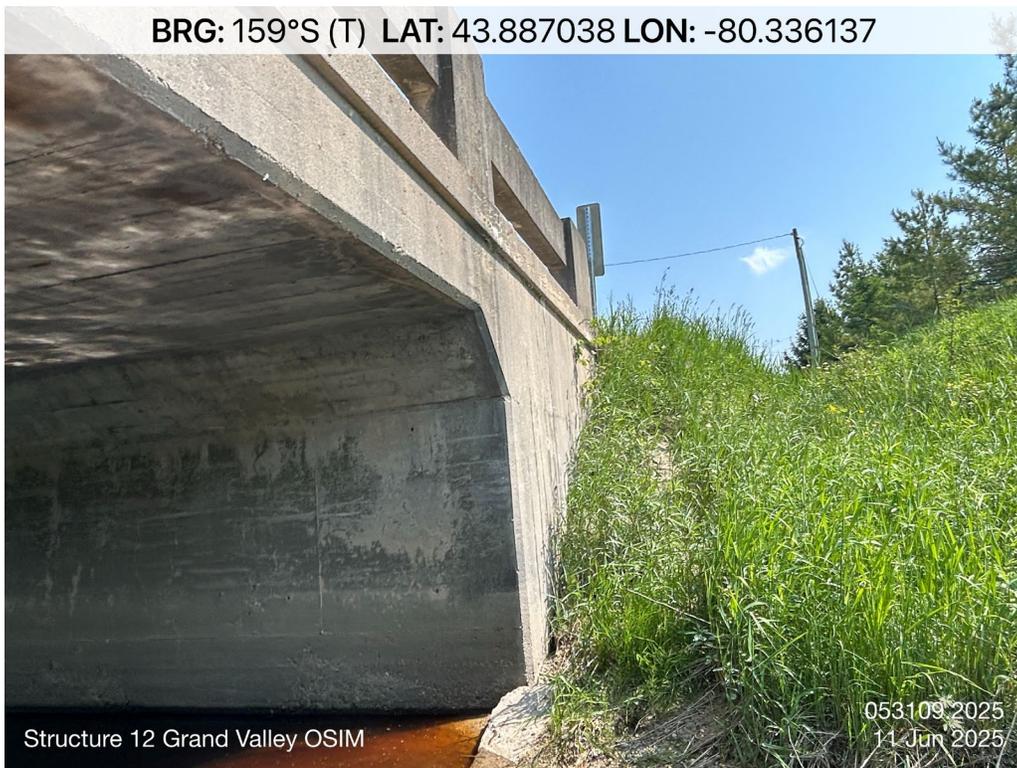
**EMBANKMENT – SOUTHWEST – LIGHT WASHOUT**

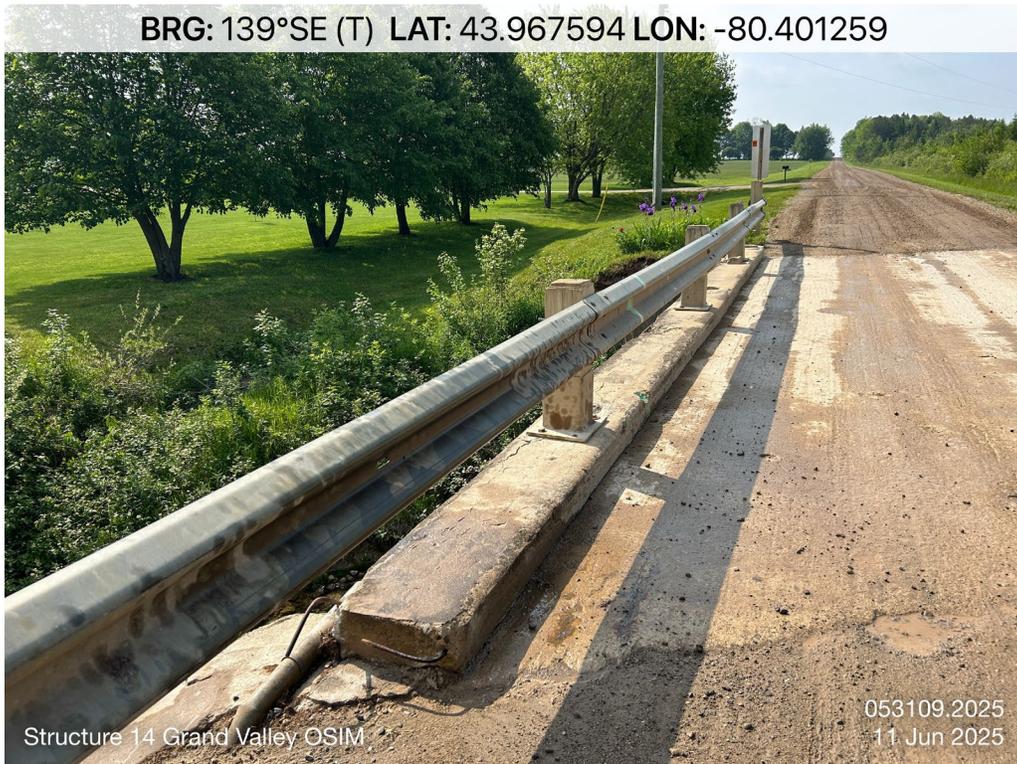
**BARRIER – WEST – MINOR IMPACT DAMAGE AT ENDS**

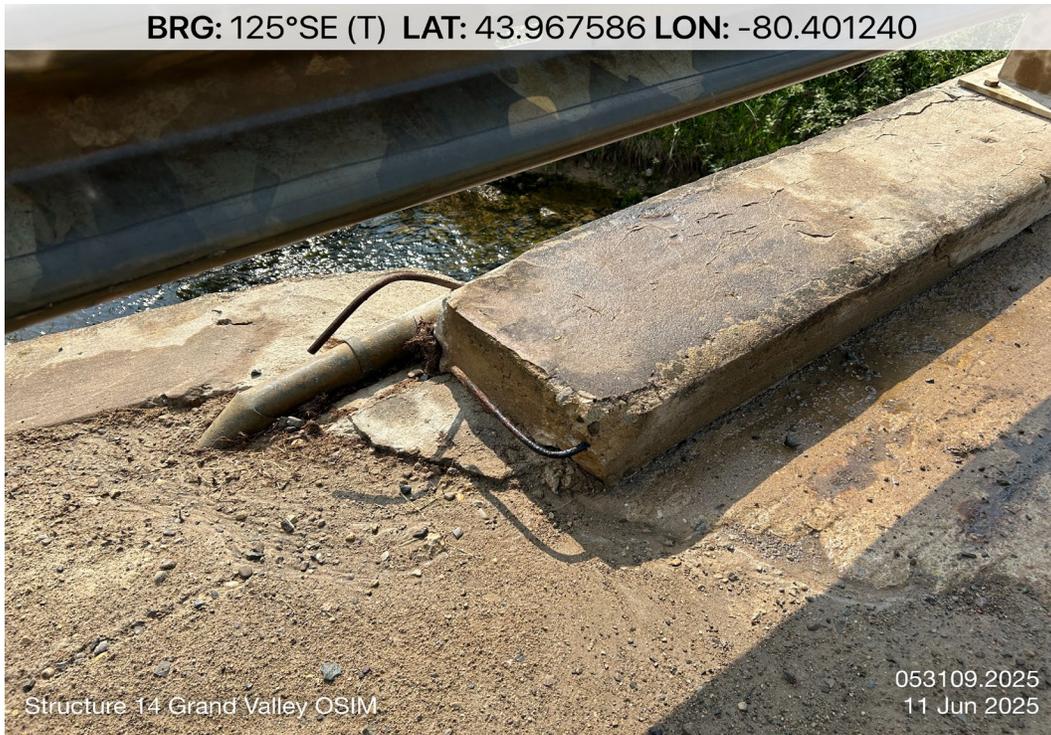
**CURB – SOUTHEAST – WIDE CRACK AND DELAMINATIONS WITH EXPOSED CORRODED REBAR**

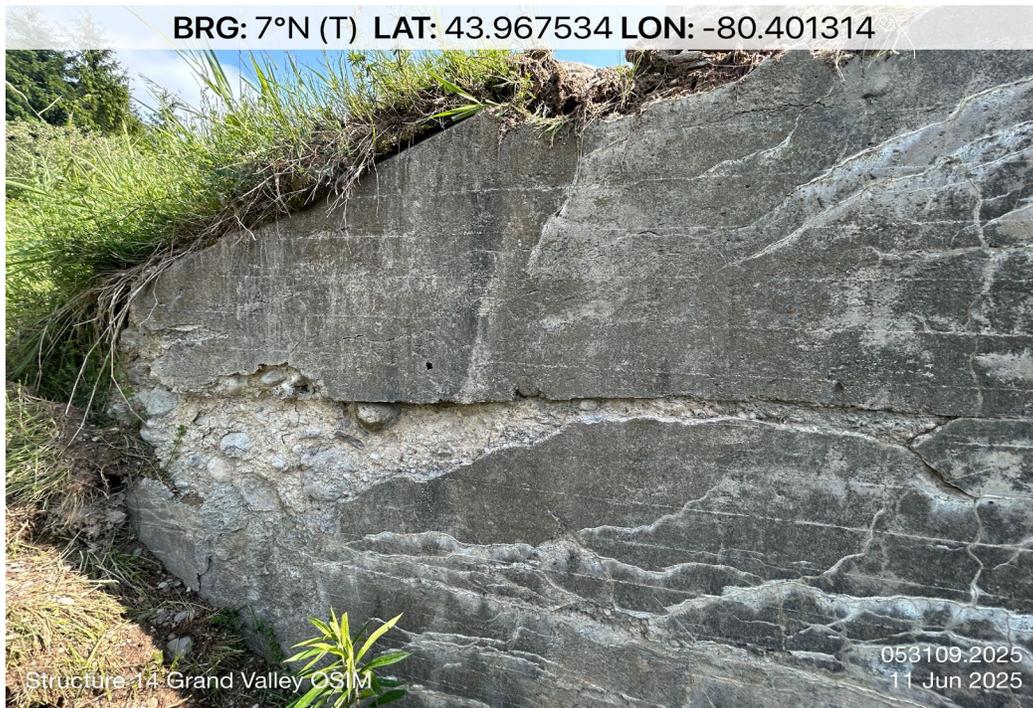
**WINGWALL – NORTHWEST – SEVERELY DISINTEGRATED, SPALLED AND DELAMINATED**

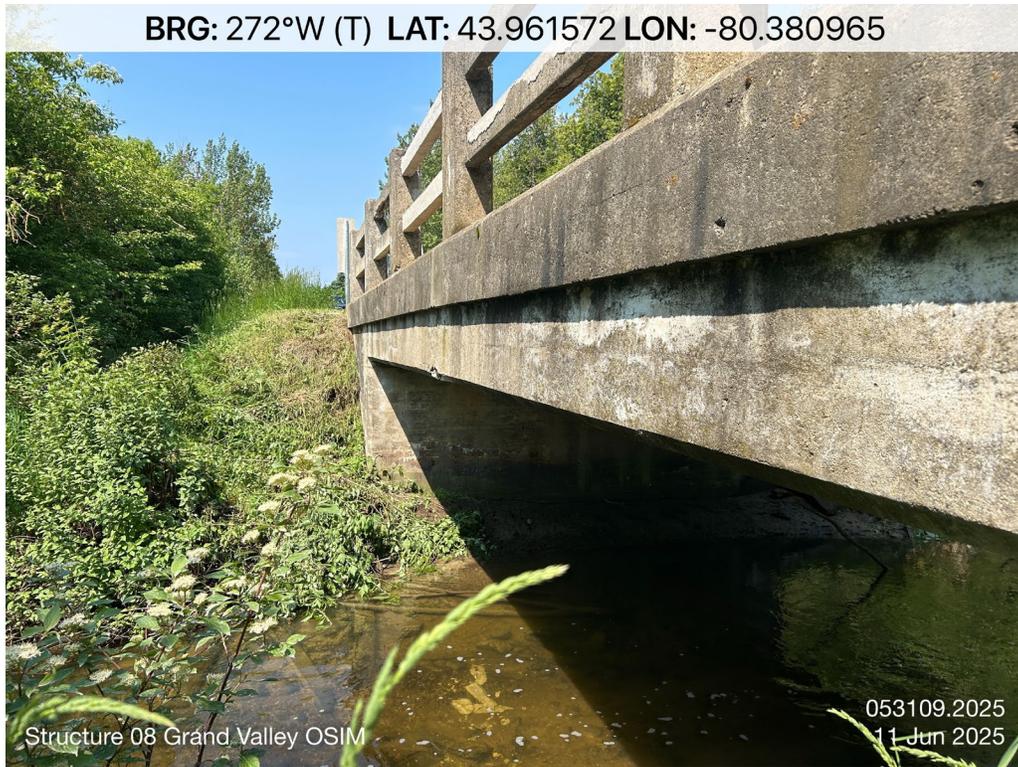
**SOFFIT EXTERIOR – WEST – SPALLS AND DELAMINATIONS**

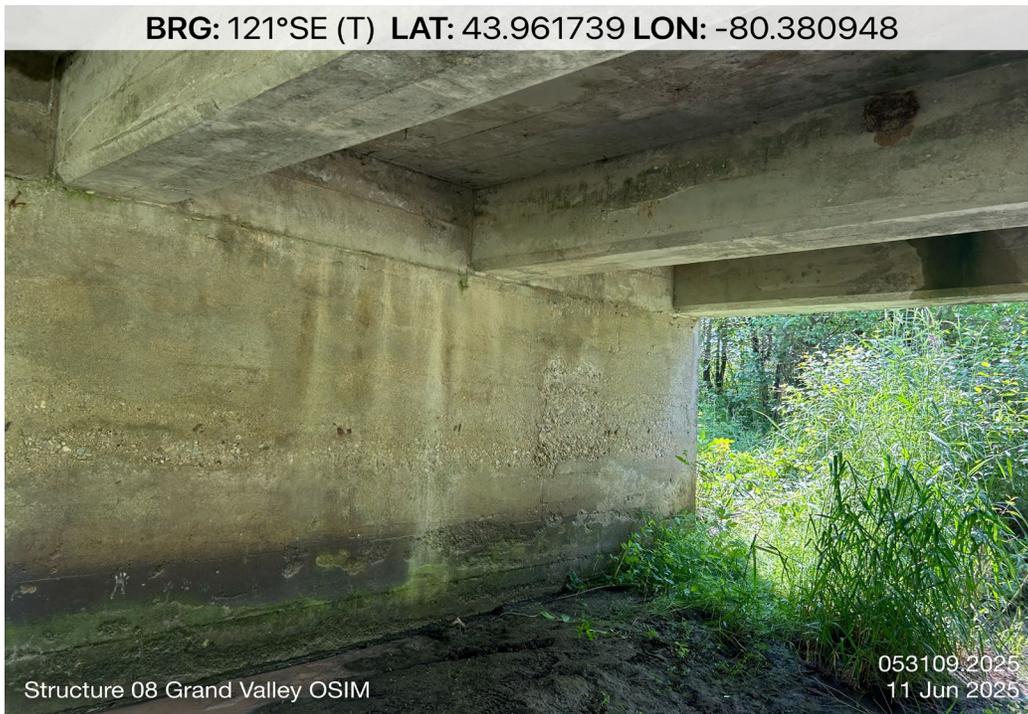
**ABUTMENT WALL – NORTH – SEVERE EROSION ALONG WATERLINE, HONEYCOMBING AND DELAMINATIONS**

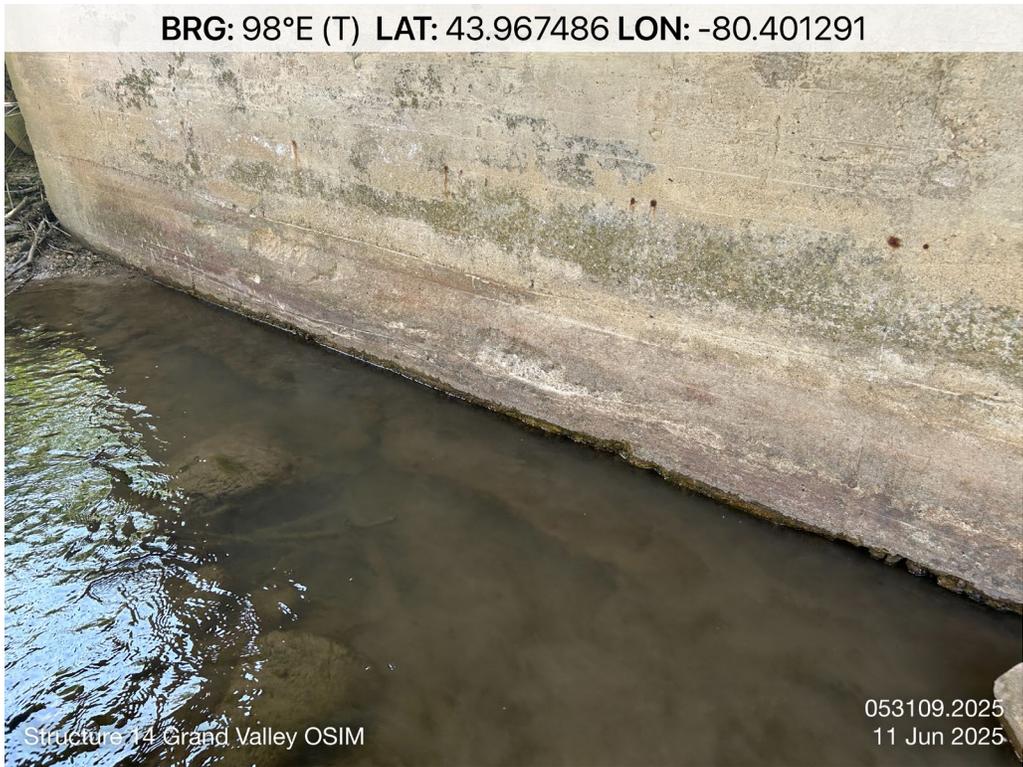
**FOUNDATION – NORTH – FOOTING EXPOSED**

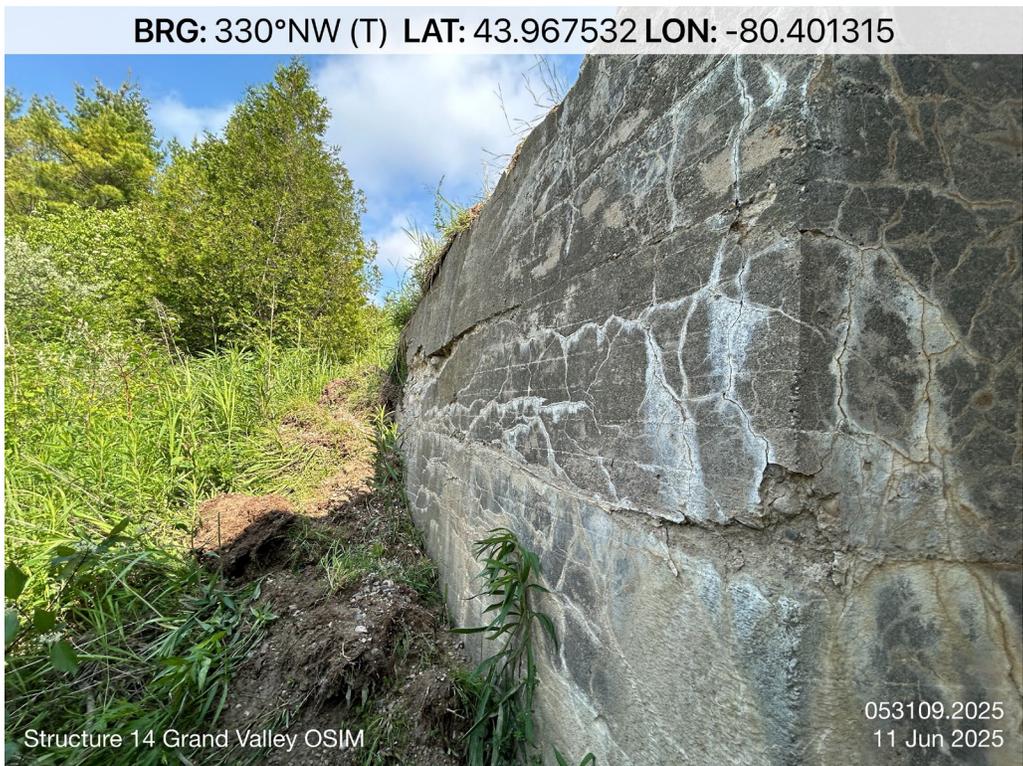
**EMBANKMENT – NORTHWEST – WASHOUTS ON ALL CORNERS**

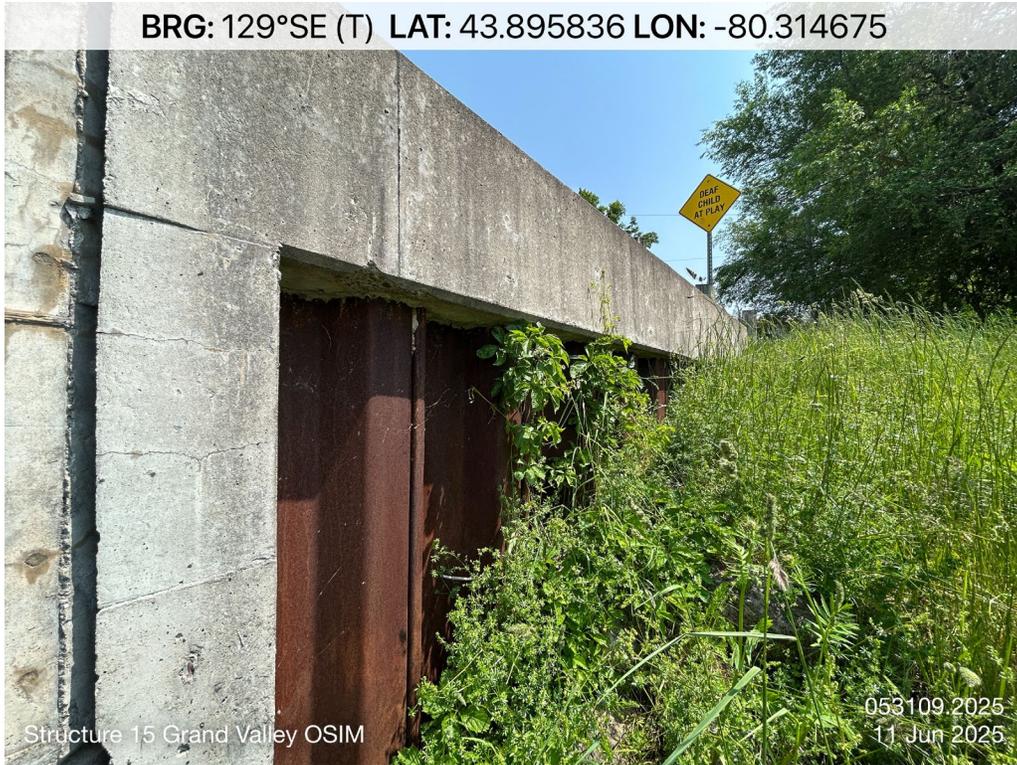
**RETAIING WALL – SOUTHWEST – SHEET PILING IS CORRODED AND WEATHERED**
