**2025 OSIM Bridge Inspections Report**

**Town of Grand Valley  
5 Main Street North  
Grand Valley, ON L9W 5S6**

**November 2025  
30053109.2025**

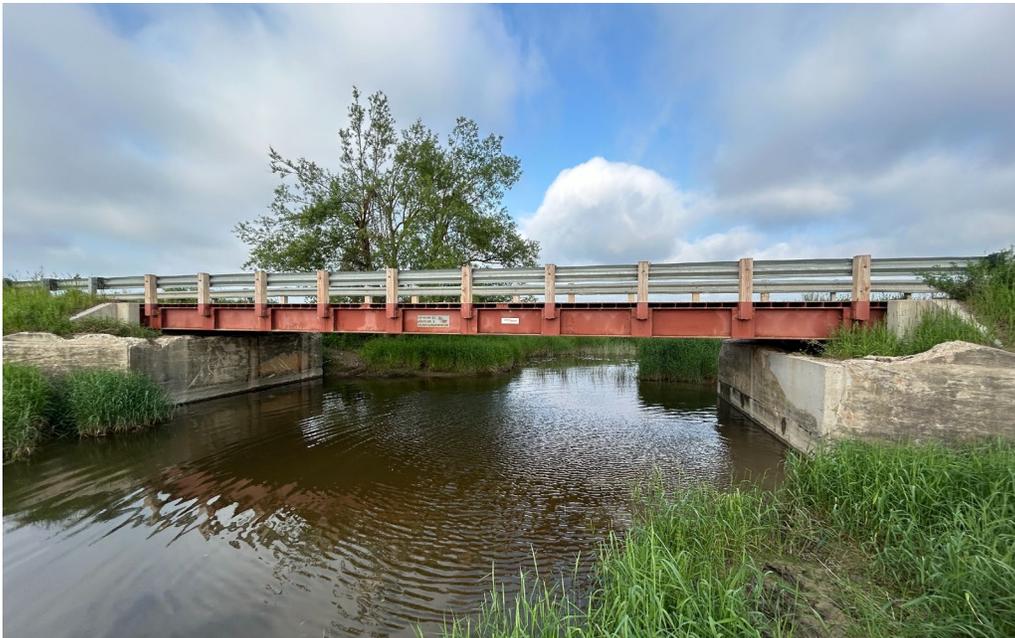
**1.1 Structure No. 01**

<u>Structure Name:</u>	Bridge No. 1	<b>2025 BCI =95.11</b>
<u>Road Name:</u>	Sideroad 27-28	
<u>Location:</u>	0.3 km South of Highway #89 (Concession XIV, Lot 27/28)	
<u>Structure Type:</u>	Modular	
<u>Number of Spans:</u>	1	<u>Span Lengths:</u> 17.95 m
<u>Overall Structure Width:</u>	4.7 m	<u>Roadway Width:</u> 4.7 m
<u>Year of Construction:</u>	2017	<u>Current Load Limit:</u> N/A

<b>Recommendation:</b>	<b>Forgo rehabilitation and replace structure in future (replacement timeline estimated to exceed 10 yrs).</b>
------------------------	--

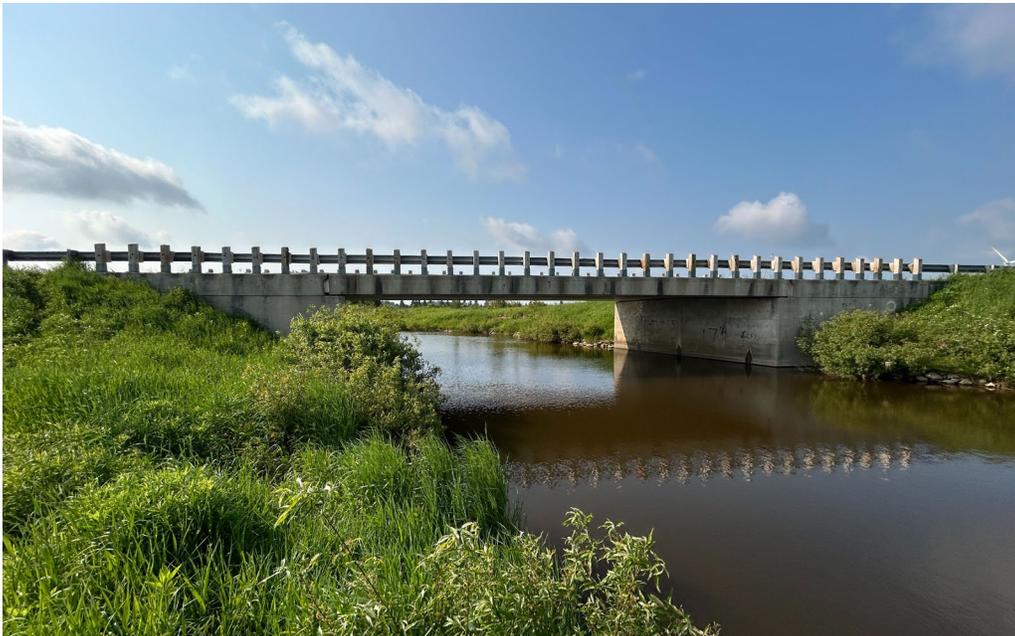
**1.2 Structure No. 02**

<u>Structure Name:</u>	Bridge No. 2	<b>2025 BCI =75.08</b>
<u>Road Name:</u>	Concession Rd. 12-13	
<u>Location:</u>	0.3 km East of Sideroad 24-25 (Conc. XII/XIII, Lot 25)	
<u>Structure Type:</u>	Precast Concrete Box Girder	
<u>Number of Spans:</u>	1	<u>Span Lengths:</u> 17 m
<u>Overall Structure Width:</u>	9.2 m	<u>Roadway Width:</u> 8 m
<u>Year of Construction:</u>	1996	<u>Current Load Limit:</u> N/A

<b>Recommendation:</b>	<b>No Capital Works estimated to be required within 10 years. Future structure rehabilitation should be considered.</b>
------------------------	---

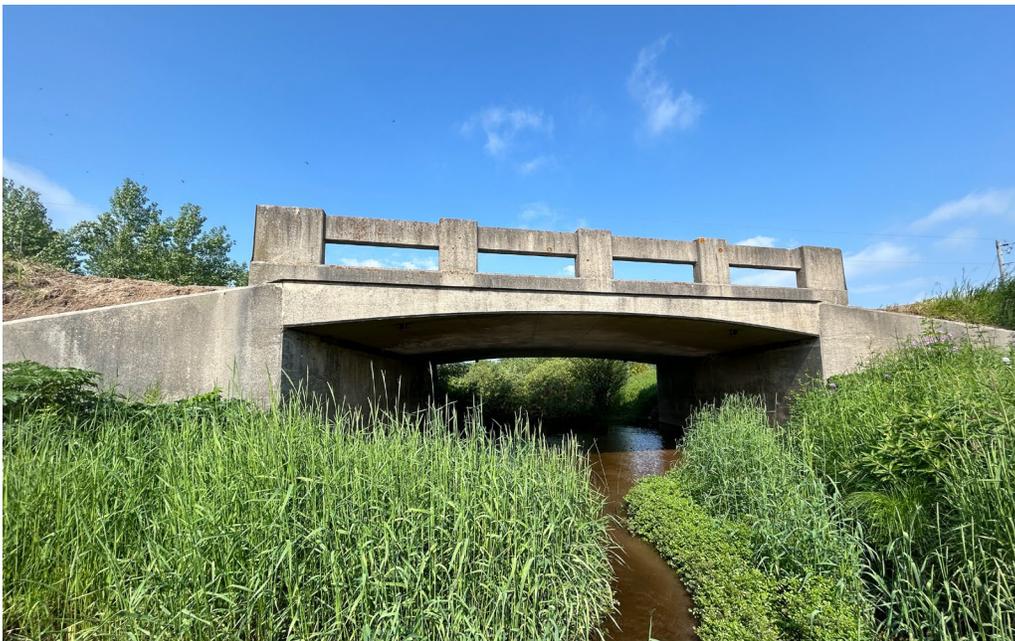
### 1.3 Structure No. 03

<u>Structure Name:</u>	Bridge No. 3	<b>2025 BCI =72.55</b>
<u>Road Name:</u>	Sideroad 21-22	
<u>Location:</u>	1.0 km North of County Road 15 (Concession XII, Lot 21/22)	
<u>Structure Type:</u>	Cast-In-Place Conc. Rigid Frame	
<u>Number of Spans:</u>	1	<u>Span Lengths:</u> 8.3 m (skew span 9.5 m) m
<u>Overall Structure Width:</u>	9.9 m	<u>Roadway Width:</u> 8 m
<u>Year of Construction:</u>	1970	<u>Current Load Limit:</u> N/A

<b>Recommendation:</b>	<b>No Capital Works estimated to be required within 10 years. Future structure rehabilitation should be considered.</b>
------------------------	---

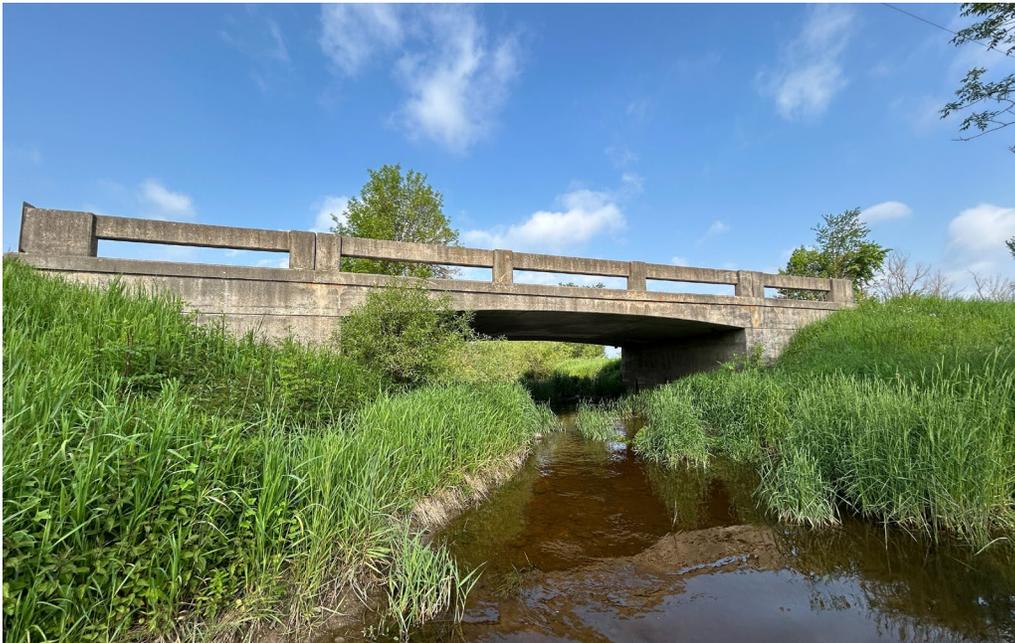
**1.4 Structure No. 04**

<u>Structure Name:</u>	Bridge No. 4	<b>2025 BCI =70.96</b>
<u>Road Name:</u>	Sideroad 24-25	
<u>Location:</u>	0.5 km South of County Road 15 (Concession X, Lot 24/25)	
<u>Structure Type:</u>	Cast-In-Place Conc. Rigid Frame	
<u>Number of Spans:</u>	1	<u>Span Lengths:</u> 10.6 m (11.05 m skew span) m
<u>Overall Structure Width:</u>	9.8 m	<u>Roadway Width:</u> 8.6 m
<u>Year of Construction:</u>	1955	<u>Current Load Limit:</u> N/A

<b>Recommendation:</b>	<b>Minor Rehabilitation is recommended within 2 years.</b>
------------------------	--

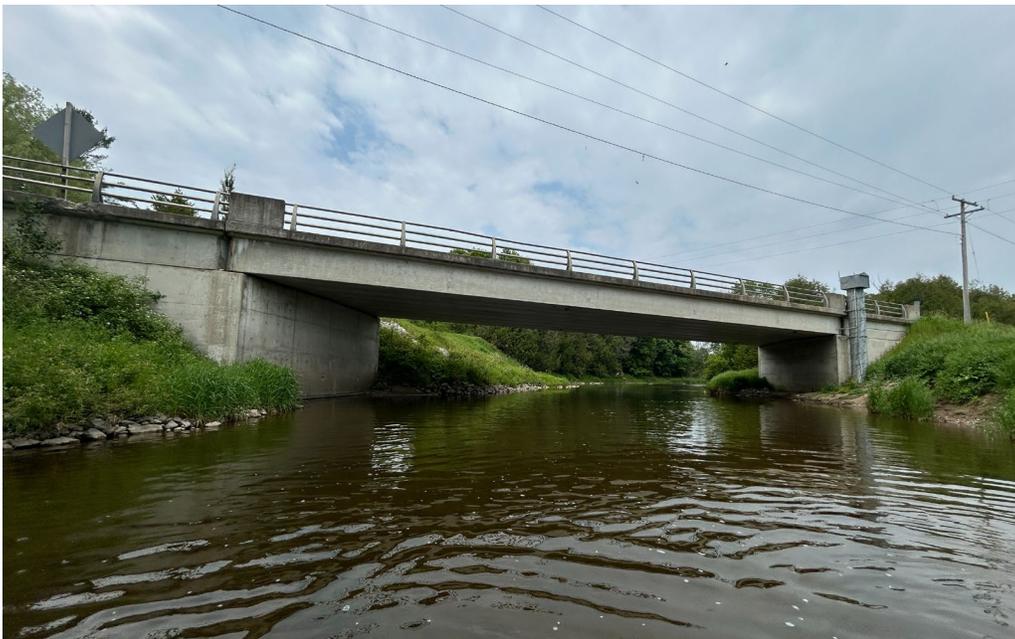
**1.5 Structure No. 05**

<u>Structure Name:</u>	Bridge No. 5 (Hall Bridge)	<b>2025 BCI =72.48</b>
<u>Road Name:</u>	Sideroad 27-28	
<u>Location:</u>	Concession Road 8-9 (between east and west intersection)	
<u>Structure Type:</u>	Precast Concrete Box Girder	
<u>Number of Spans:</u>	1	<u>Span Lengths:</u> 26.4 m (skew span 30.5) m
<u>Overall Structure Width:</u>	9.3 m	<u>Roadway Width:</u> 7.5 m
<u>Year of Construction:</u>	1979	<u>Current Load Limit:</u> N/A

<b>Recommendation:</b>	<b>No Capital Works estimated to be required within 10 years. Future structure rehabilitation should be considered.</b>
------------------------	---

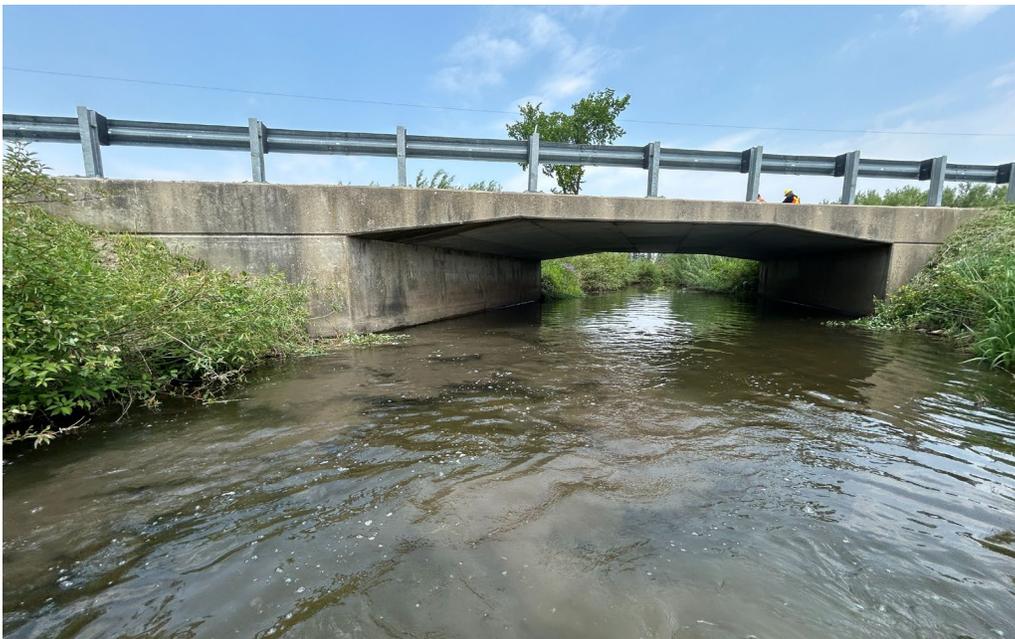
**1.6 Structure No. 06**

<u>Structure Name:</u>	Bridge No. 6	<b>2025 BCI =75.24</b>
<u>Road Name:</u>	Concession Road 8-9	
<u>Location:</u>	0.4 km east of Sideroad 24-25 (Conc. VII/IX, Lot 25)	
<u>Structure Type:</u>	Cast-In-Place Conc. Rigid Frame	
<u>Number of Spans:</u>	1	<u>Span Lengths:</u> 8.0 m (skew span 9.2 m) m
<u>Overall Structure Width:</u>	8.9 m	<u>Roadway Width:</u> 6.7 m
<u>Year of Construction:</u>	1986	<u>Current Load Limit:</u> N/A

<b>Recommendation:</b>	<b>No Capital Works estimated to be required within 10 years. Future structure rehabilitation should be considered.</b>
------------------------	---

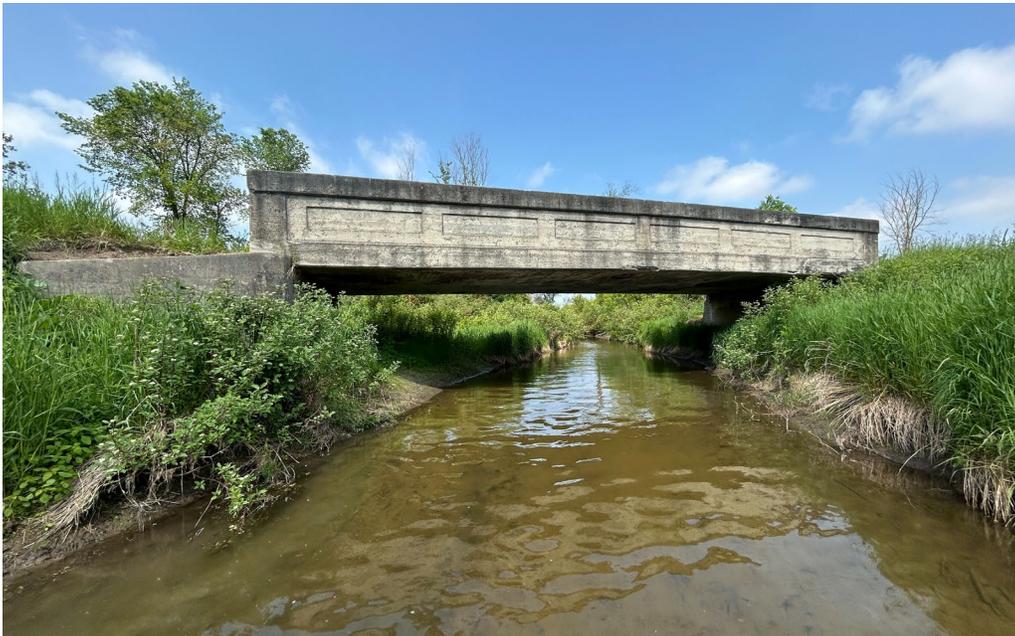
**1.7 Structure No. 07**

<u>Structure Name:</u>	Bridge No. 7	<b>2025 BCI =53.51</b>
<u>Road Name:</u>	Sideroad 24-25	
<u>Location:</u>	0.3 km south of Concession Road 8-9 (Conc. VIII, Lot 24/25)	
<u>Structure Type:</u>	Through Girder (Concrete)	
<u>Number of Spans:</u>	1	<u>Span Lengths:</u> 15.15 m
<u>Overall Structure Width:</u>	6.5 m	<u>Roadway Width:</u> 4.9 m
<u>Year of Construction:</u>	1920	<u>Current Load Limit:</u> N/A

<b>Recommendation:</b>	<b>Forgo rehabilitation and replace structure within 2 years.</b>
------------------------	---

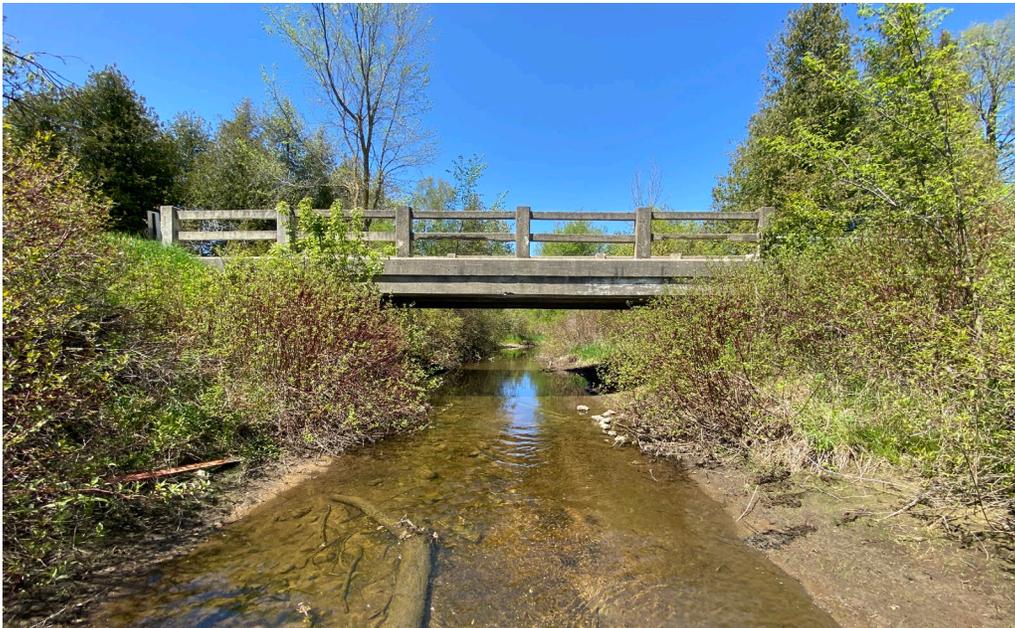
**1.8 Structure No. 08**

<u>Structure Name:</u>	Bridge No. 8	<b>2025 BCI =59.21</b>
<u>Road Name:</u>	Concession Road 8-9	
<u>Location:</u>	0.3 km west of Sideroad 24-25 (Conc. VIII/IX, Lot 24)	
<u>Structure Type:</u>	Cast-In-Place Concrete T-Beam	
<u>Number of Spans:</u>	1	<u>Span Lengths:</u> 9.7 m
<u>Overall Structure Width:</u>	5.8 m	<u>Roadway Width:</u> 4.85 m
<u>Year of Construction:</u>	1950	<u>Current Load Limit:</u> N/A

<b>Recommendation:</b>	<b>No Capital Works is estimated to be required within the next 10 years.</b>
------------------------	---

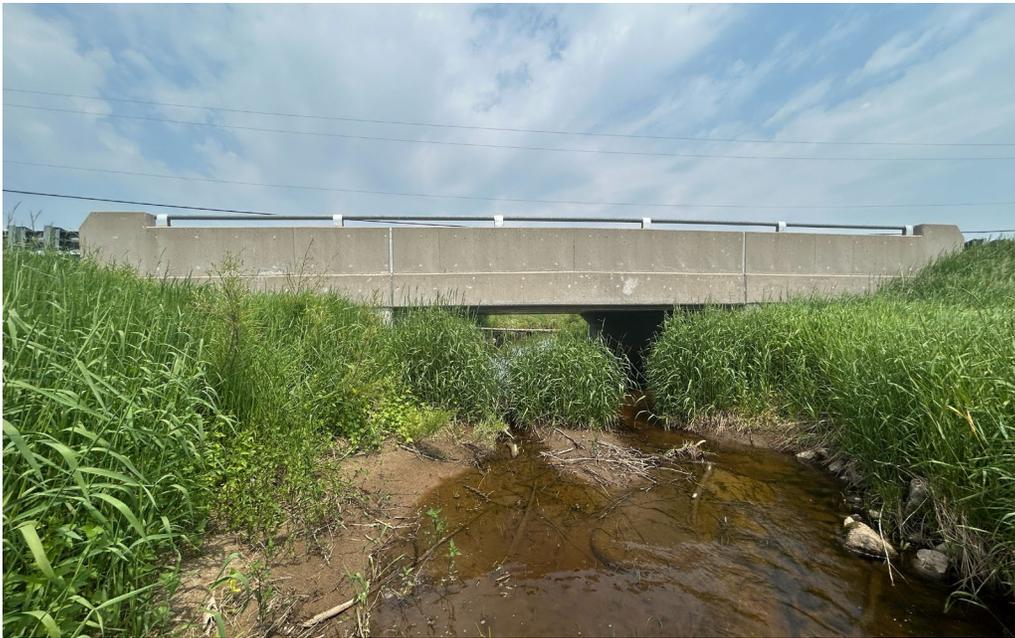
**1.9 Structure No. 09**

<u>Structure Name:</u>	Bridge No. 9	<b>2025 BCI =97.17</b>
<u>Road Name:</u>	Concession Rd. 8-9	
<u>Location:</u>	0.7 km West of County Rd. 25 (Conc. VIII/IX, Lot 29)	
<u>Structure Type:</u>	Precast Concrete Rigid Frame	
<u>Number of Spans:</u>	1	<u>Span Lengths:</u> 6.1 m
<u>Overall Structure Width:</u>	9.6 m	<u>Roadway Width:</u> 9 m
<u>Year of Construction:</u>	2013	<u>Current Load Limit:</u> N/A

<b>Recommendation:</b>	<b>No Capital Works estimated to be required within 10 years. Future structure rehabilitation should be considered.</b>
------------------------	---

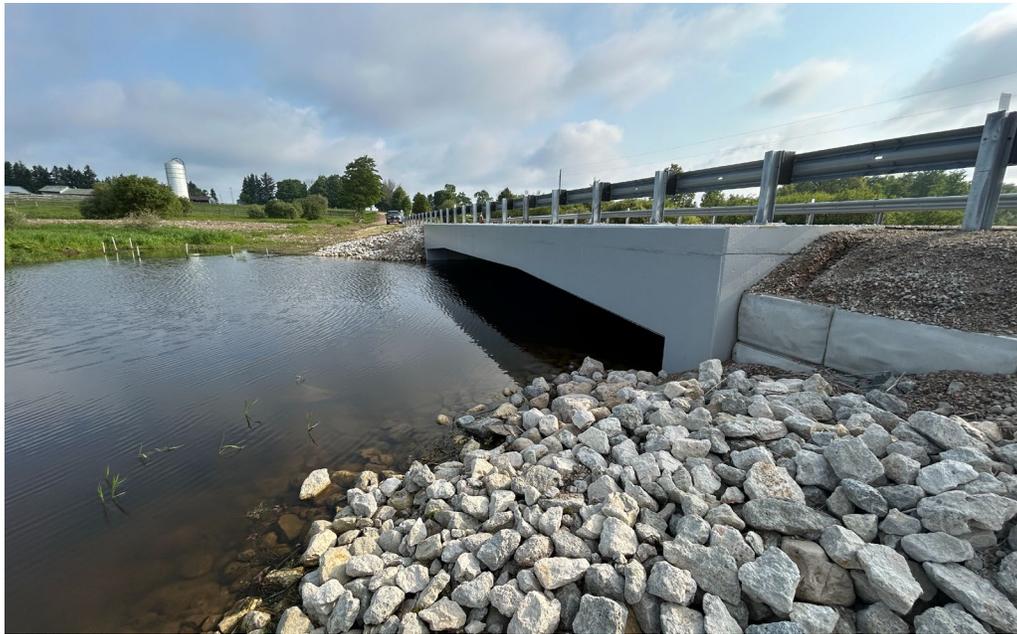
**1.10 Structure No. 10**

<u>Structure Name:</u>	Bridge No. 10	<b>2025 BCI =100</b>
<u>Road Name:</u>	Sideroad 27-28	
<u>Location:</u>	1.75 km north of County Rd. 15 (Conc. XII, Lot 27/28)	
<u>Structure Type:</u>	Precast Concrete Rigid Frame	
<u>Number of Spans:</u>	1	<u>Span Lengths:</u> 16.2 m
<u>Overall Structure Width:</u>	12 m	<u>Roadway Width:</u> 6 m
<u>Year of Construction:</u>	2024	<u>Current Load Limit:</u> N/A

<b>Recommendation:</b>	<b>Forgo rehabilitation and replace structure in future (replacement timeline estimated to exceed 10 yrs).</b>
------------------------	--

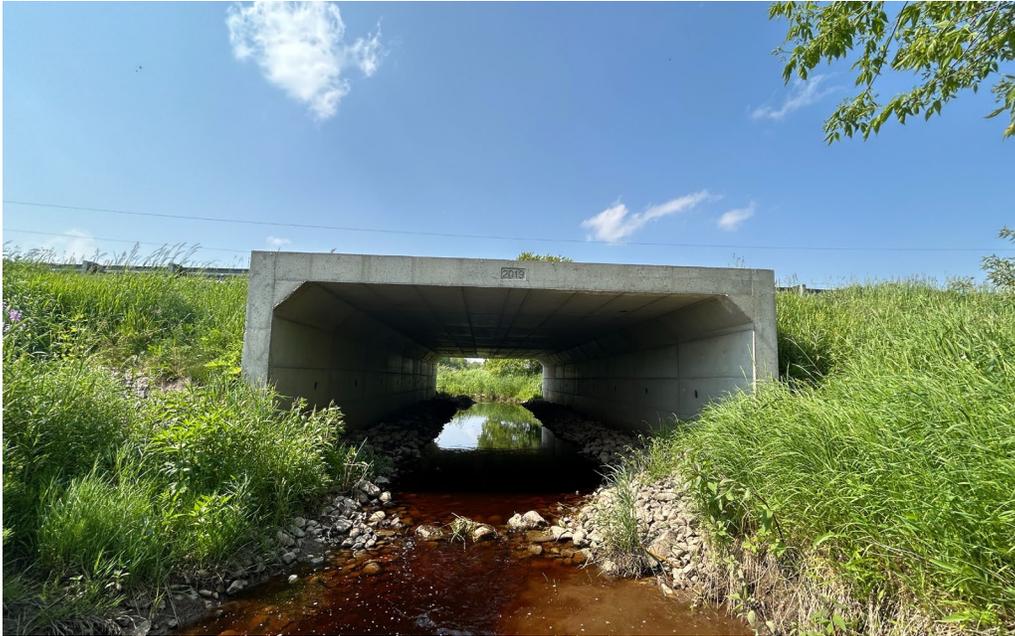
**1.11 Structure No. 11**

<u>Structure Name:</u>	Bridge No. 11	<b>2025 BCI =99.68</b>
<u>Road Name:</u>	Concession Road 2-3	
<u>Location:</u>	1 km East of Sideroad 24-25 (Conc. II/III, Lot 26)	
<u>Structure Type:</u>	Precast Concrete Box Culvert	
<u>Number of Spans:</u>	1	<u>Span Lengths:</u> 6 m
<u>Overall Structure Width:</u>	6.5 m	<u>Roadway Width:</u> 7 m
<u>Year of Construction:</u>	2019	<u>Current Load Limit:</u> N/A

<b>Recommendation:</b>	<b>No Capital Works estimated to be required within 10 years. Future structure rehabilitation should be considered.</b>
------------------------	---

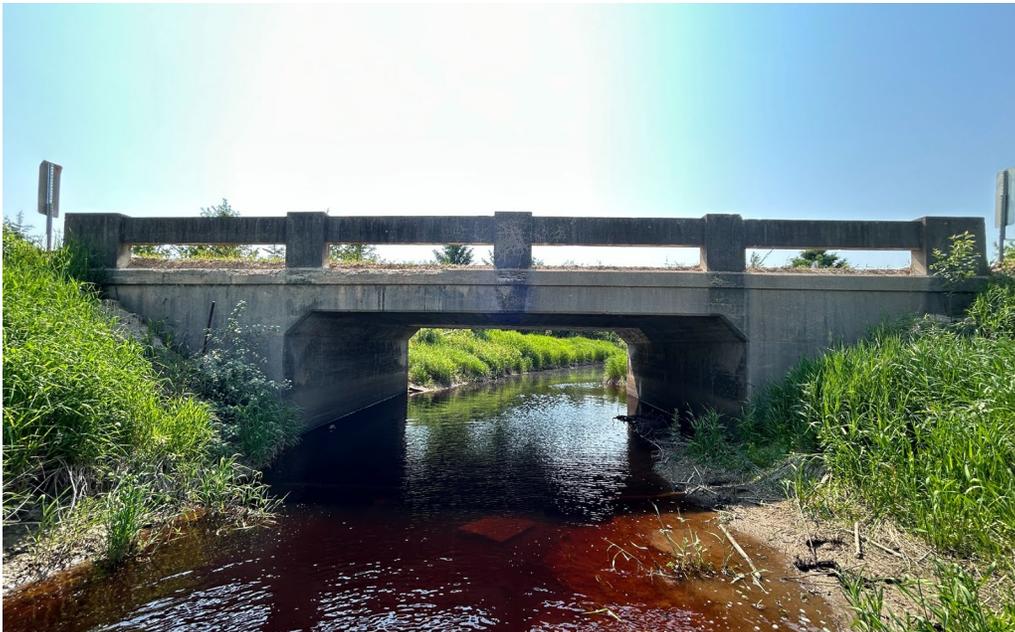
**1.12 Structure No. 12**

<u>Structure Name:</u>	Bridge No. 12	<b>2025 BCI =69.96</b>
<u>Road Name:</u>	Sideroad 27-28	
<u>Location:</u>	0.9 km south of Concession Road 2-3 (Conc. II, Lot 27/28)	
<u>Structure Type:</u>	Cast-In-Place Conc. Rigid Frame	
<u>Number of Spans:</u>	1	<u>Span Lengths:</u> 7.3 m
<u>Overall Structure Width:</u>	7.6 m	<u>Roadway Width:</u> 6 m
<u>Year of Construction:</u>	1966	<u>Current Load Limit:</u> N/A

<b>Recommendation:</b>	<b>Forgo rehabilitation and replace structure in future (replacement timeline estimated to exceed 10 yrs).</b>
------------------------	--

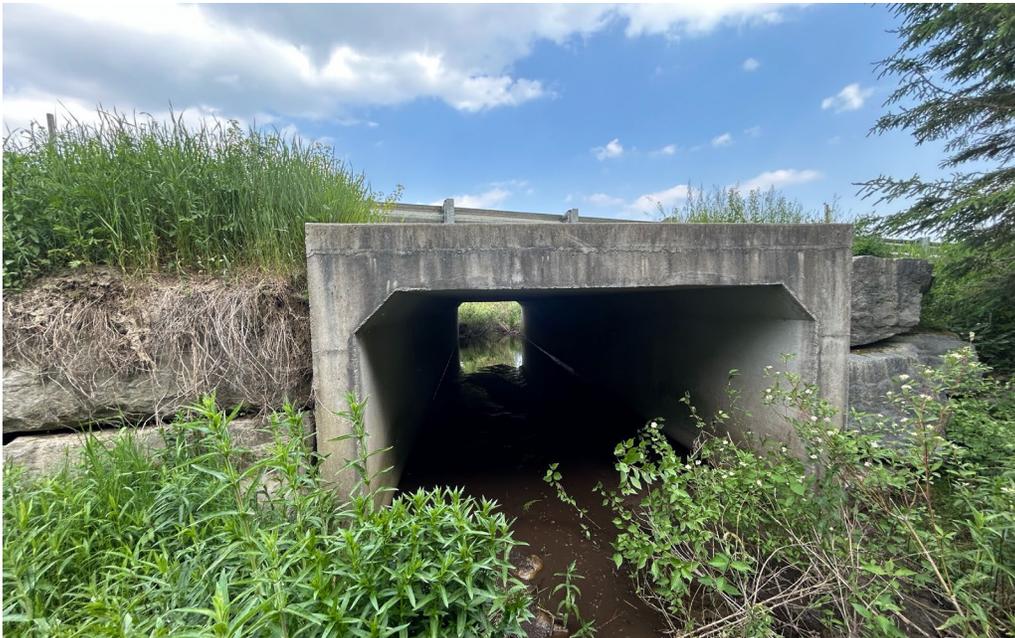
**1.13 Structure No. 13**

<u>Structure Name:</u>	Bridge No. 13	<b>2025 BCI =97.36</b>
<u>Road Name:</u>	Sideroad 21-22	
<u>Location:</u>	1.2 km south of Concession Road 2-3	
<u>Structure Type:</u>	Precast Concrete Box Culvert	
<u>Number of Spans:</u>	1	<u>Span Lengths:</u> 3.05 m
<u>Overall Structure Width:</u>	17.6 m	<u>Roadway Width:</u> 7 m
<u>Year of Construction:</u>	2011	<u>Current Load Limit:</u> N/A

<b>Recommendation:</b>	<b>No Capital Works is estimated to be required within the next 10 years.</b>
------------------------	---

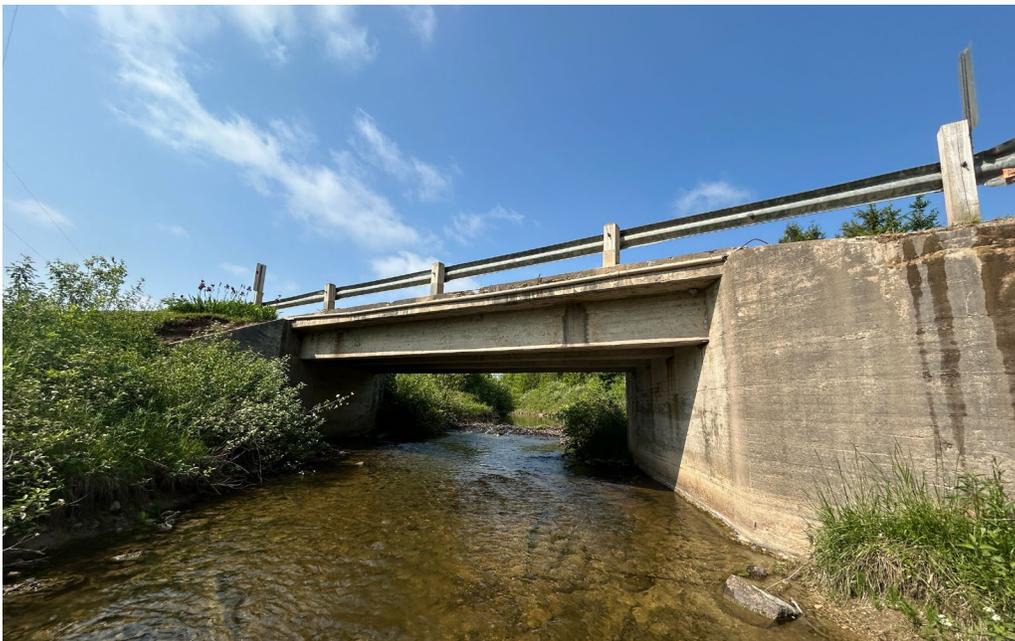
**1.14 Structure No. 14**

<u>Structure Name:</u>	Bridge No. 14	<b>2025 BCI =58.69</b>
<u>Road Name:</u>	Sideroad 21-22	
<u>Location:</u>	1.1 km north of Concession Road 8-9 (Conc. IX, Lot 21/22)	
<u>Structure Type:</u>	Cast-In-Place Concrete T-Beam	
<u>Number of Spans:</u>	1	<u>Span Lengths:</u> 9.2m (10.6 m skew span) m
<u>Overall Structure Width:</u>	5.8 m	<u>Roadway Width:</u> 4.9 m
<u>Year of Construction:</u>	1970	<u>Current Load Limit:</u> N/A

<b>Recommendation:</b>	<b>Forgo rehabilitation and replace structure within 4 years.</b>
------------------------	---

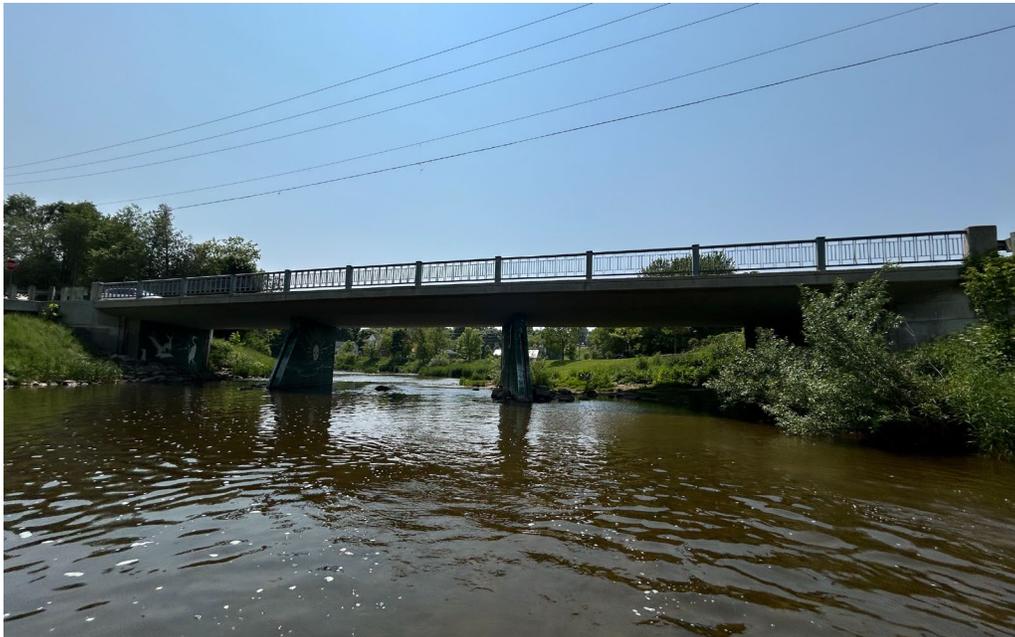
**1.15 Structure No. 15**

<u>Structure Name:</u>	Bridge No. 15	<b>2025 BCI =72.33</b>
<u>Road Name:</u>	Main Street South	
<u>Location:</u>	Main St. Just South of County Road 25	
<u>Structure Type:</u>	Cast-In-Place Conc. Rigid Frame	
<u>Number of Spans:</u>	3	<u>Span Lengths:</u> North 10.75; Middle 10.75; South 10.75 m
<u>Overall Structure Width:</u>	8.9 m	<u>Roadway Width:</u> 6.6 m
<u>Year of Construction:</u>	1994	<u>Current Load Limit:</u> N/A

<b>Recommendation:</b>	<b>No Capital Works estimated to be required within 10 years. Future structure rehabilitation should be considered.</b>
------------------------	---

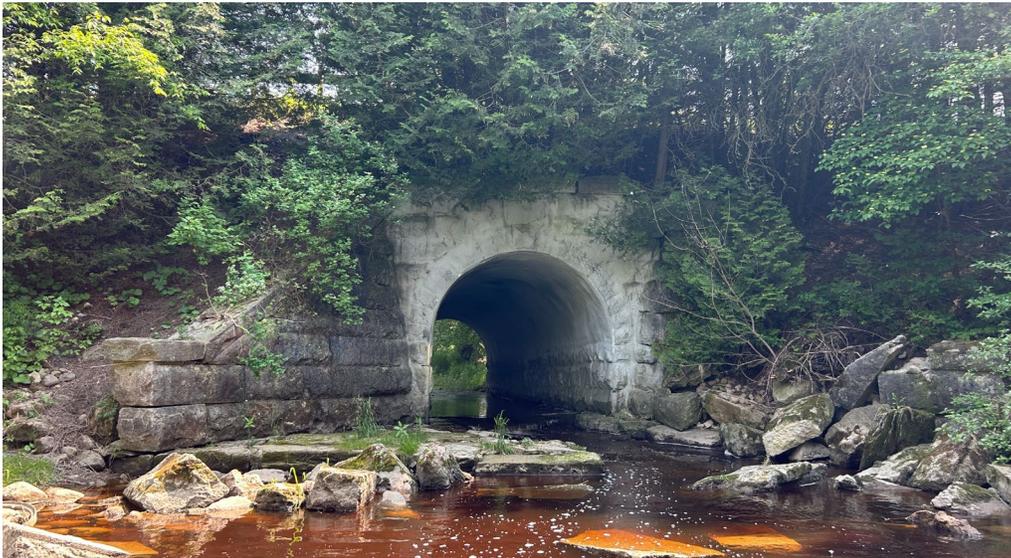
**1.16 Structure No. 16**

<u>Structure Name:</u>	Bridge No. 16 (Boyne Creek Arch Culvert)	<b>2025 BCI =59.83</b>
<u>Road Name:</u>	Upper Grand Trailway	
<u>Location:</u>	Approximately 0.6 km east of CR25	
<u>Structure Type:</u>	Arch (Masonry)	
<u>Number of Spans:</u>	1	<u>Span Lengths:</u> 3.6 m
<u>Overall Structure Width:</u>	19.5 m	<u>Roadway Width:</u> 3.3 m
<u>Year of Construction:</u>	1919	<u>Current Load Limit:</u> N/A

<b>Recommendation:</b>	<b>No Capital Works is estimated to be required within the next 10 years.</b>
------------------------	---

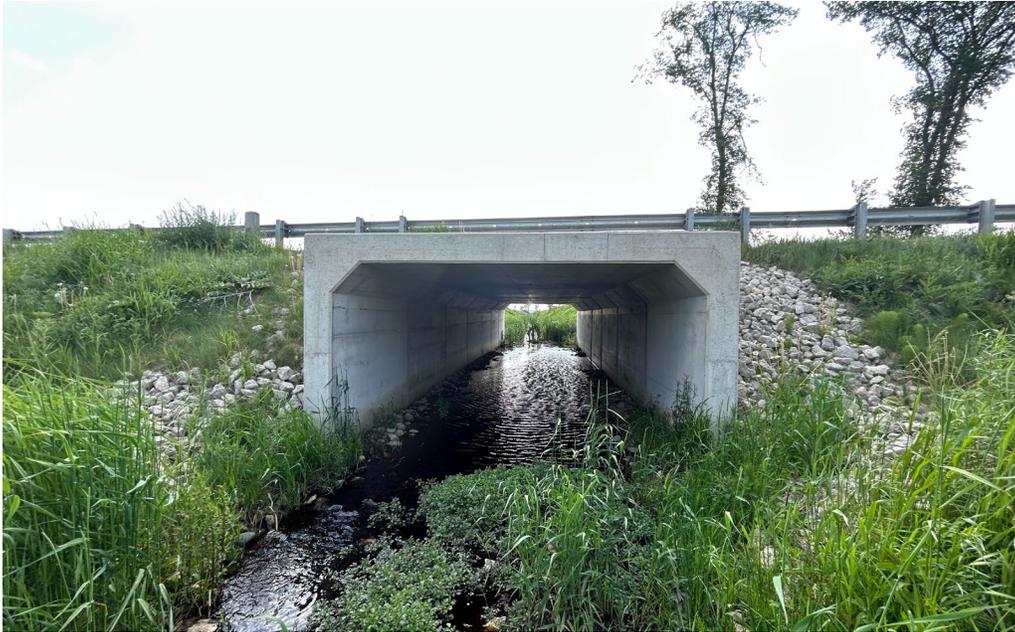
**1.17 Structure No. 17**

<u>Structure Name:</u>	Bridge No. 17	<b>2025 BCI =99.6</b>	
<u>Road Name:</u>	Sideroad 24-25		
<u>Location:</u>	Approximately 400 m North of Concession 2-3		
<u>Structure Type:</u>	Precast Concrete Box Culvert		
<u>Number of Spans:</u>	1	<u>Span Lengths:</u>	3.658 m
<u>Overall Structure Width:</u>	17.107 m	<u>Roadway Width:</u>	8 m
<u>Year of Construction:</u>	2020	<u>Current Load Limit:</u>	N/A

<b>Recommendation:</b>	<b>No Capital Works is estimated to be required within the next 10 years.</b>
------------------------	---

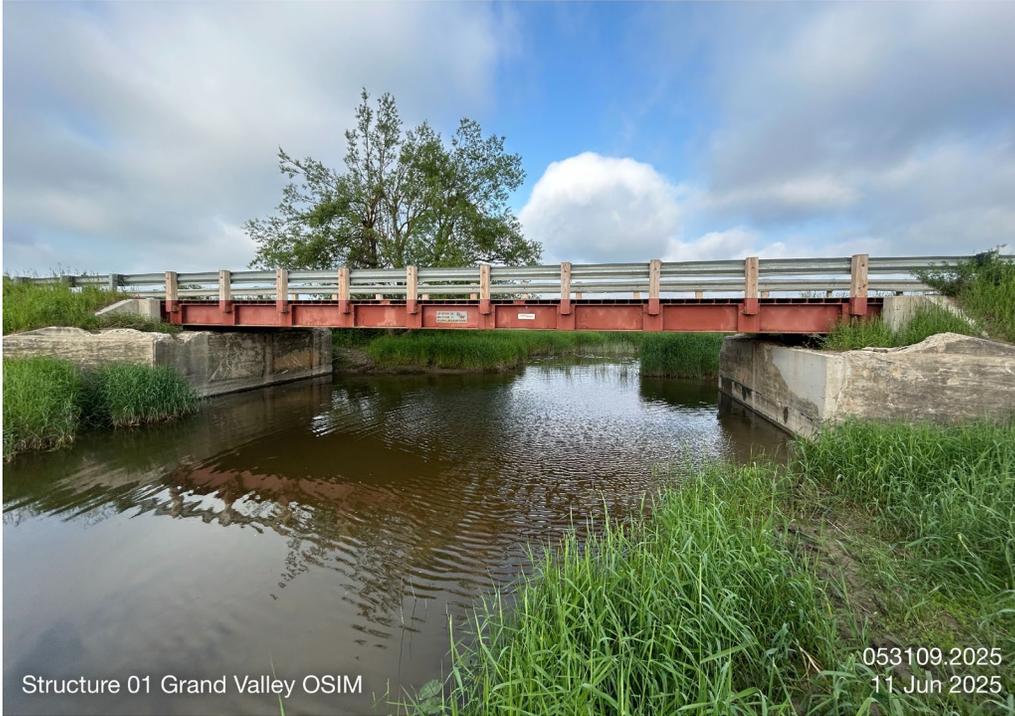
**ELEVATION SHOT – WEST**

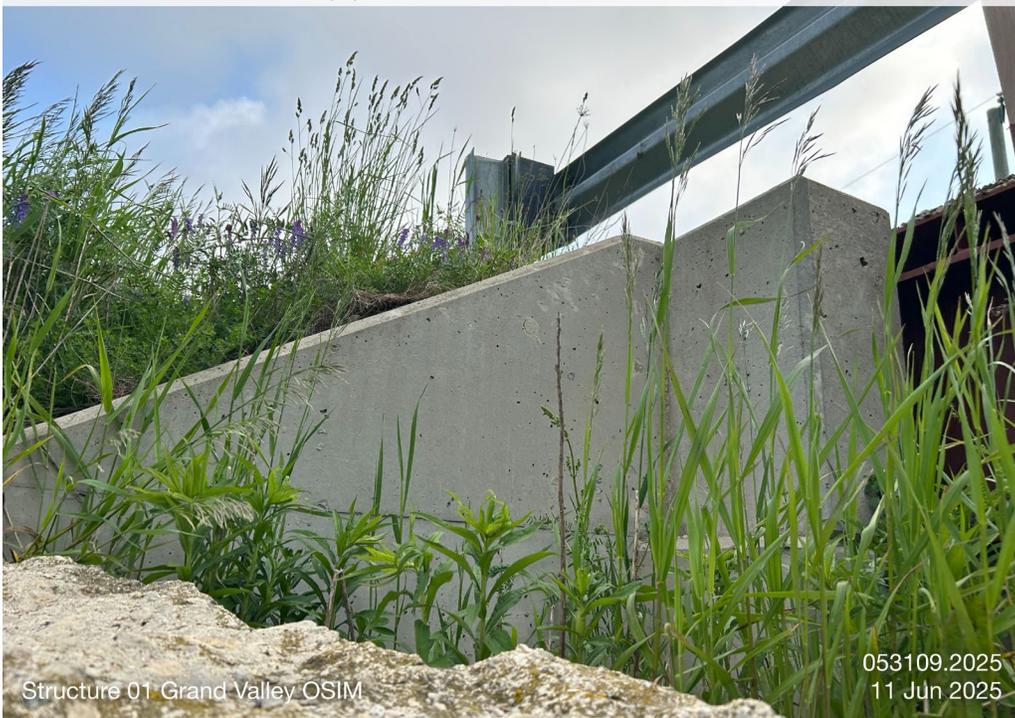
**BARRIER – EAST – IMPACT DAMAGE TO NORTH POSTS**

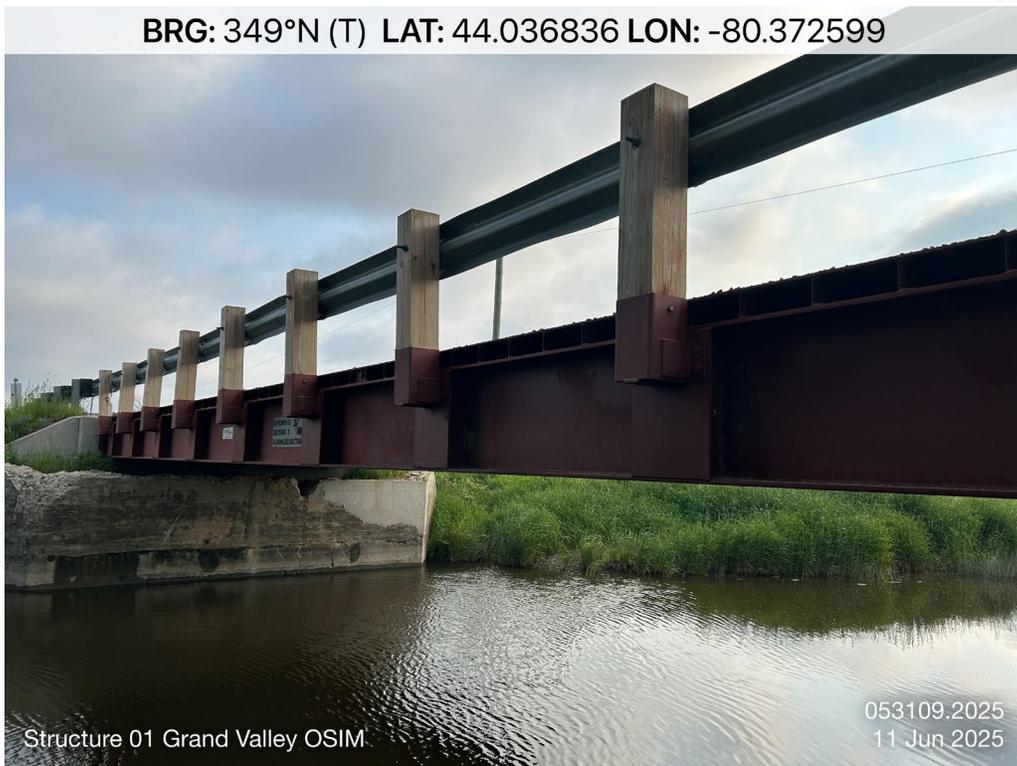
**STREAM – NORTHWEST – FLOWS WEST TO EAST**

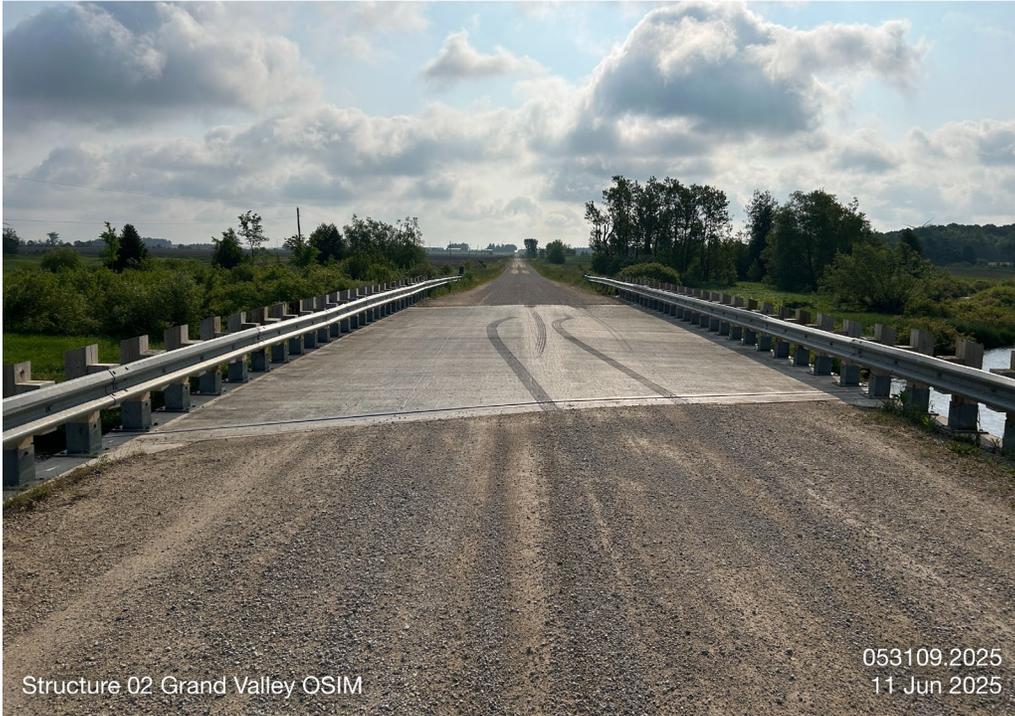
**APPROACH WEARING SURFACE – WEST**

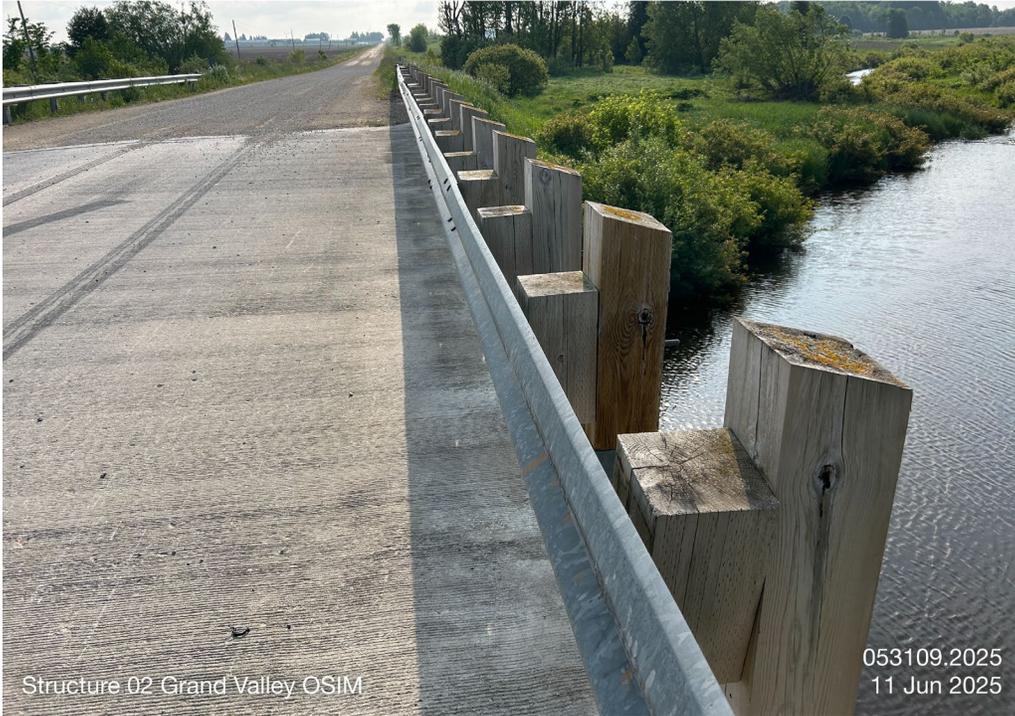
**RAILING SYSTEM – SOUTH – SOME POSTS ROTTING**

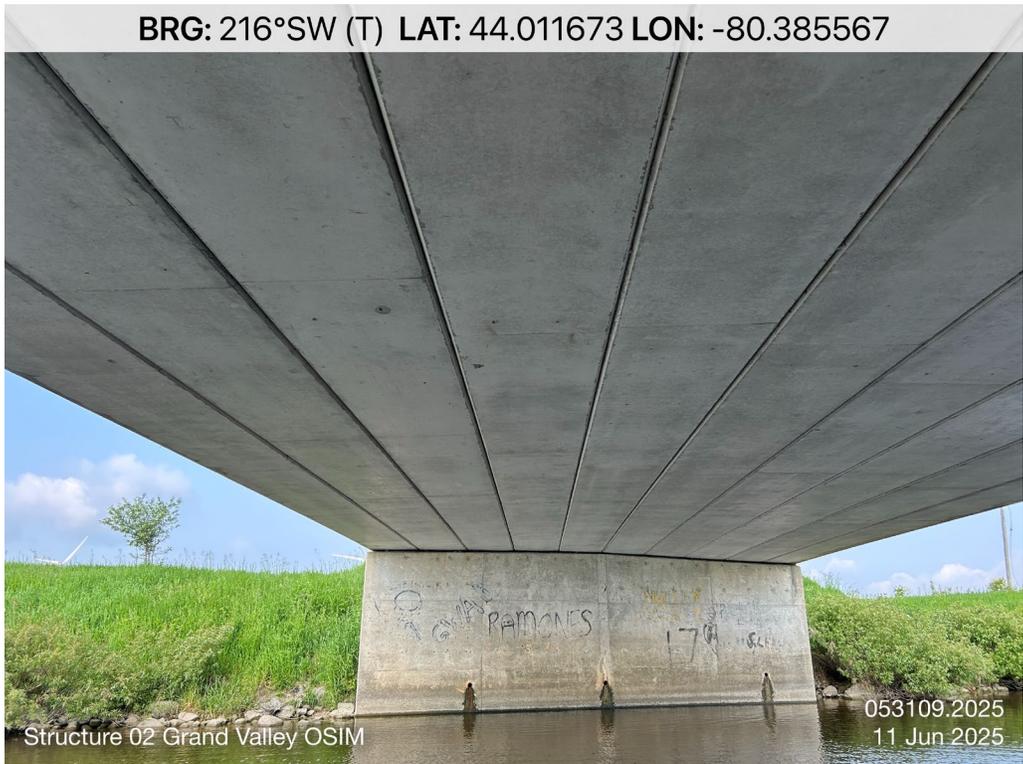
**GIRDERS – MIDDLE**

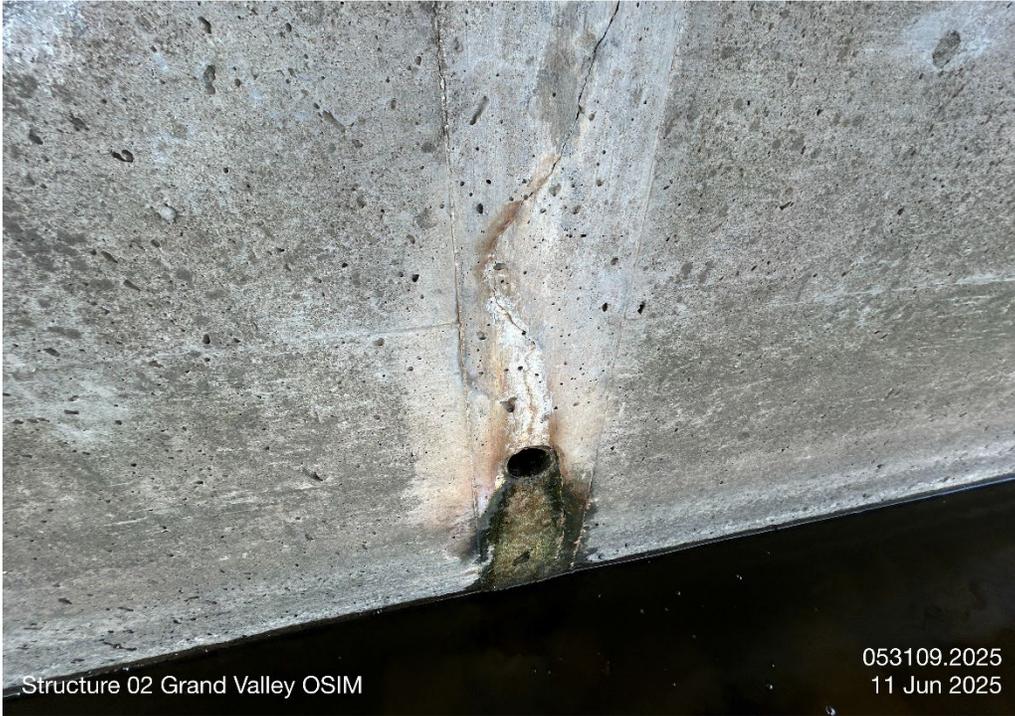
**ABUTMENT WALLS – WEST – STAINING BELOW DRAINS**

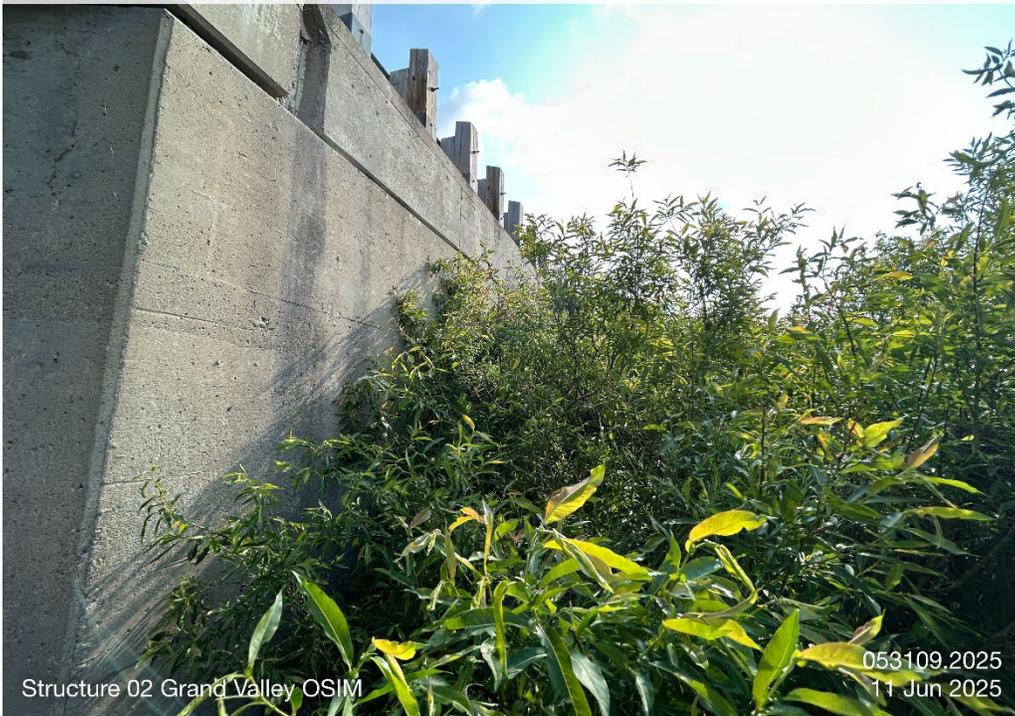
**EMBANKMENT – WEST – WELL VEGETATED, APPEAR STABLE**

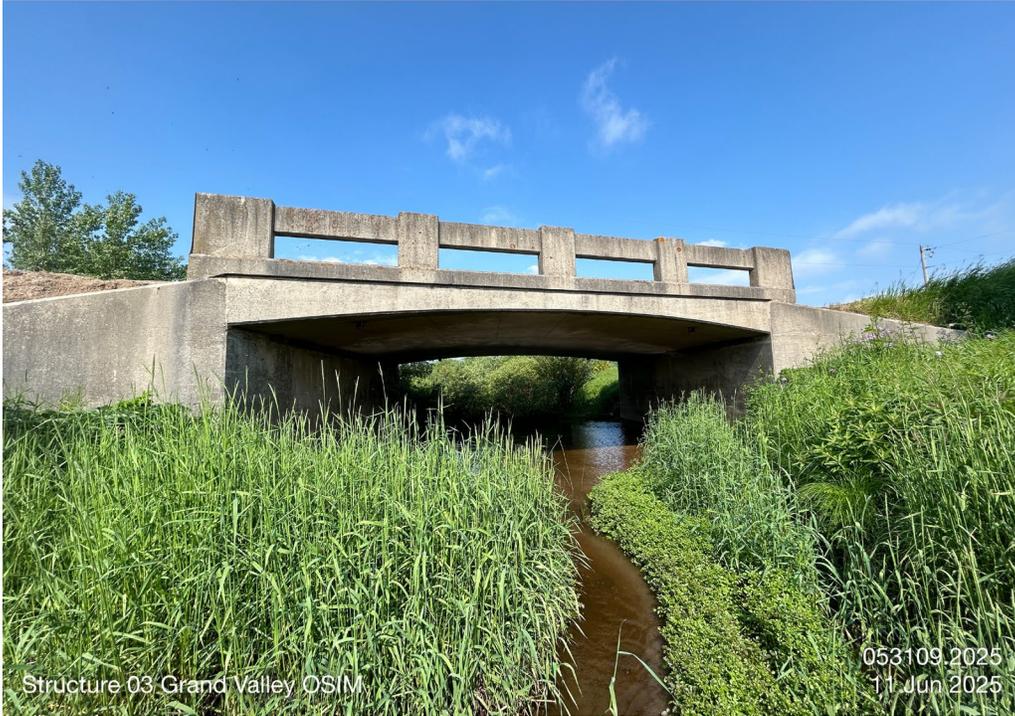
**ELEVATION SHOT – EAST**

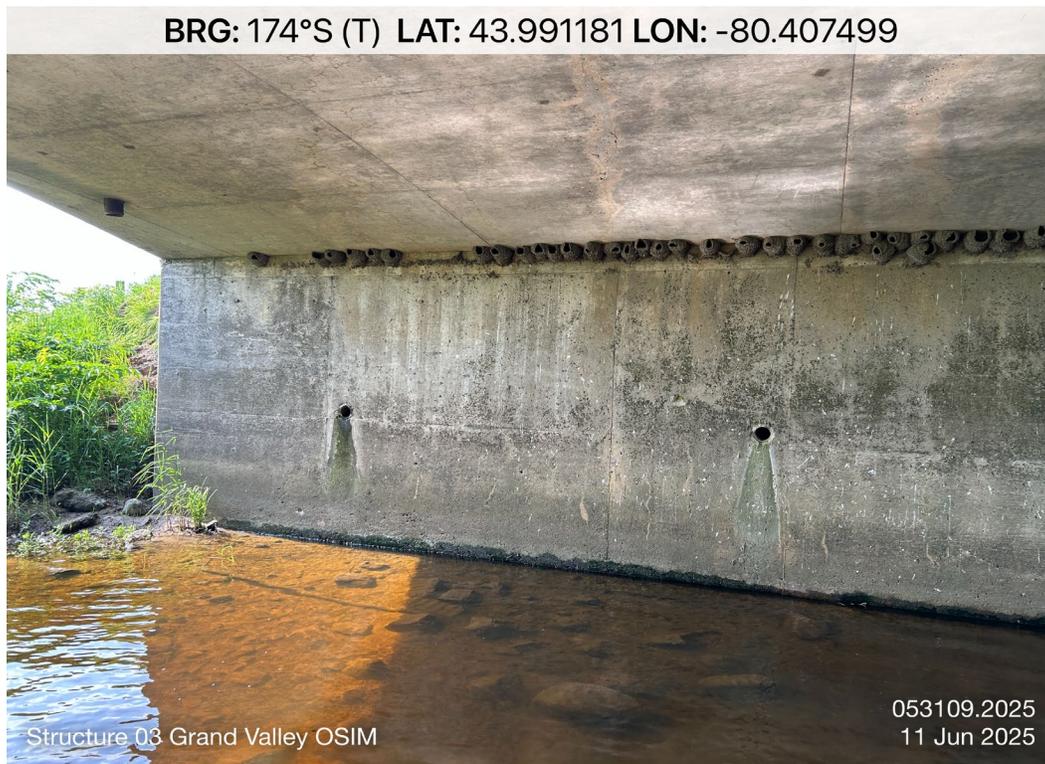
**ABUTMENT WALL – SOUTH – MODERATE HONEYCOMBING AND MEDIUM CRACKS**

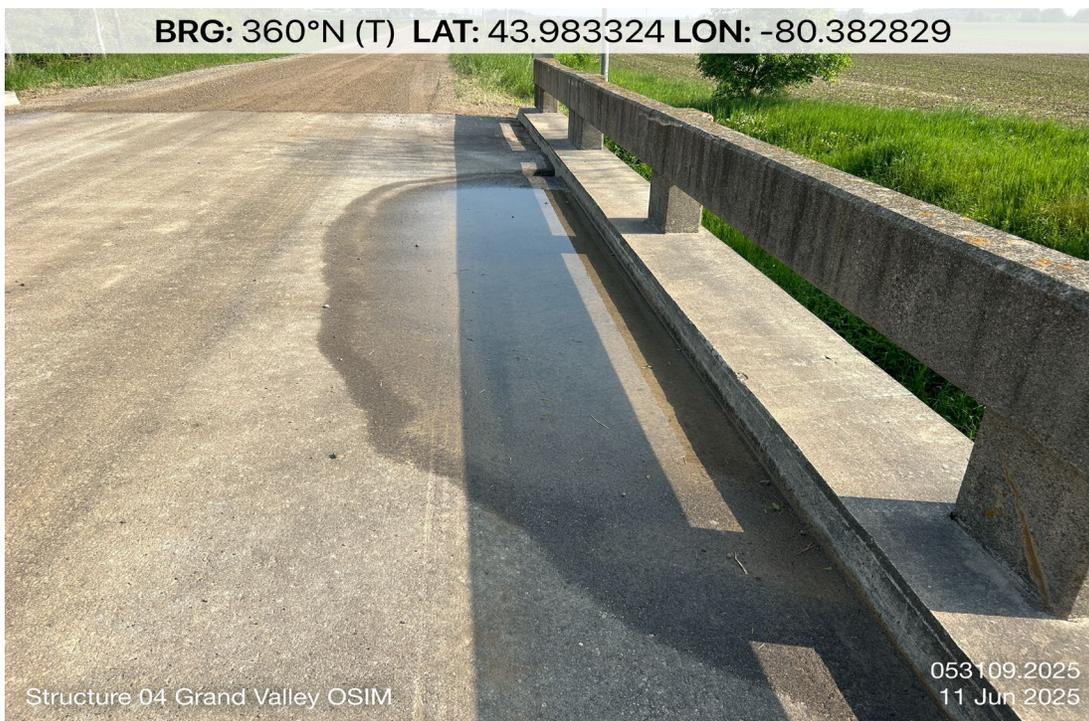
**BARRIERS – EAST**

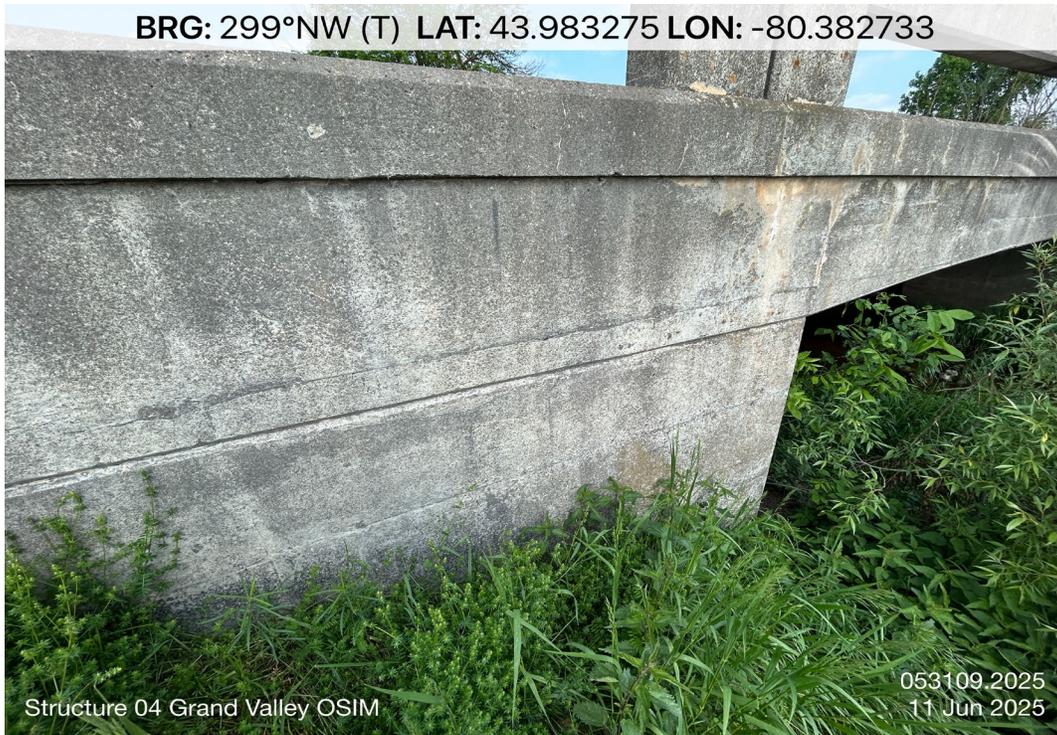
**WINGWALL – SOUTHEAST – LIGHT SCALING AND EFFLORESCENCE STAINED  
CRACKS**
