**2025 OSIM Bridge Inspections Report**

**Town of Grand Valley  
5 Main Street North  
Grand Valley, ON L9W 5S6**

**November 2025  
30053109.2025**

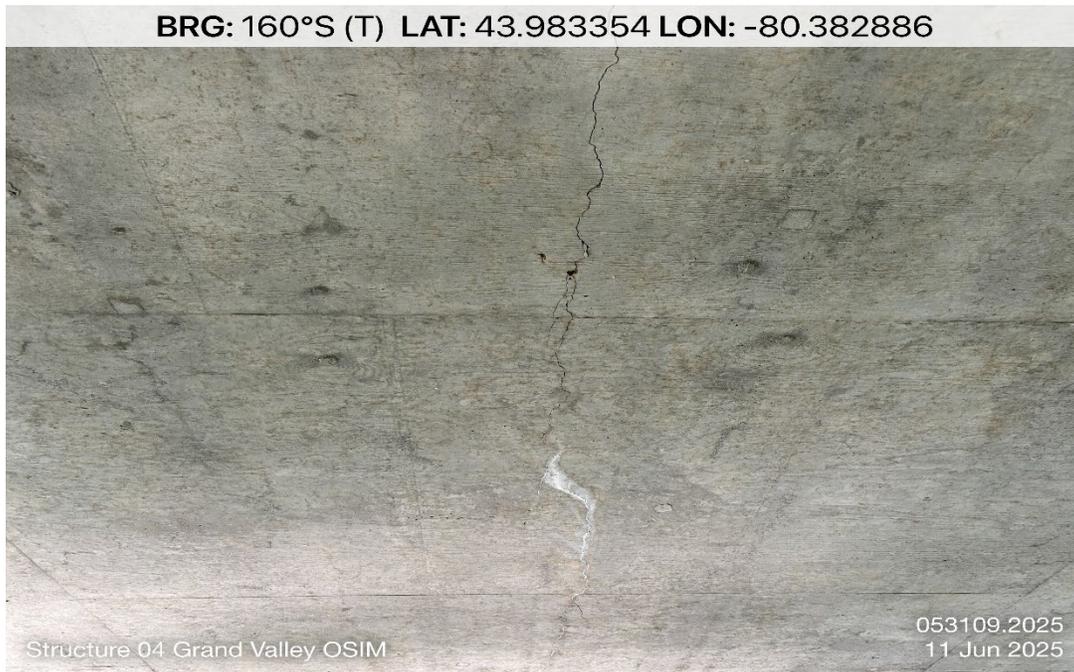
**SOFFIT – INTERIOR – SIGNS OF MOISTURE PENETRATION THROUGH DECK TOP WITH  
FULL SPAN WIDE CRACK**

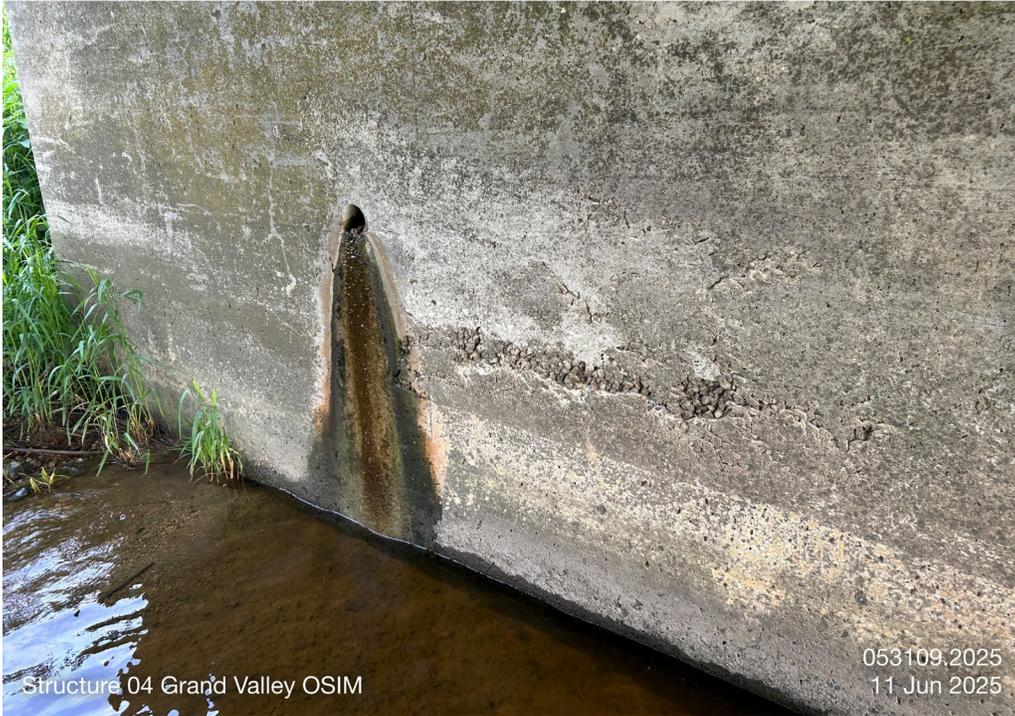
**ABUTMENT WALLS – NORTH – MOISTURE STAINING AND HONEYCOMBING**

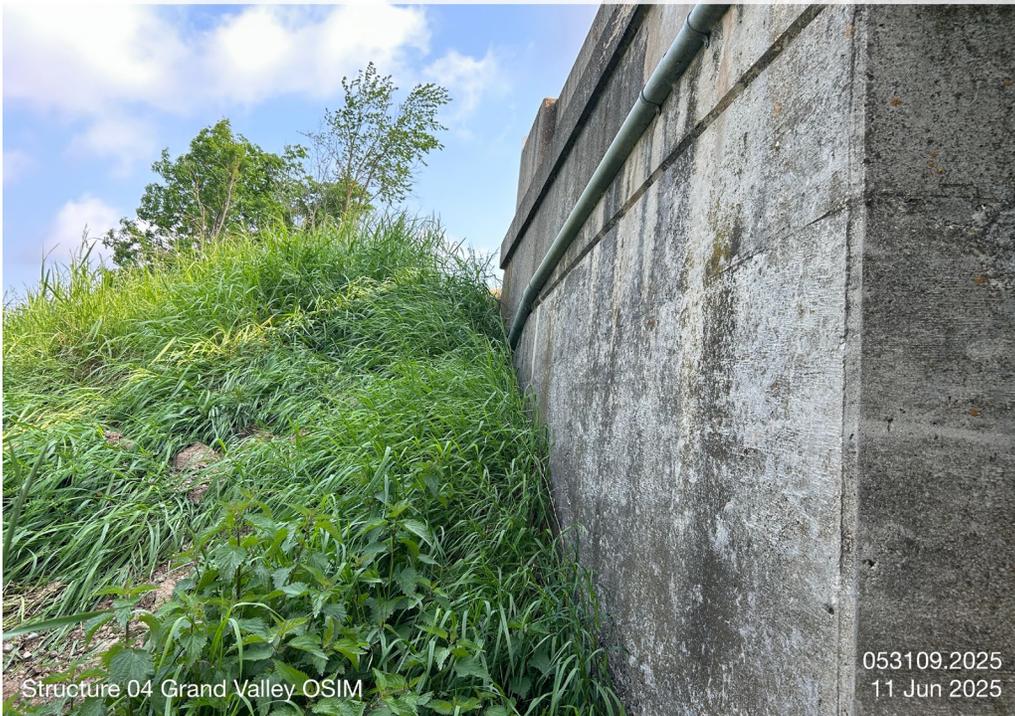
**EMBANKMENT – NORTHWEST**

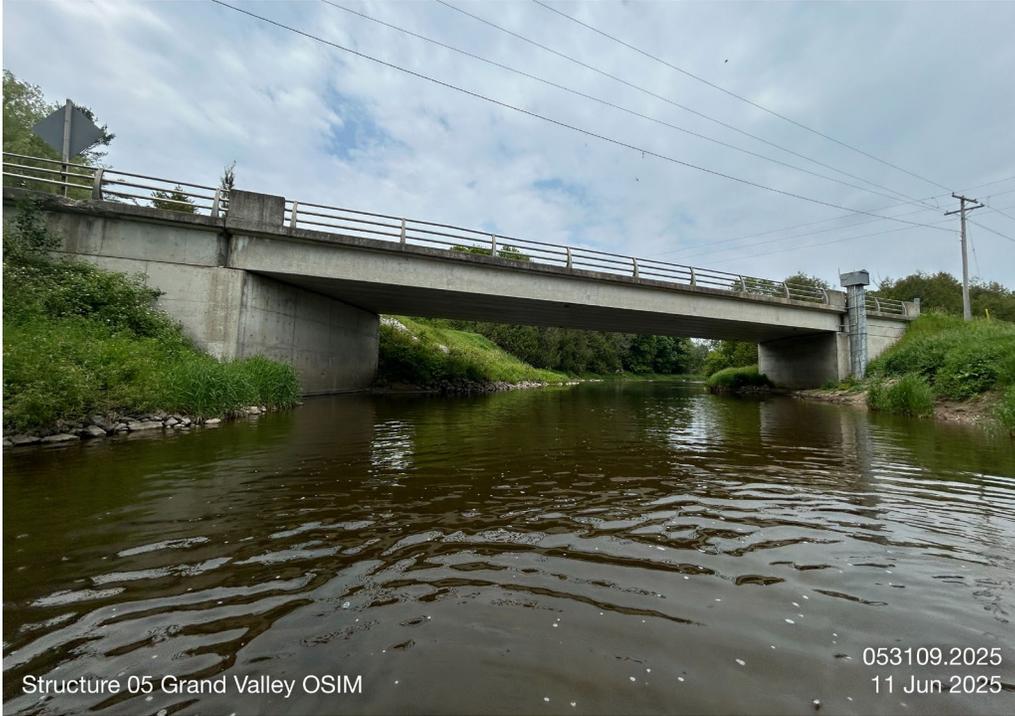
**ELEVATION SHOT – EAST**

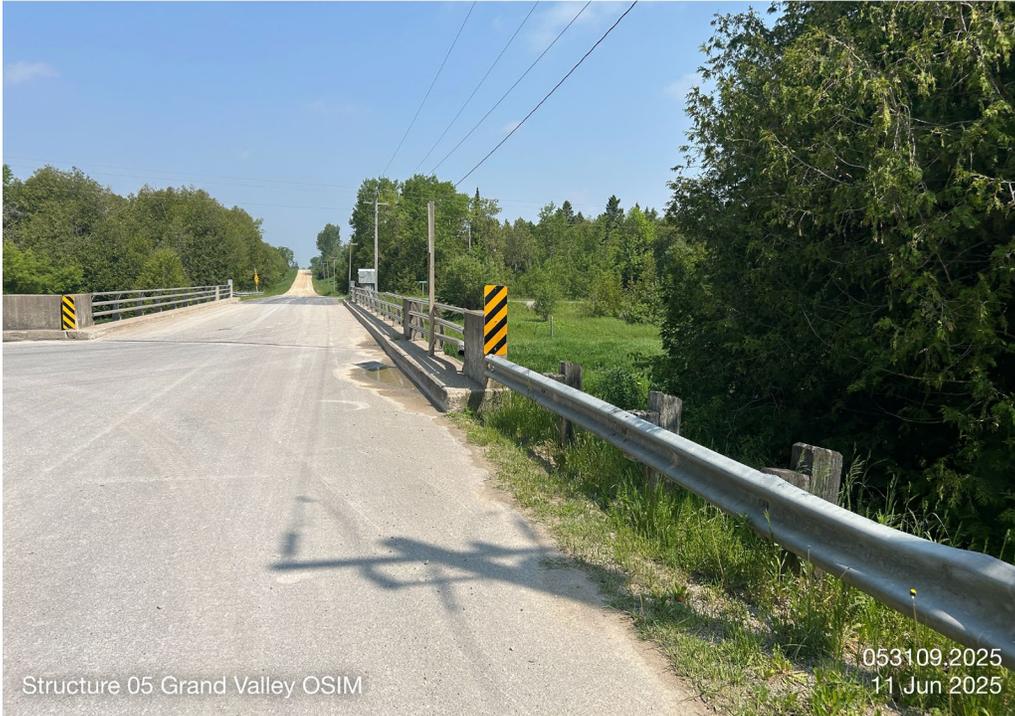
**APPROACH GUIDERAIL – SOUTHEAST – SEVERAL ROTTEN POSTS**

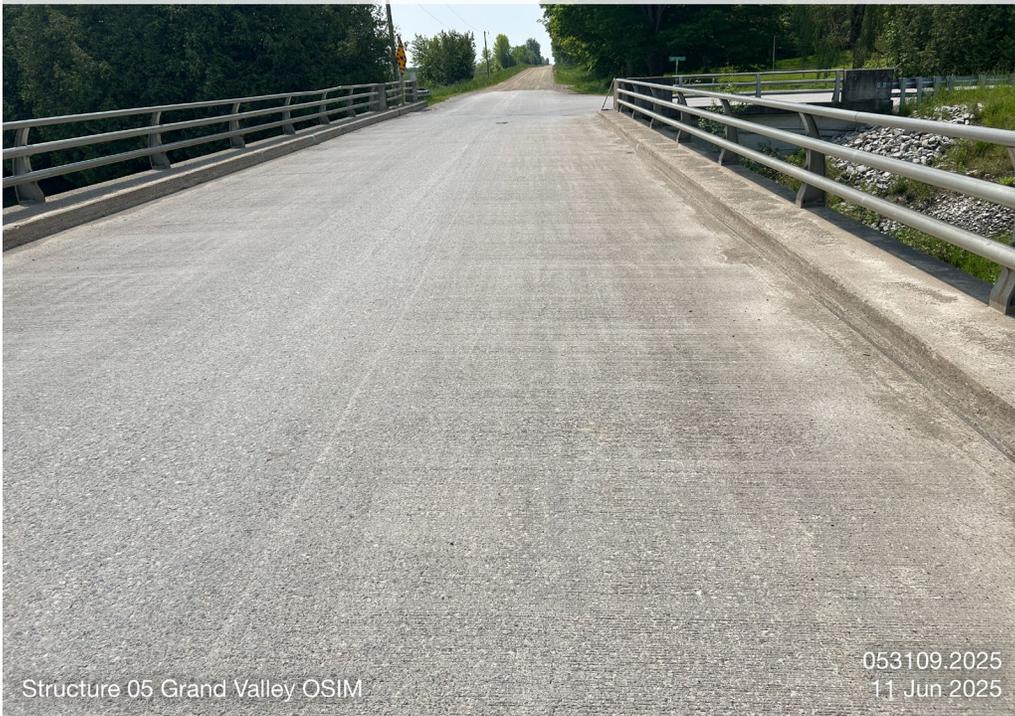
**DECK TOP – NORTH – 5 SECTIONS OF UNSOUND CONCRETE**

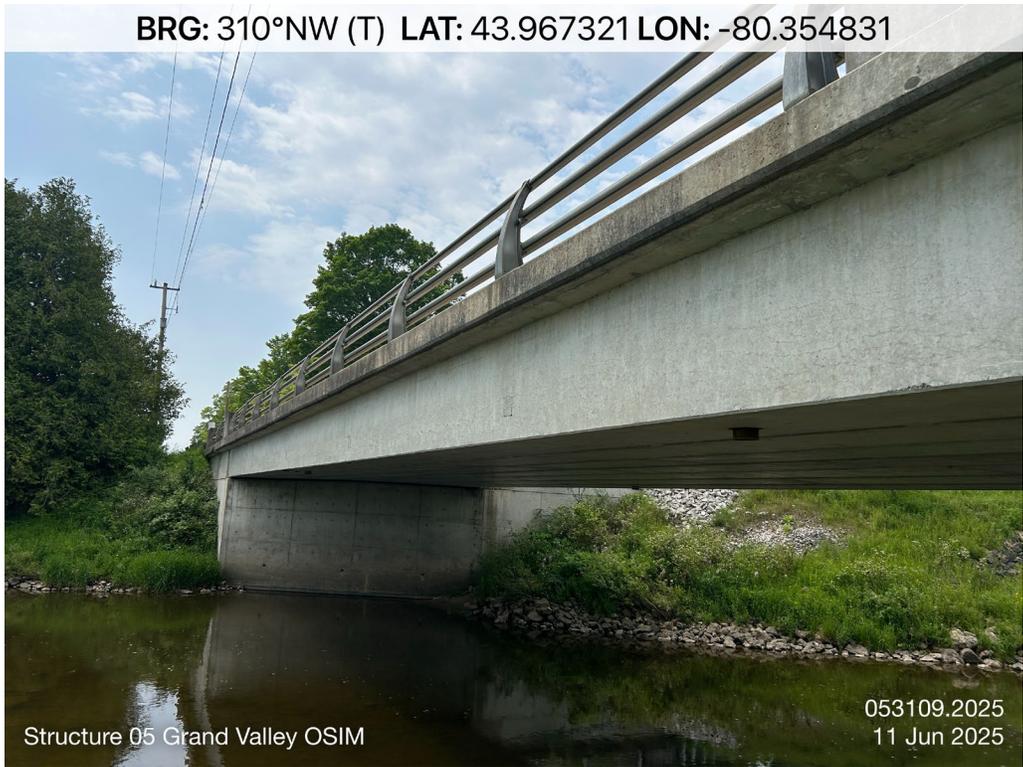
**SOFFIT EXTERIOR – EAST**

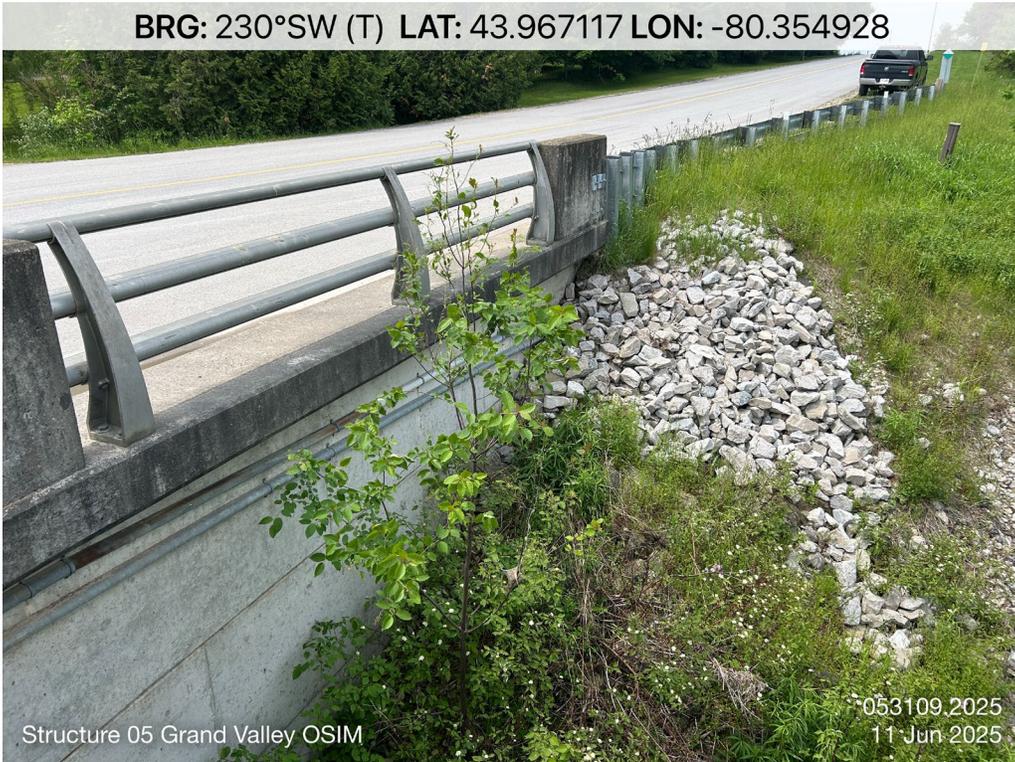
**EMBANKMENT – SOUTHWEST – ROCK PROTECTION**

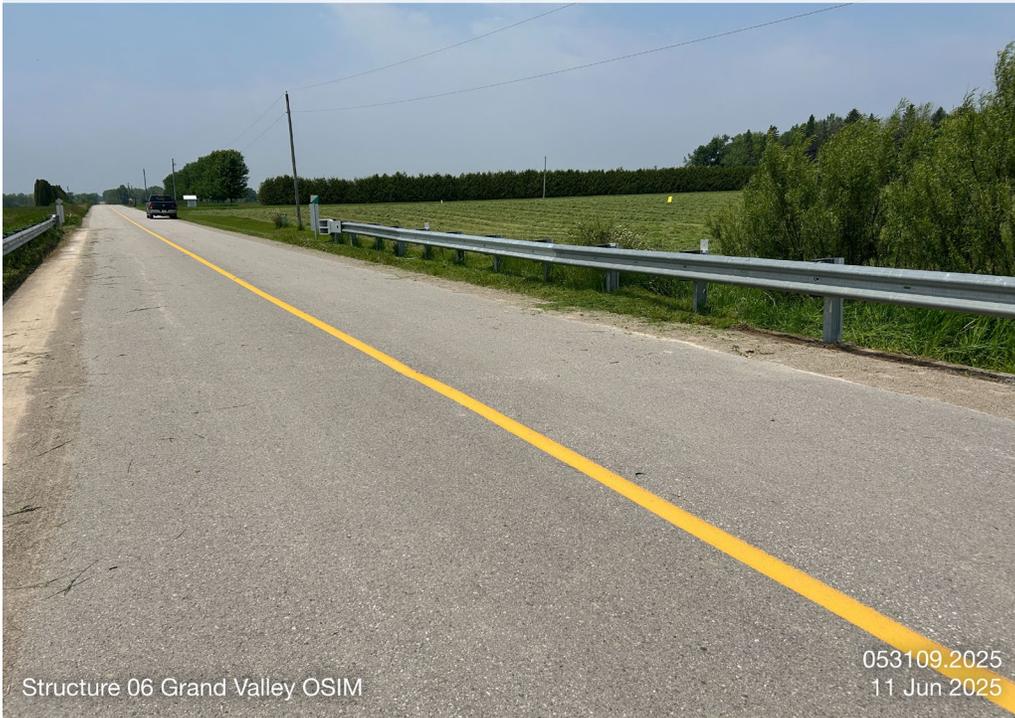
**DEACK WEARING SURFACE – WEST – RE-PAVED IN 2023**

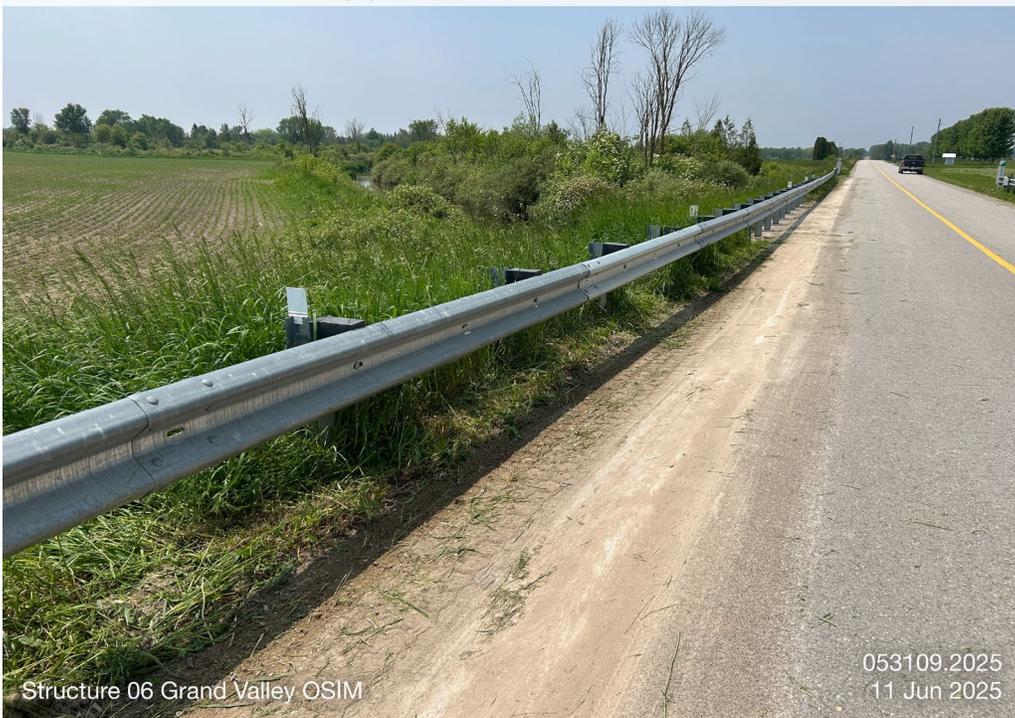
**GUIDERAIL – SOUTHWEST – INSTALLED 2023**

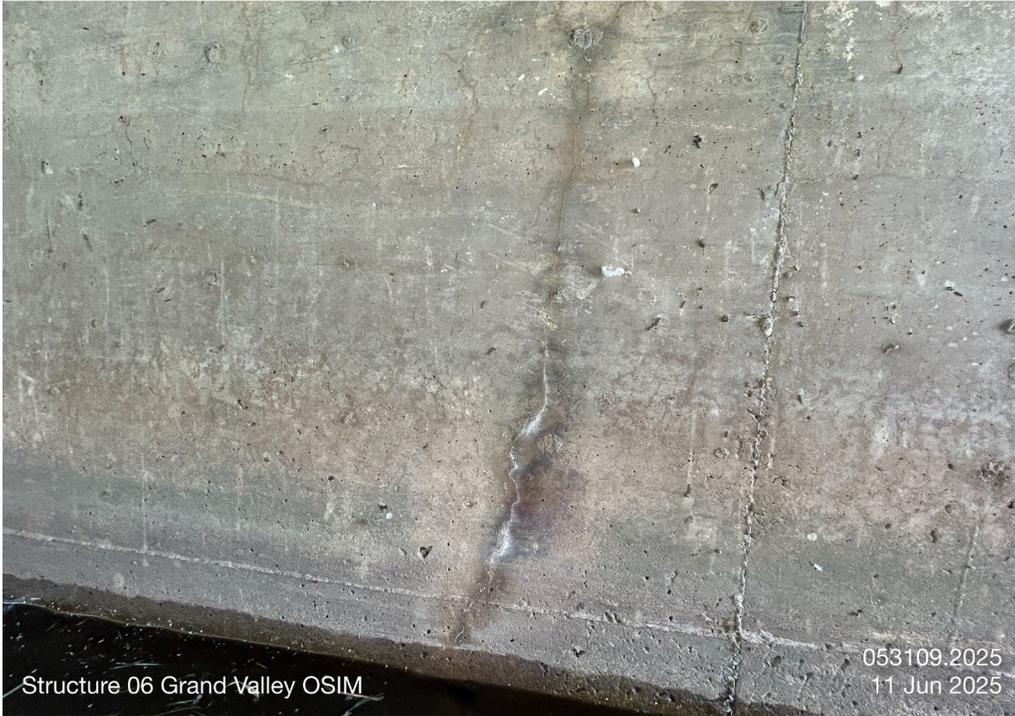
**ABUTMENT WALLS – EAST – CRACKS AND MEDIUM STAINED CRACKS**

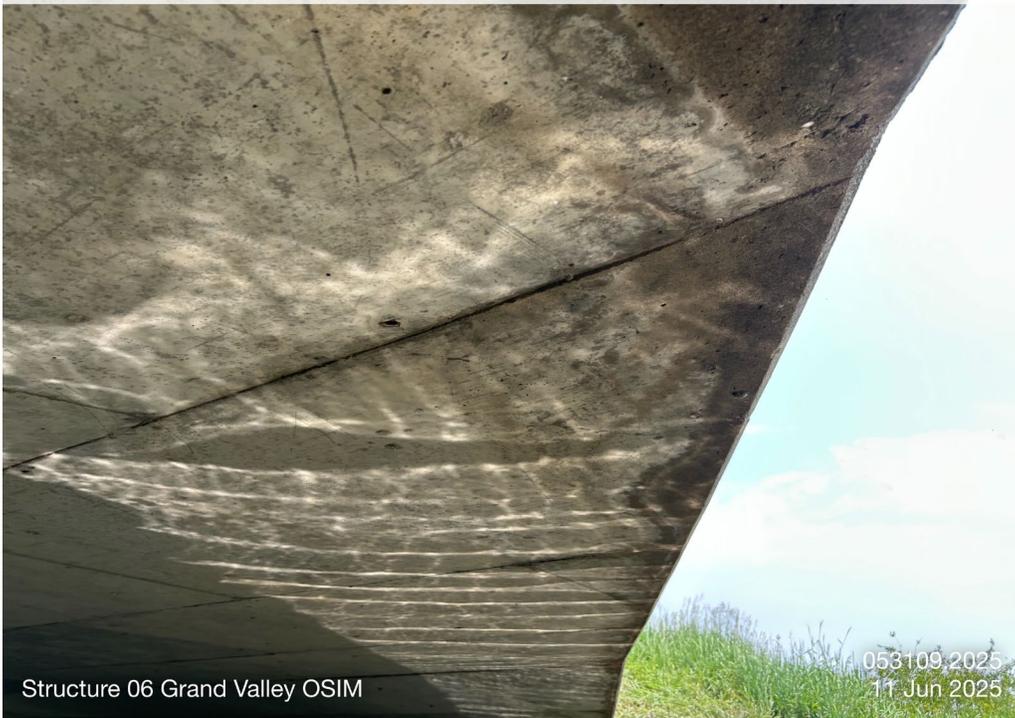
**SOFFIT – INTERIOR – NARROW TO MEDIUM CRACKS ALONG SPAN**

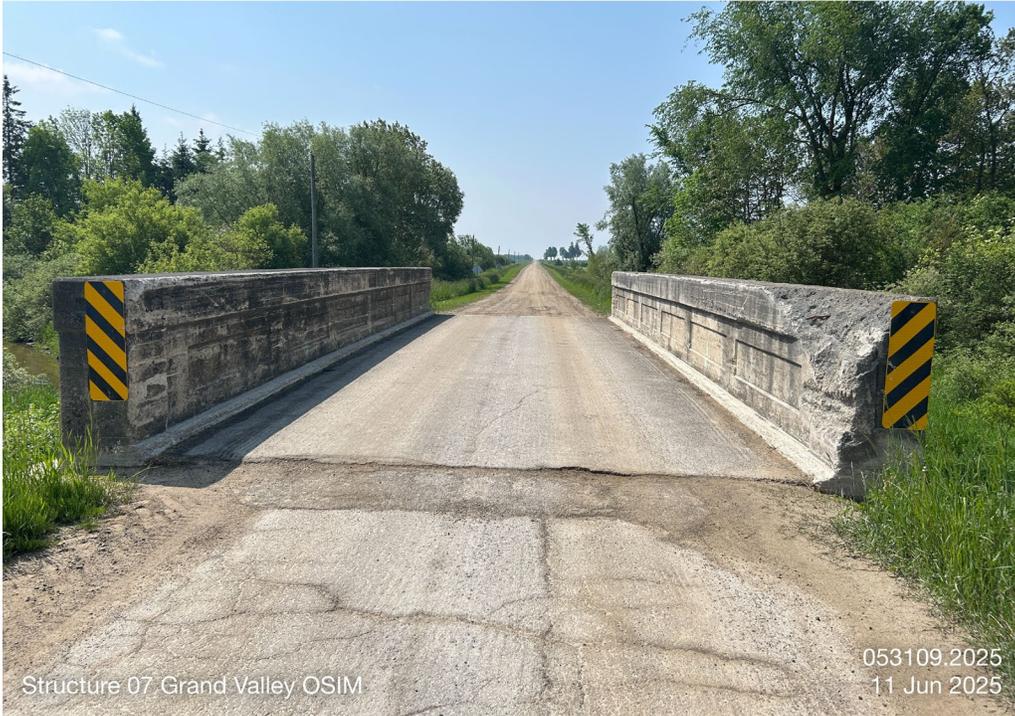
**APPROACH WEARING SURFACE – NORTH – WIDE TRANSVERSE CRACKS**

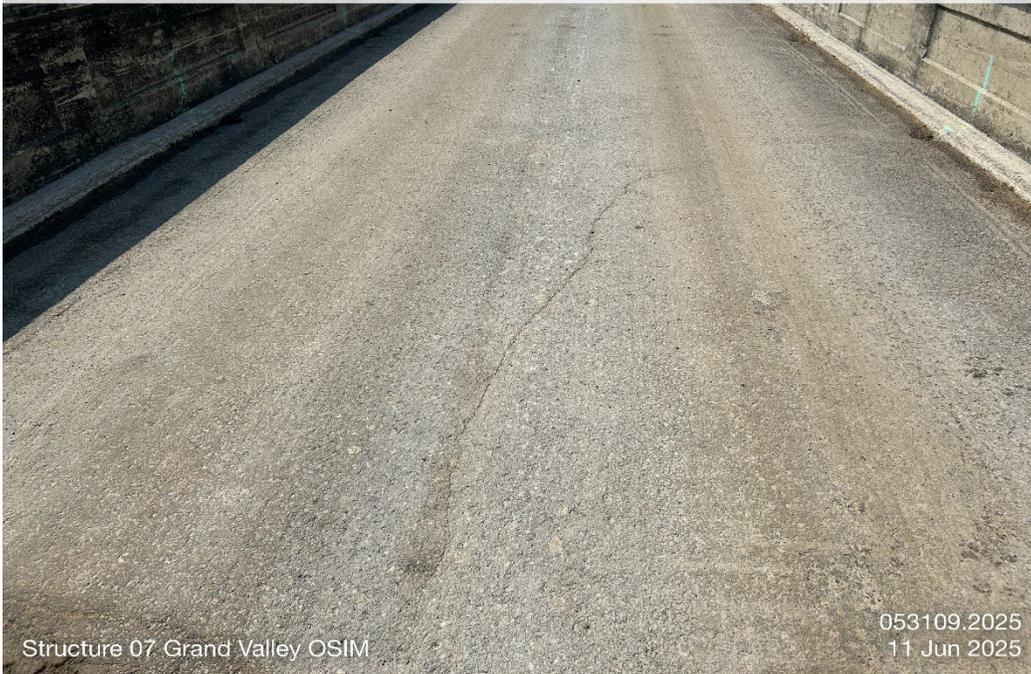
**DECK WEARING SURFACE – NORTH – MEDIUM LONGITUDINAL AND TRANSVERSE CRACKS**

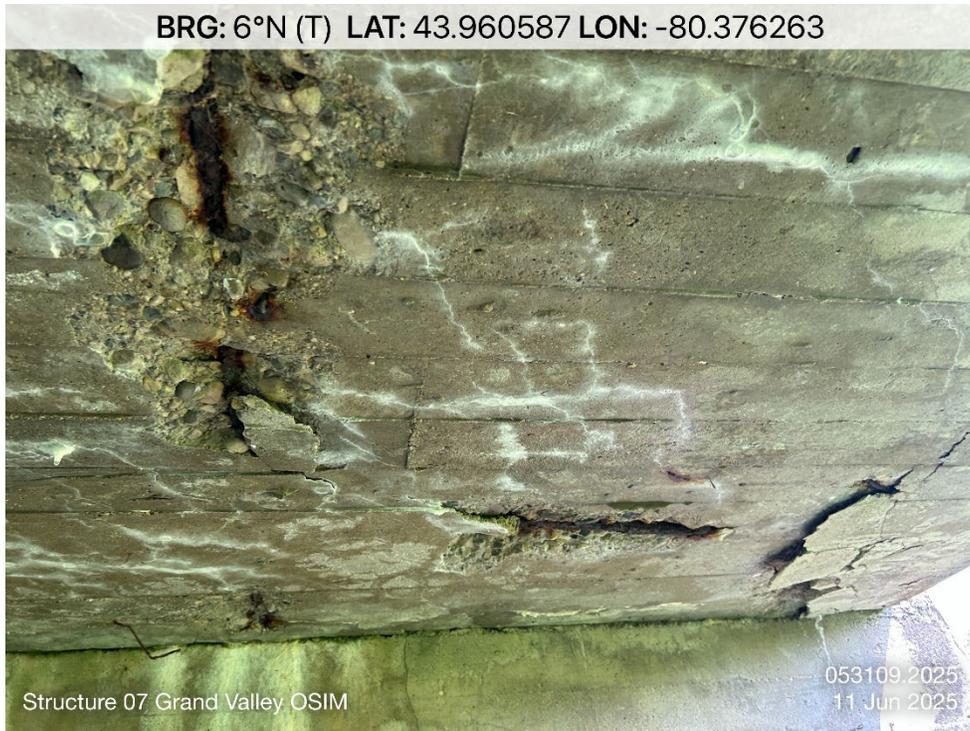
**SOFFIT – INTERIOR – SPALLS WITH EXPOSED CORRODED REBAR, DELAMINATIONS AND STAINING THROUGHOUT**

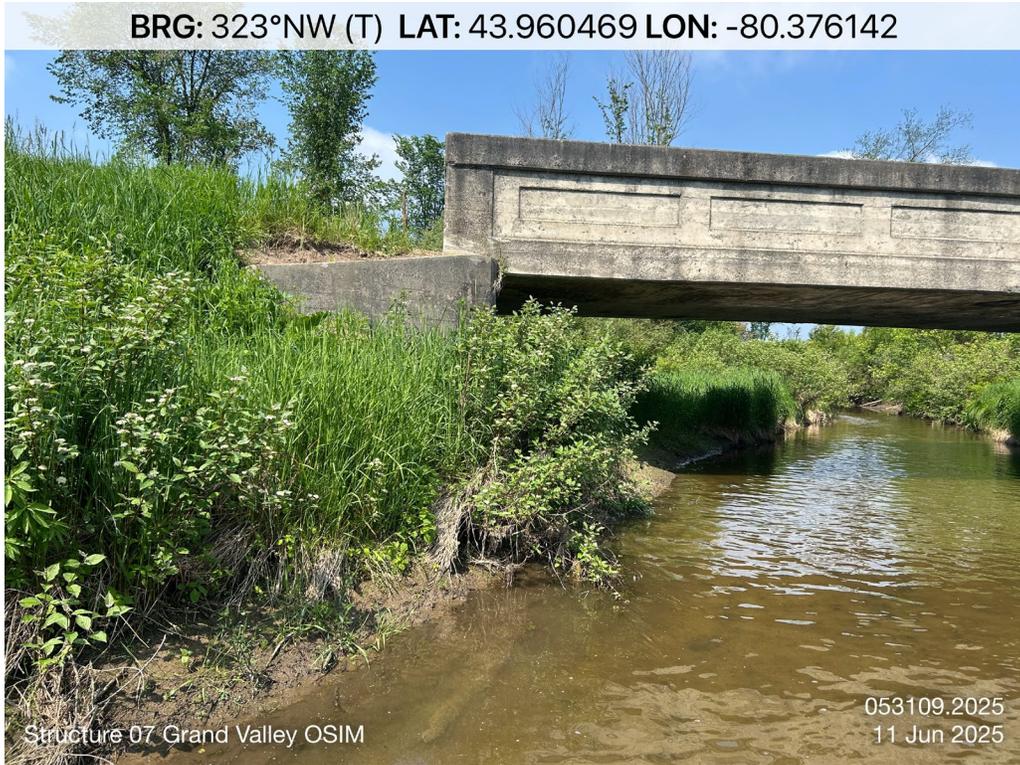
**STREAM – NORTHEAST – WELL ALIGNED WITH STRUCTURE**

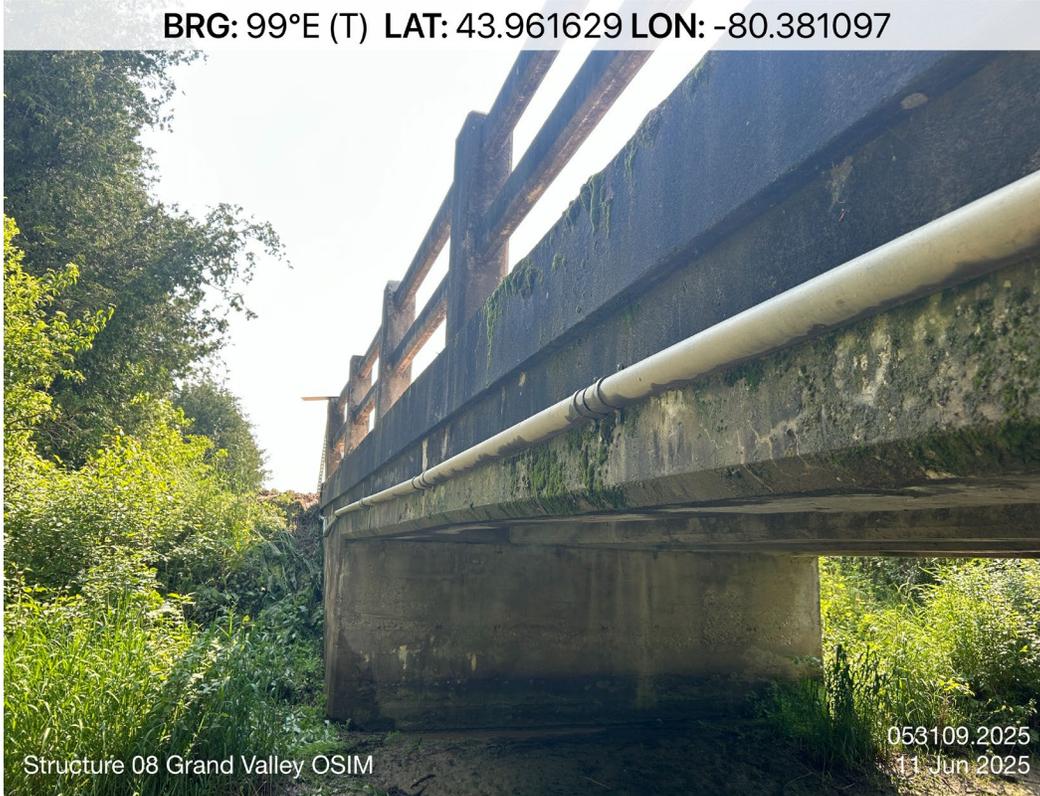
**ELEVATION SHOT – NORTH**

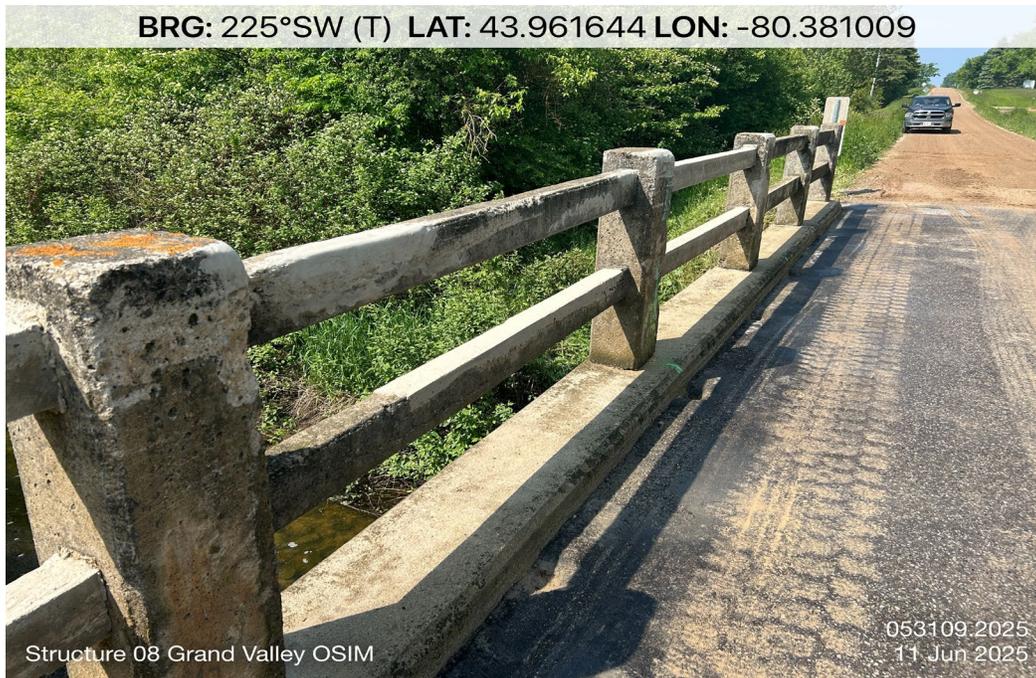
**BARRIER – SOUTH – SEVERE SPALLS AND ABRASIONS THROUGHOUT WITH PATCH WORK**

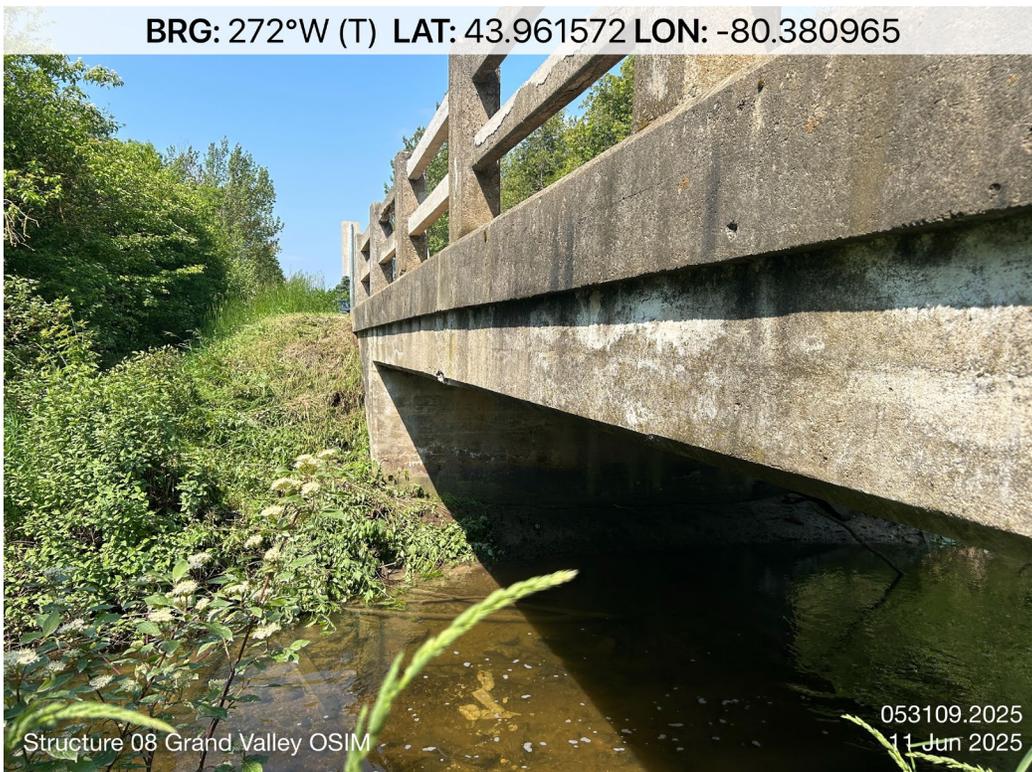
**STREAM – SOUTH – FLOWS NORTH TO SOUTH**

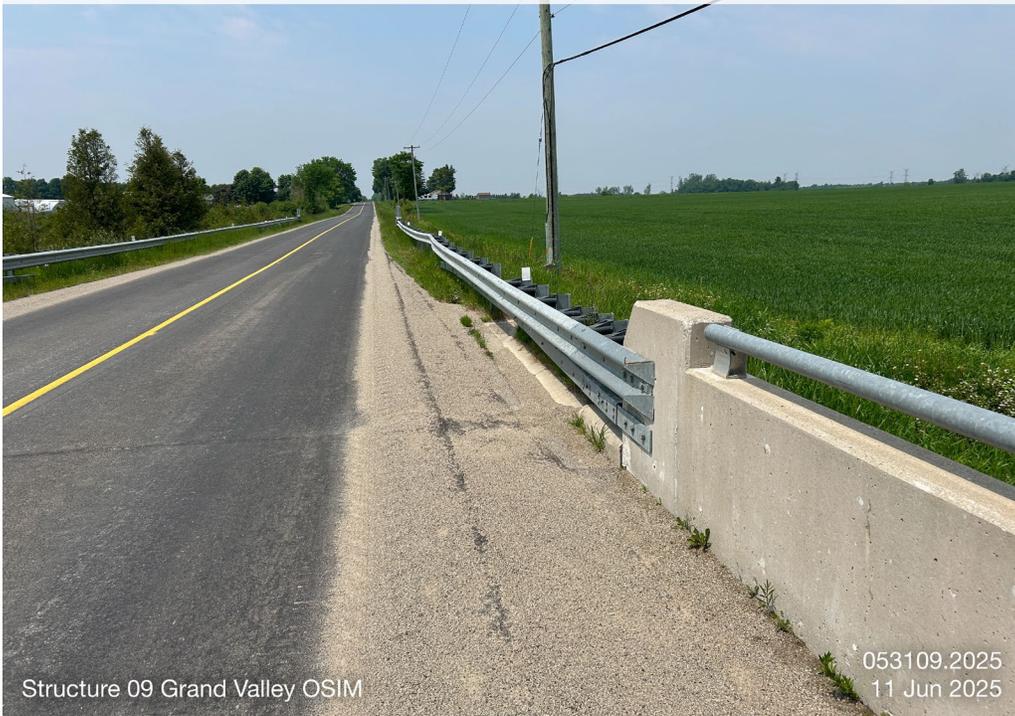
**DECK WEARING SURFACE – NORTH – LIGHT TO MEDIUM CRACKS**

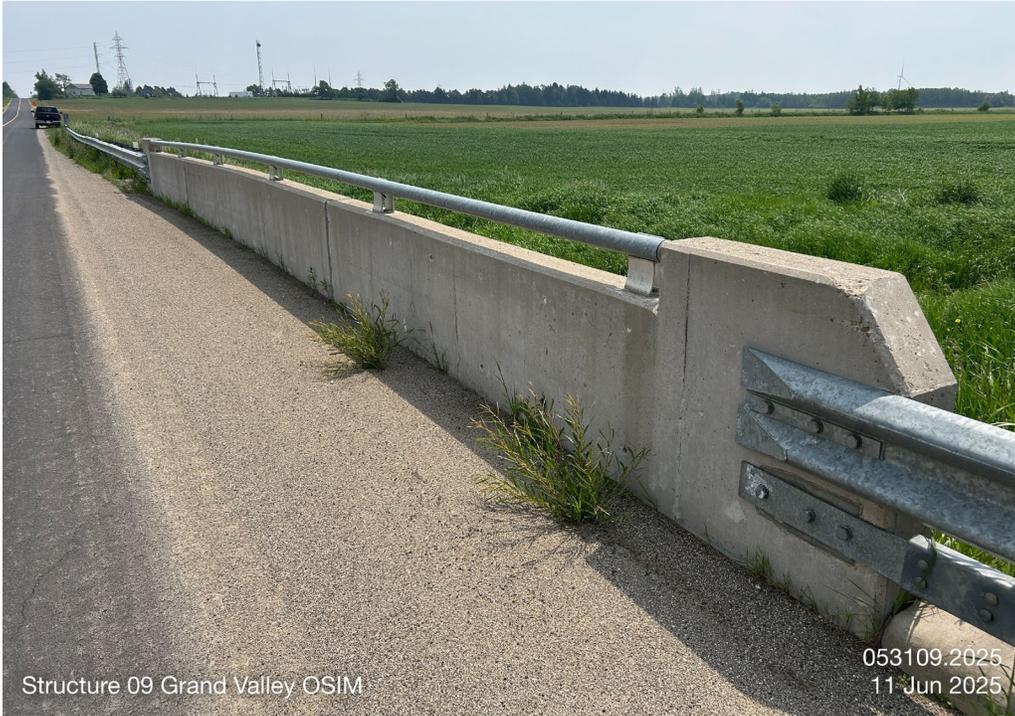
**GUIDERAIL – NORTHWEST – MINOR IMPACT DAMAGE**

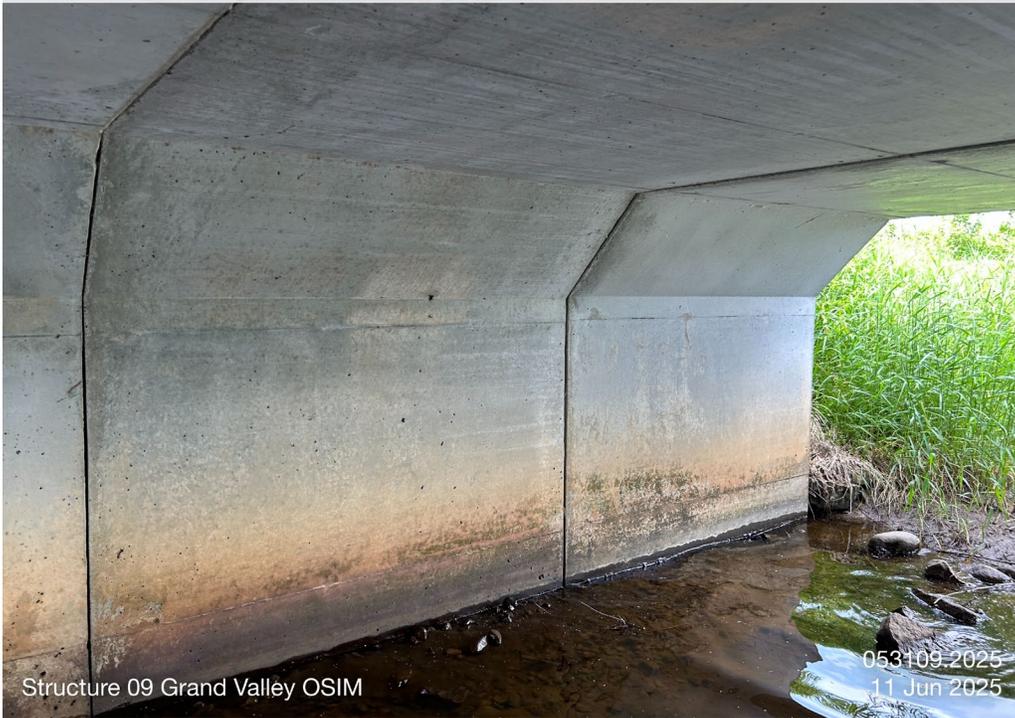
**SOFFIT – INTERIOR – LIGHT MOISTURE STAINING**

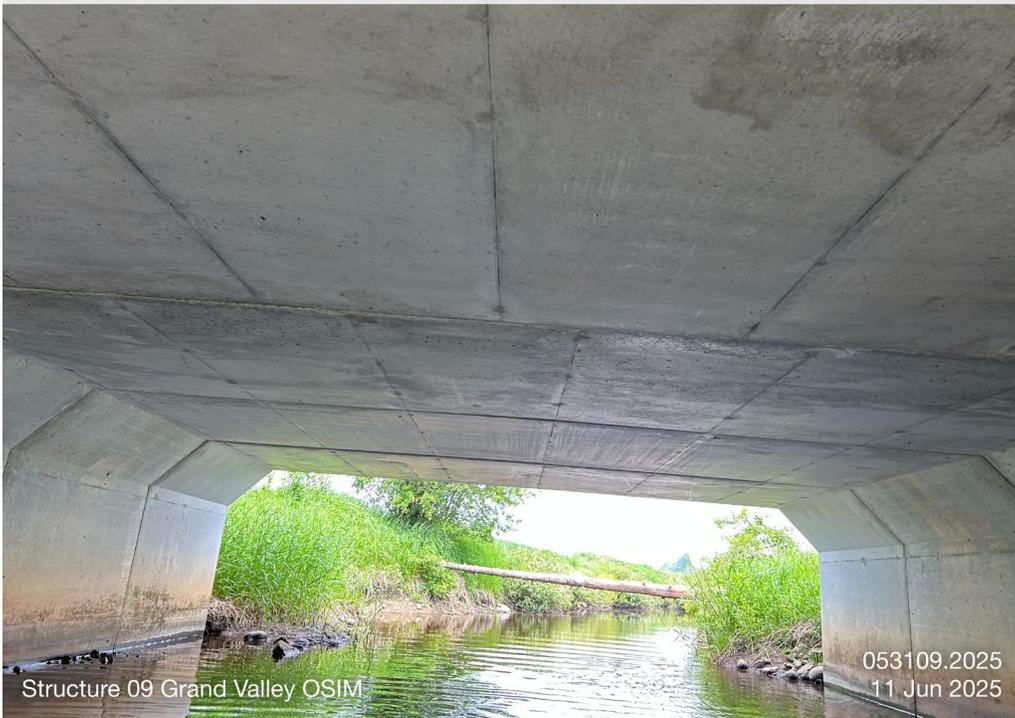
**ABUTMENT WALLS – WEST – WATER STAINING ALONG JOINTS**

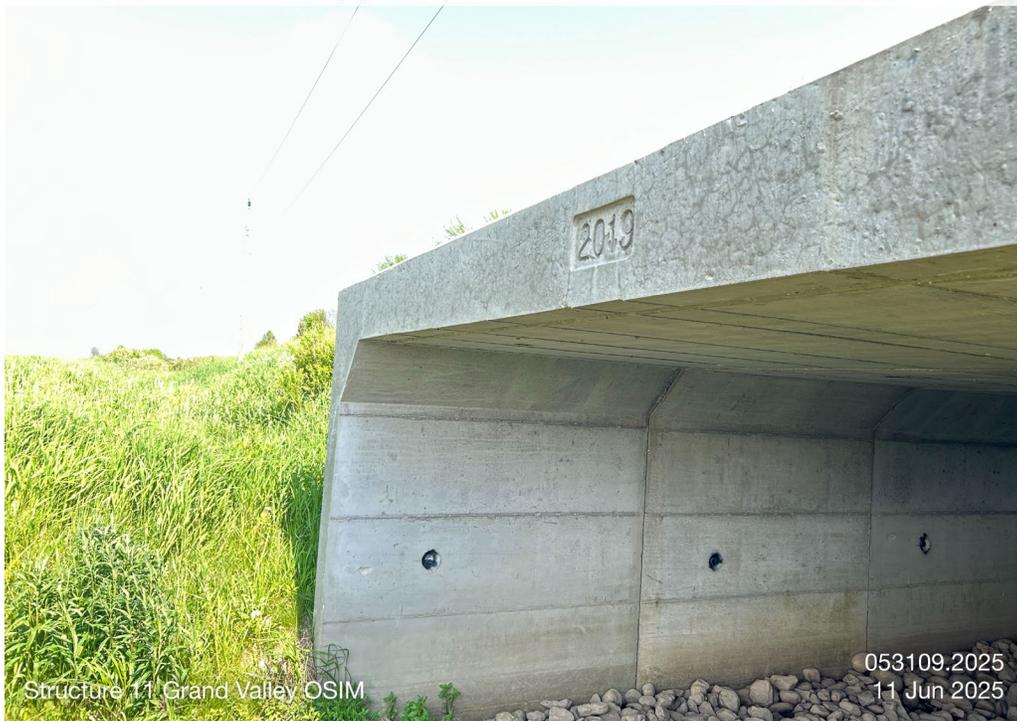
**BARREL – INSIDE – SMALL POPOUTS**

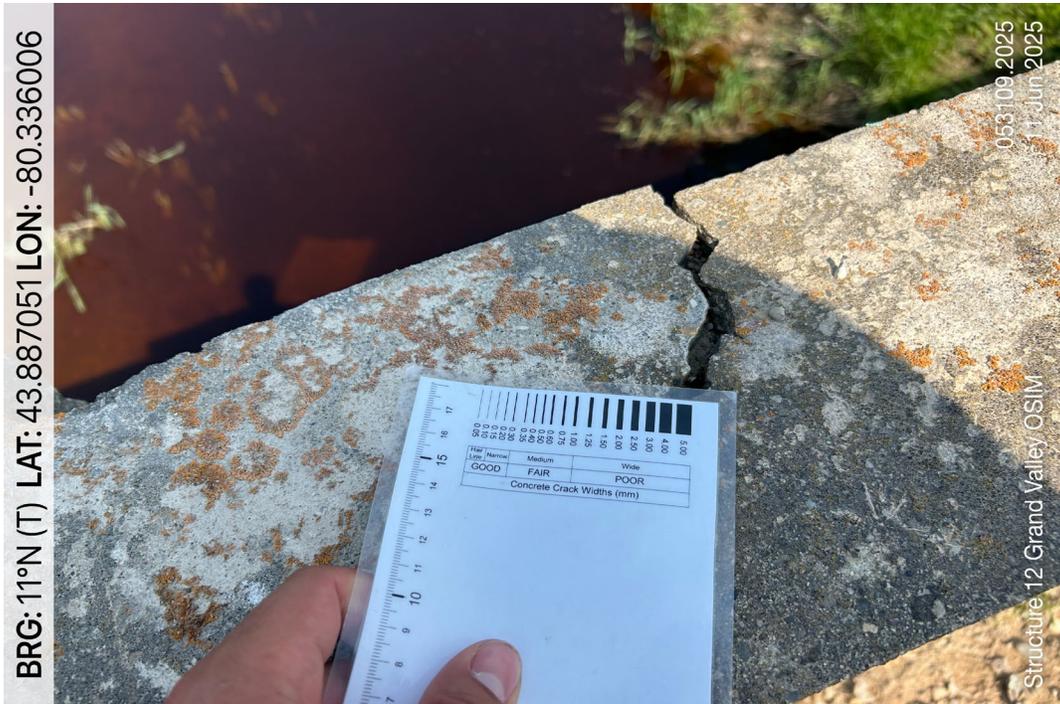
**BARRIER – EAST – LIGHT SPALLS AND ABRASIONS**

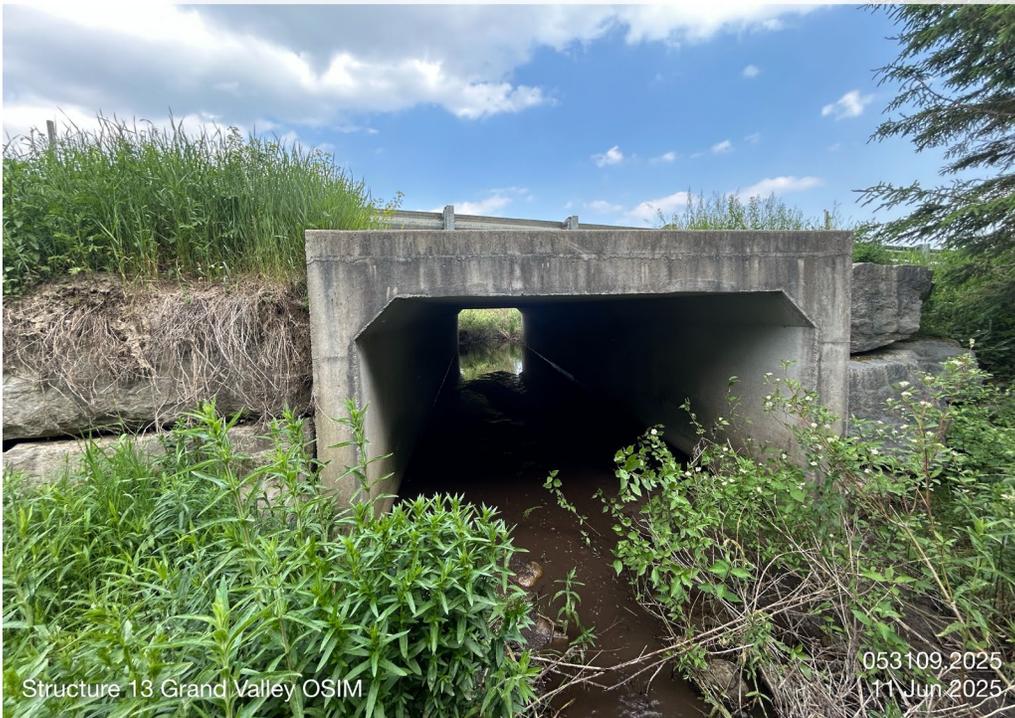
**BARREL – INTERIOR – GAPS AT JOINTS**

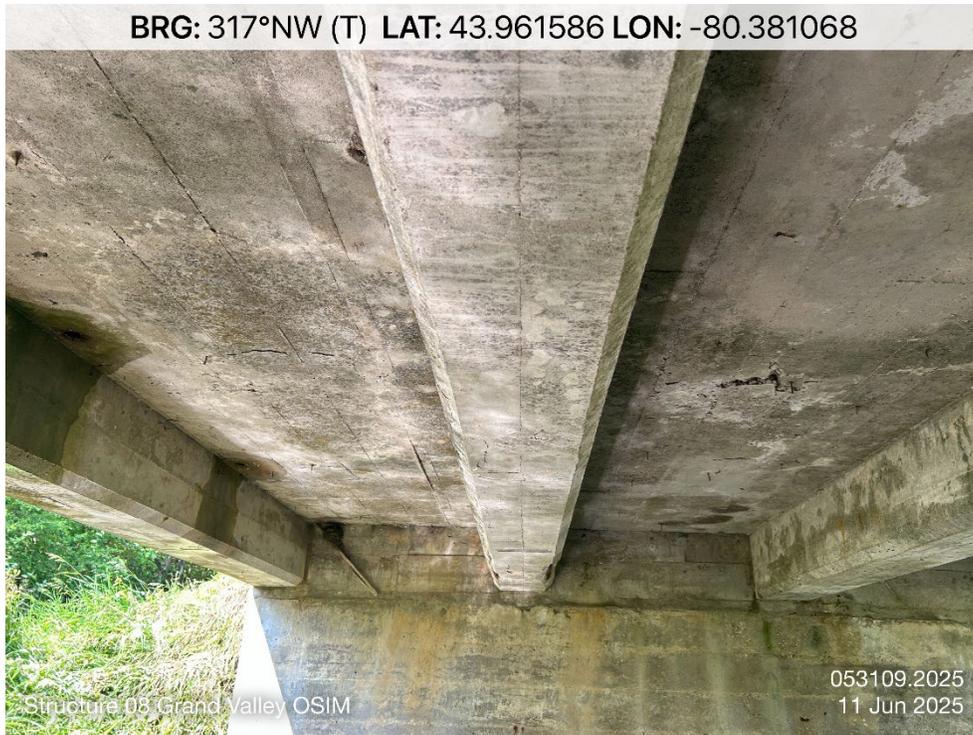
**SOFFIT- INTERIOR – EXPOSED CORRODED REBAR AND DELAMINATIONS THROUGHOUT**

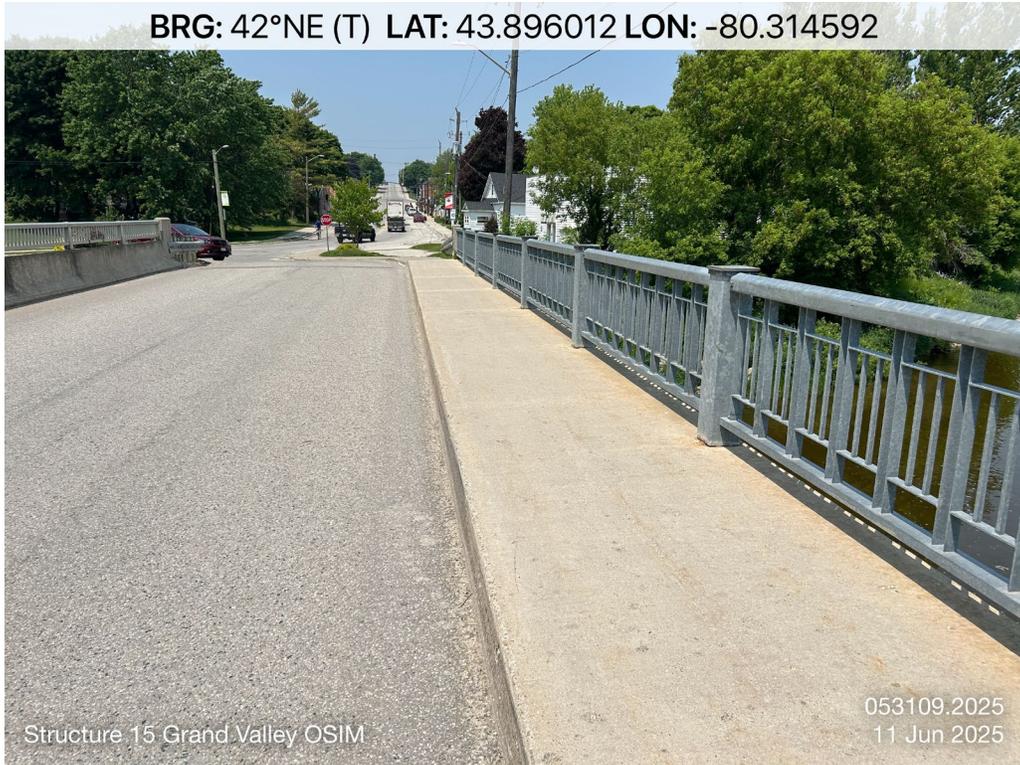
**RAILING SYSTEM – EAST**

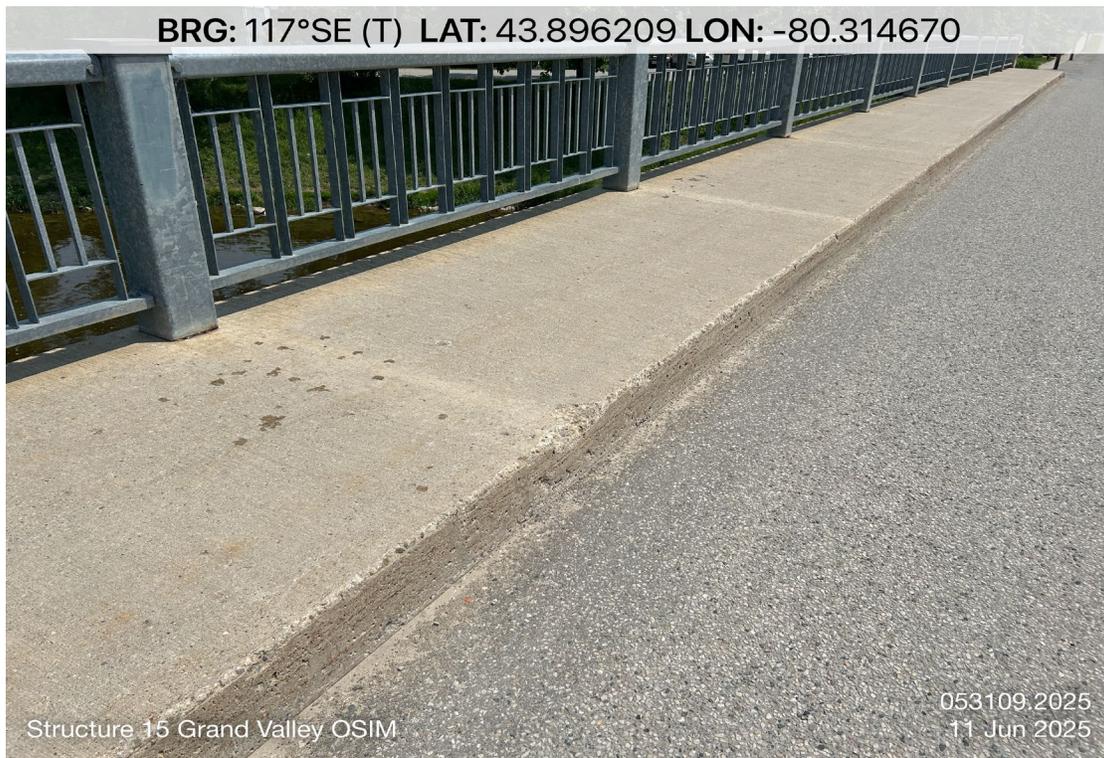
**SIDEWALK – EAST – SMALL POPOUTS THROUGHOUT**

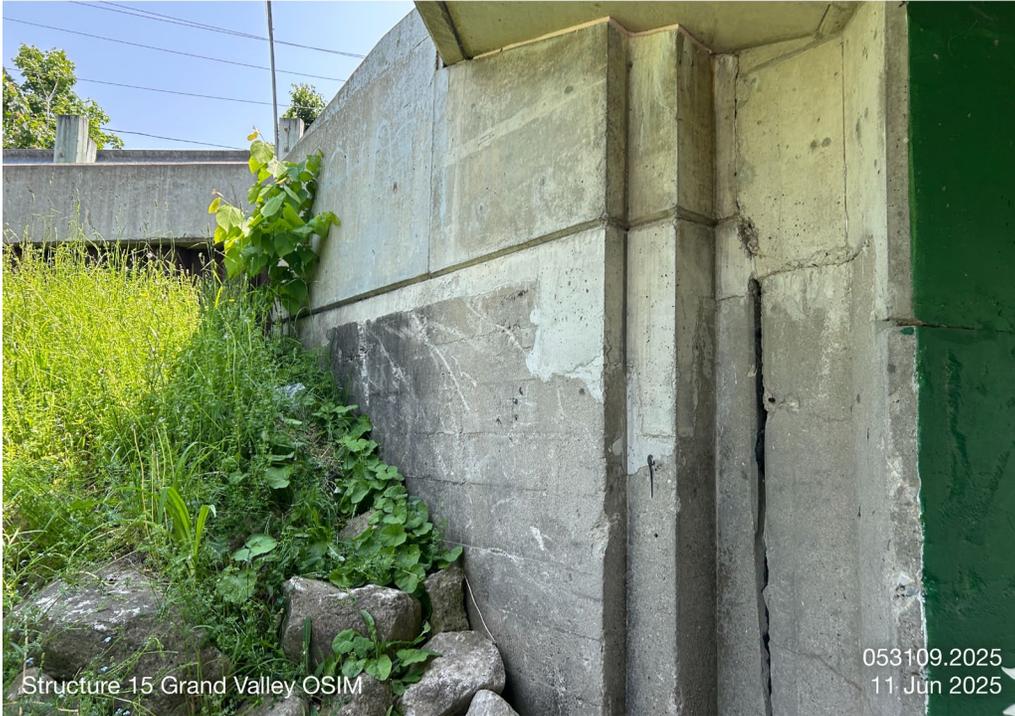
**WINGWALL – SOUTHEAST – LIGHT SCALING AND DELAMINATIONS**
