**2025 OSIM Bridge Inspections Report**

**Town of Grand Valley  
5 Main Street North  
Grand Valley, ON L9W 5S6**

**November 2025  
30053109.2025**

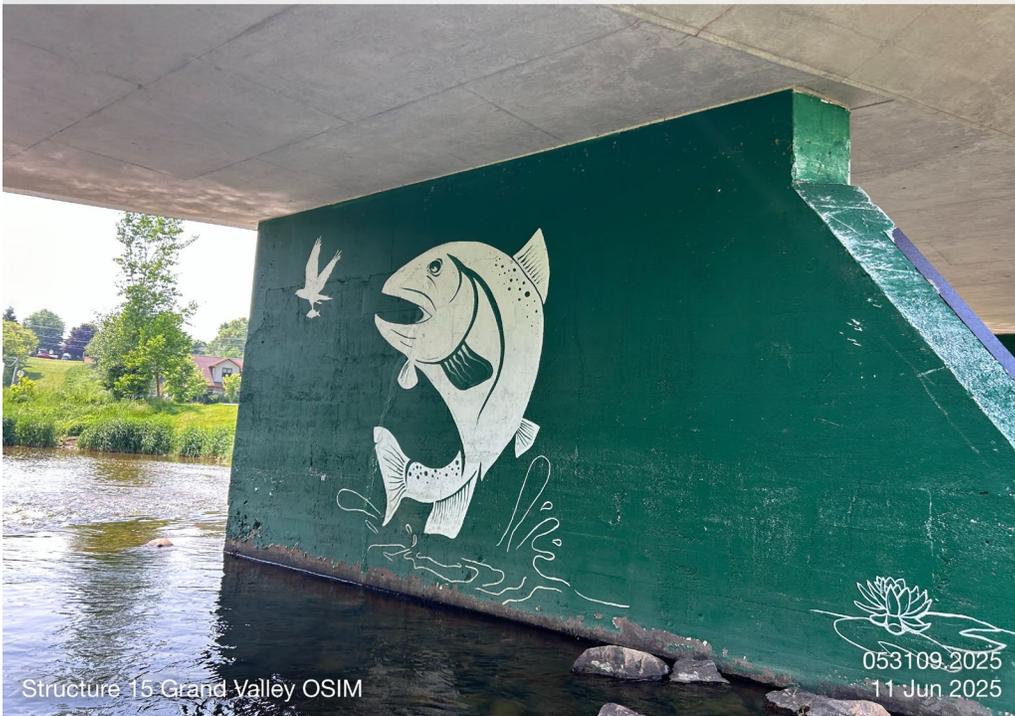
**ABUTMENT WALLS – SOUTH – MINOR HAIRLINE CRACKING**

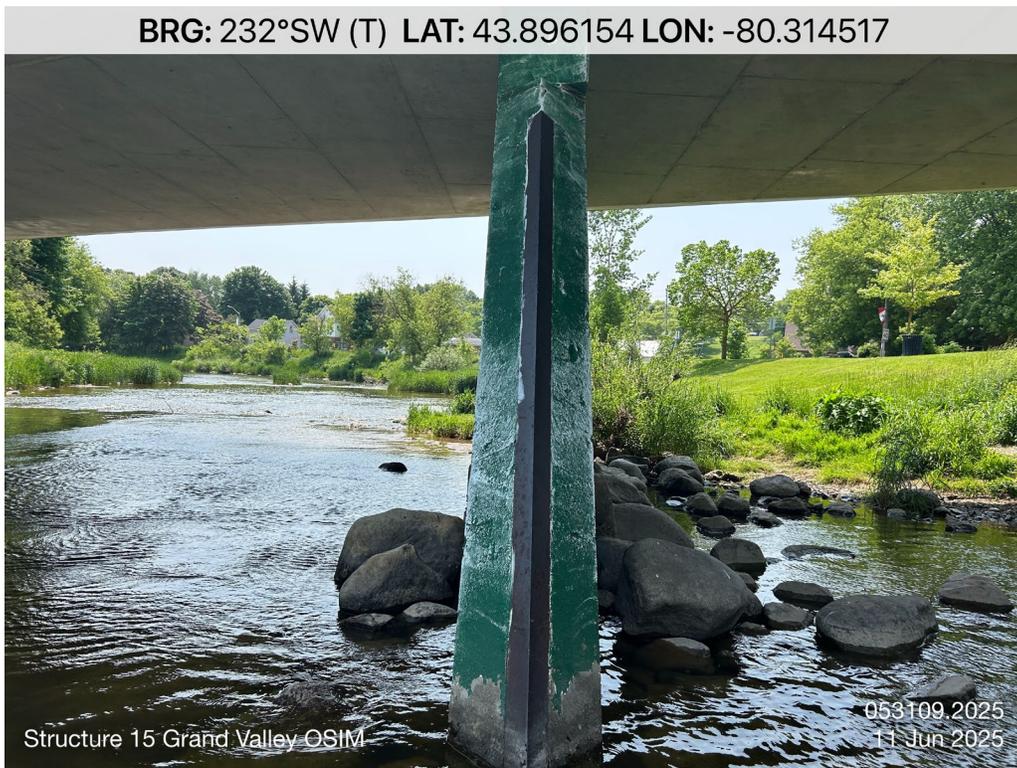
**STREAM – THROUGH STRUCTURE – FLOWS EAST TO WEST**

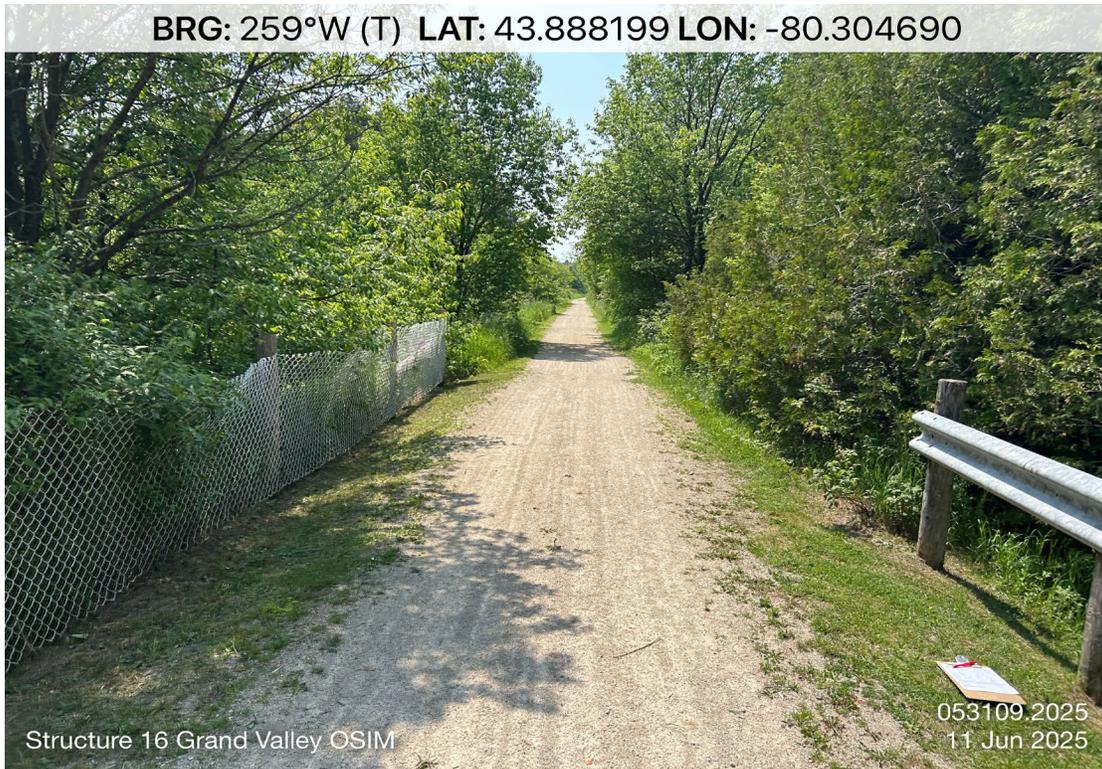
**DECK WEARING SURFACE – WEST – GRAVEL ON WALKING TRAIL**

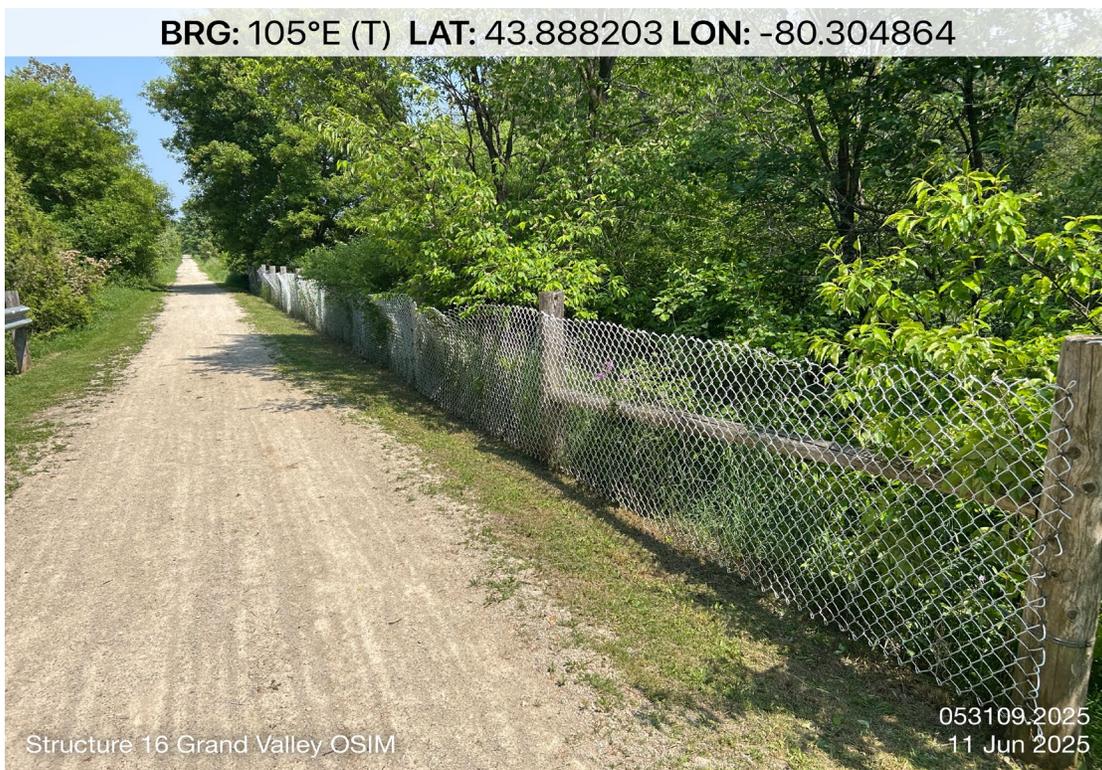
**BARRIER – SOUTH – WHITE CHAIN LINKED FENCE ON WOODEN POSTS**

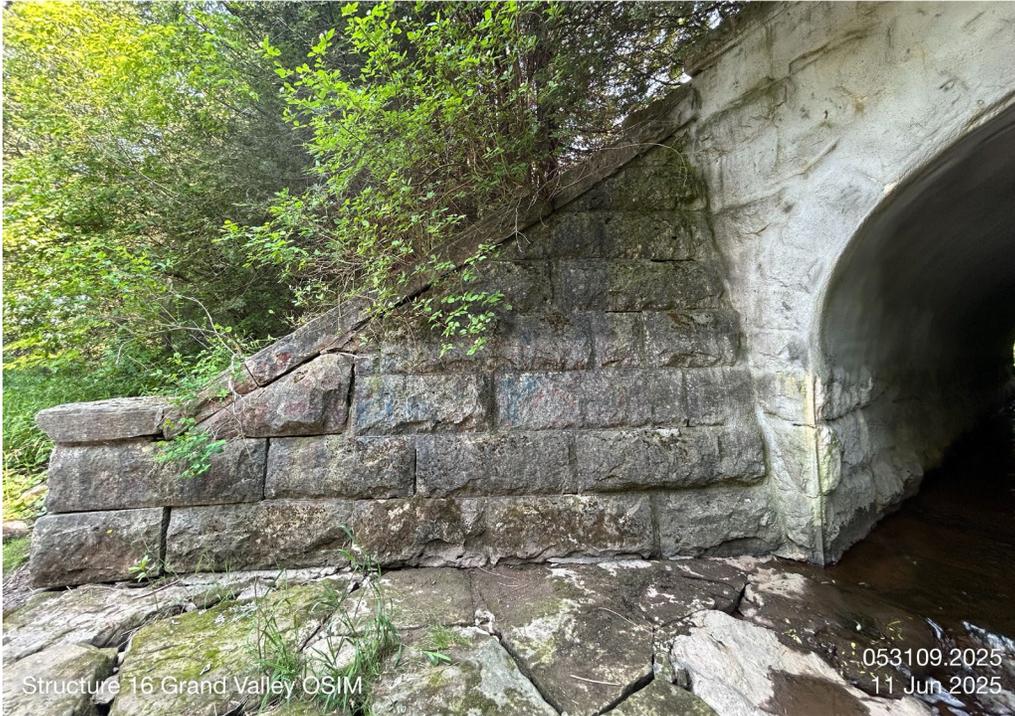
**WINGWALL – NORTHEAST**

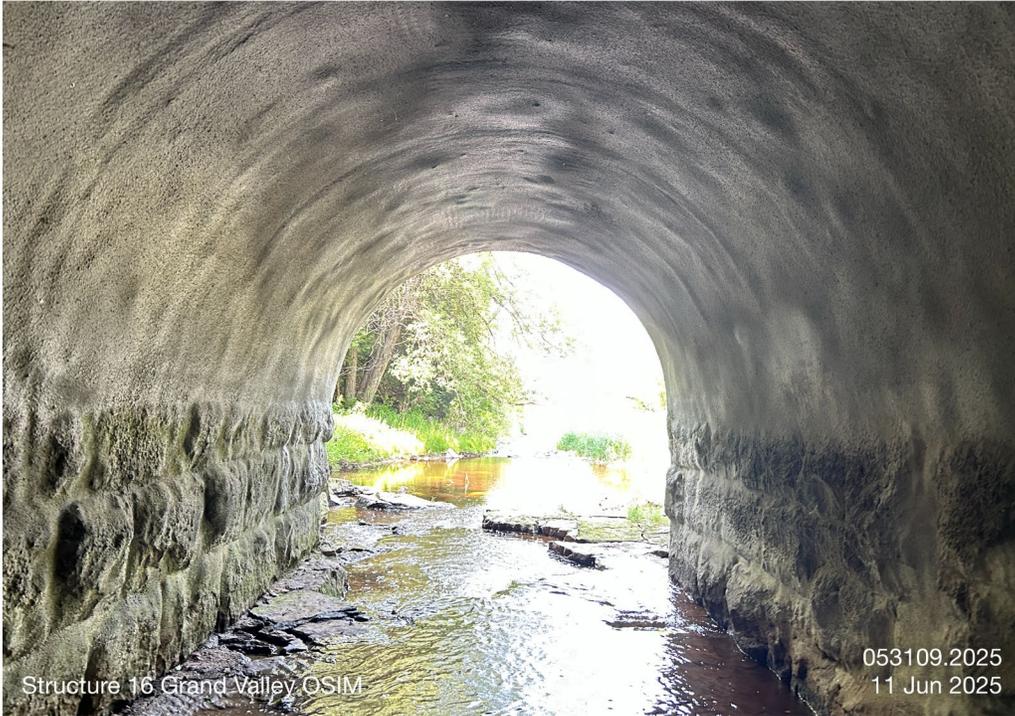
**BARREL – INSIDE – DESCRIPTION**

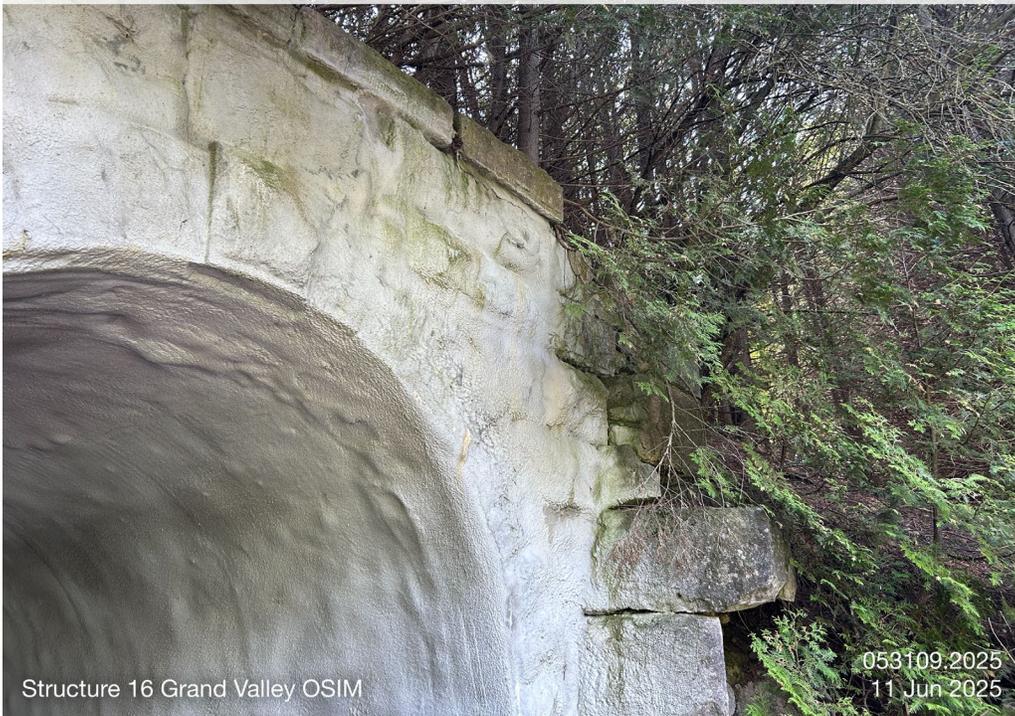
**OUTLET – NORTH – CRACK ON HEADWALL**

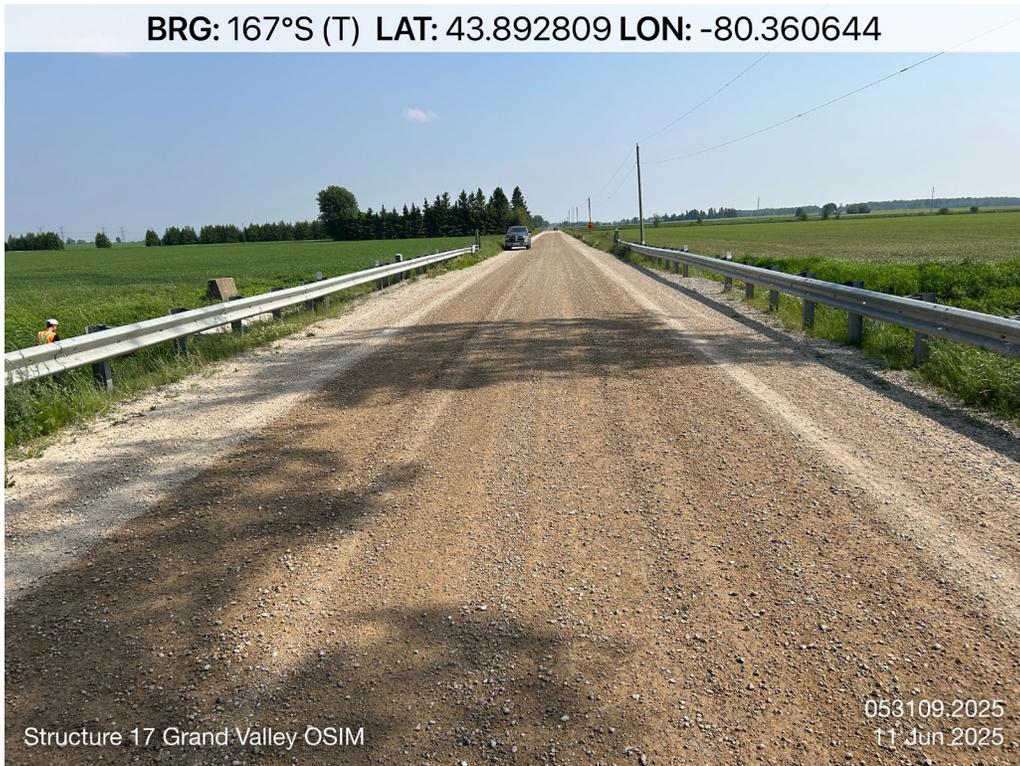
**DECK WEARING SURFACE – SOUTH**

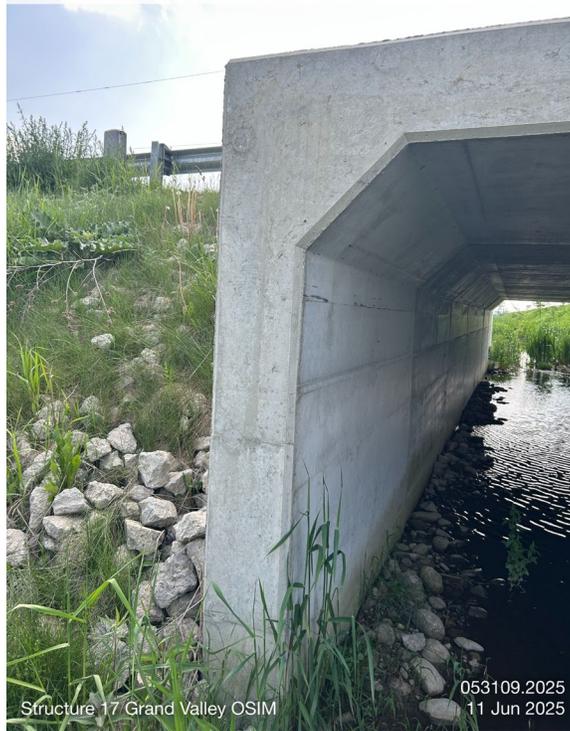
**INLET – WEST**

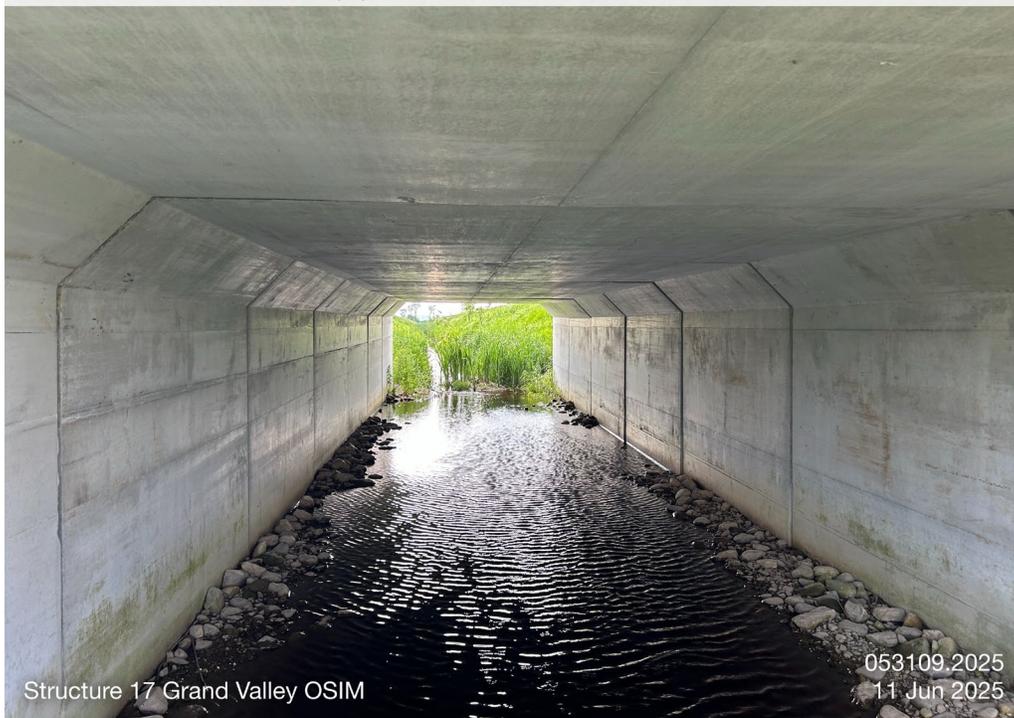
**BARREL – INTERIOR – SMALL POPOUTS**

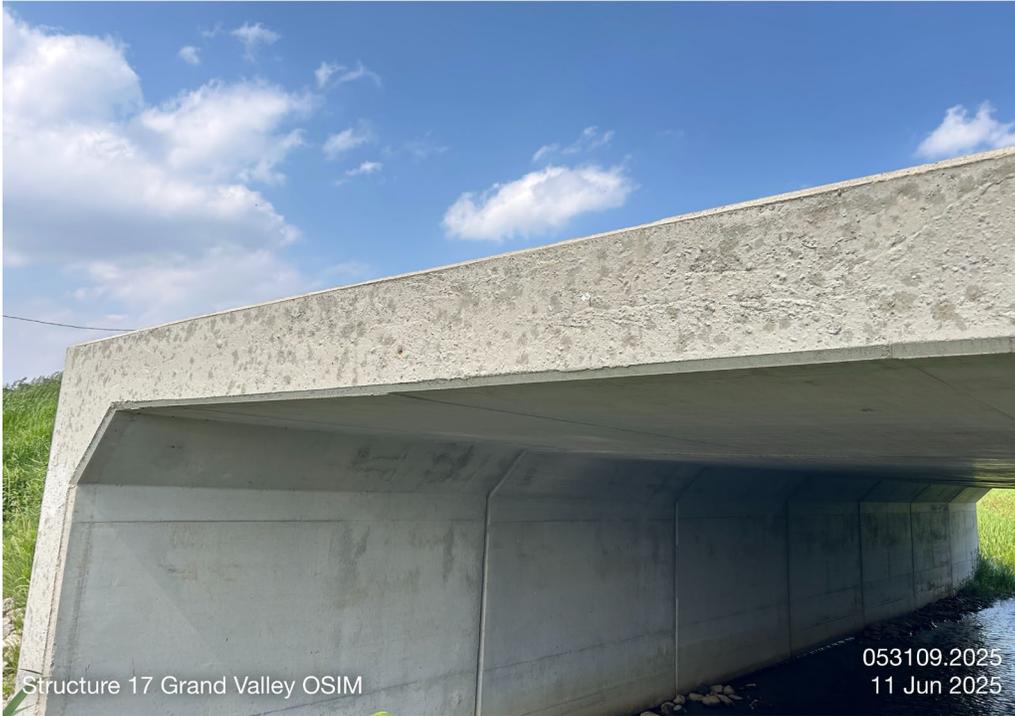
**OUTLET – WEST**
